## **CONTAMINATION SCREENING EVALUATION REPORT**

**I-75 FROM SOUTH OF SR 44 TO SR 200**  
Marion County and Sumter County, Florida  
Financial Project ID No. 443623-1-22-01  
GEC Project No. 4477E1

I-75 Improvements Project Development and Environment (PD&E) Study  
(Southern Section)

Limits of Project: I-75 from South of S.R. 44 to S.R. 200

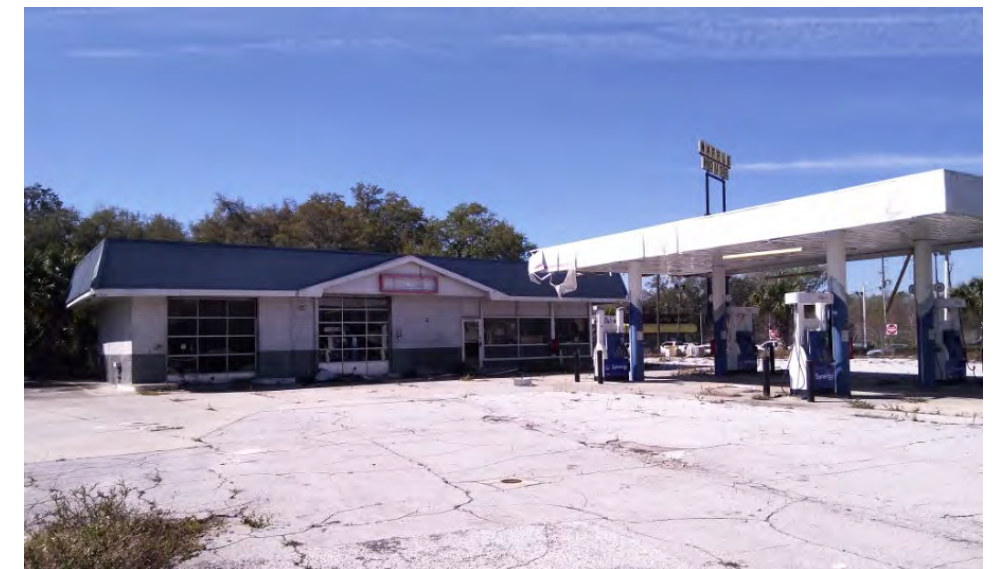
**SITE OBSERVATIONS:** The site consists of a vacant building, fueling canopy, and four fueling pumps. The gas station is no longer in operation. Monitoring wells were observed throughout the site.

**CONCLUSIONS:** Due to existing impacts, this site has been assigned a CRR of **Medium**. Based on the depth to the groundwater impacts, they are not expected to affect this project.

Looking south at the former gas station and fueling pumps. A monitoring well is in the foreground.

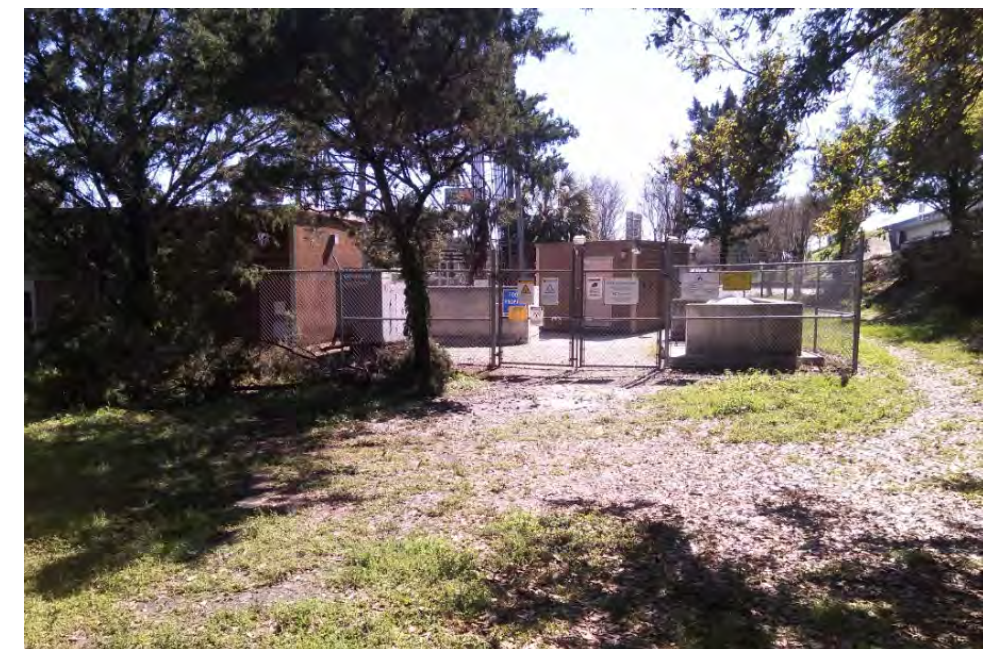
**PUBLIC RECORDS:** This site is a radio tower with an approximately 500-gallon aboveground emergency generator diesel belly tank. This tank appears to be below the FDEP tank registration size of 550 gallons. No violations, complaints, or discharges have been recorded at this site.

**CONCLUSIONS:** Due to the small size of the tank and lack of recorded contamination impacts, this site has been assigned a CRR of **Low**.

View of the radio tower base on-site.

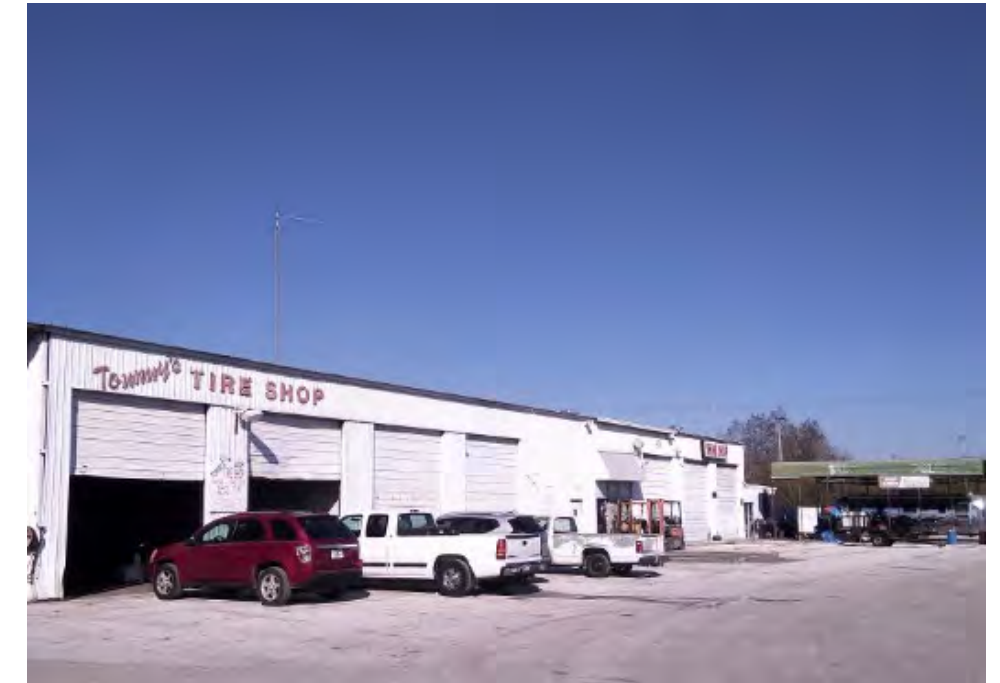
**CONCLUSIONS:** Due to the lack of recorded contamination impacts, and distance from I-75, this site has been assigned a CRR of **Low**.

Looking north at the auto repair shop.

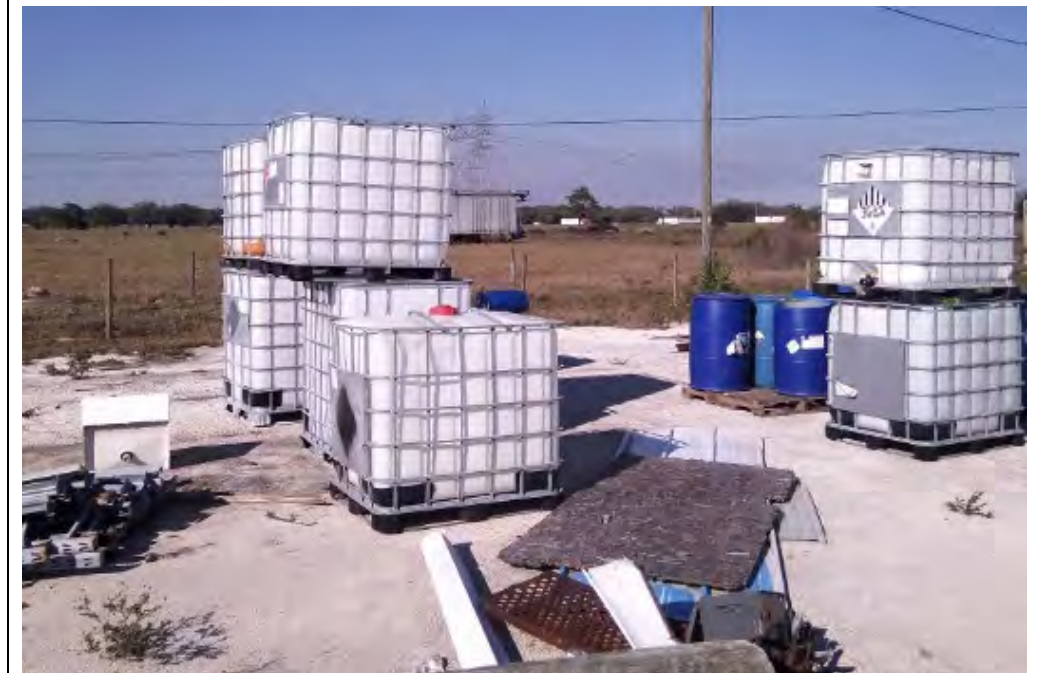
View of seven 250-gallon totes and a pallet of 55-gallon plastic drums.

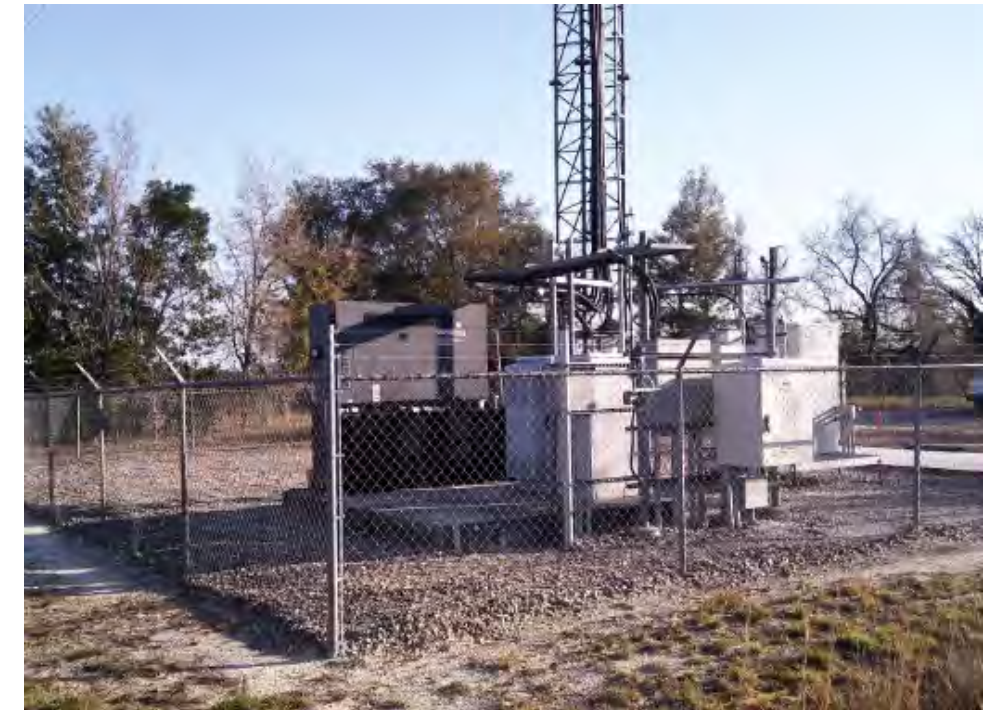
**CONCLUSIONS:** Due to the small size of the tank and lack of recorded contamination impacts, this site has been assigned a CRR of **Low**.

View of the base of the radio tower.

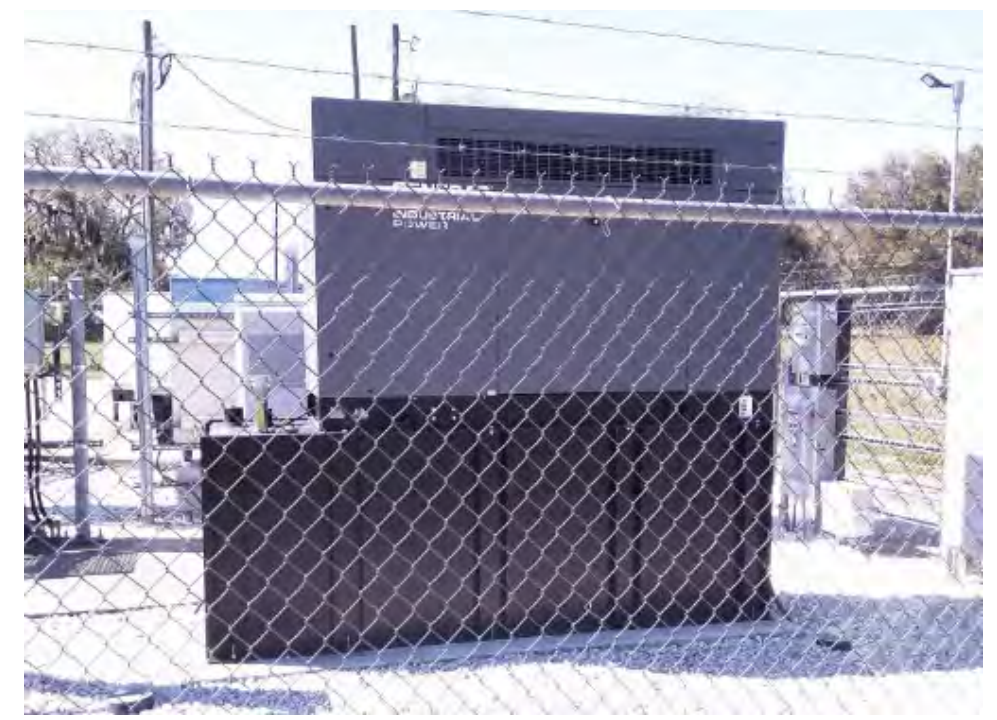
**CONCLUSIONS:** Due to the small size of the tanks and lack of recorded contamination impacts, this site has been assigned a CRR of **Low**.

View of first emergency generator diesel tank.

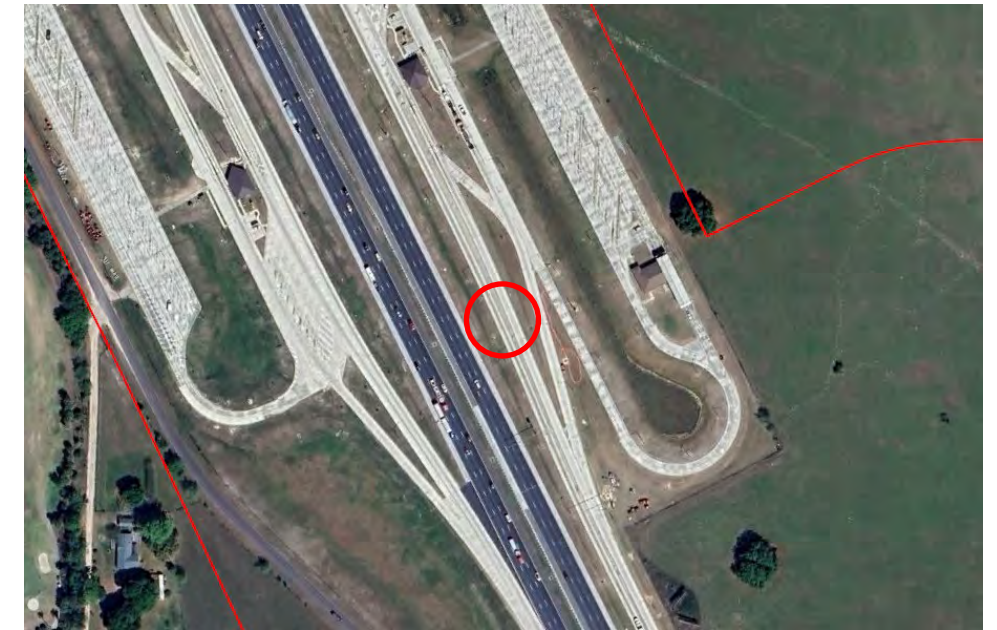
**SITE OBSERVATIONS:** No evidence of the petroleum spill was observed.

**CONCLUSIONS:** Due to the potential for petroleum soil impacts, this site has been assigned a CRR of **Medium**.

View of the approximate area of the spill on the 2023 aerial photograph.

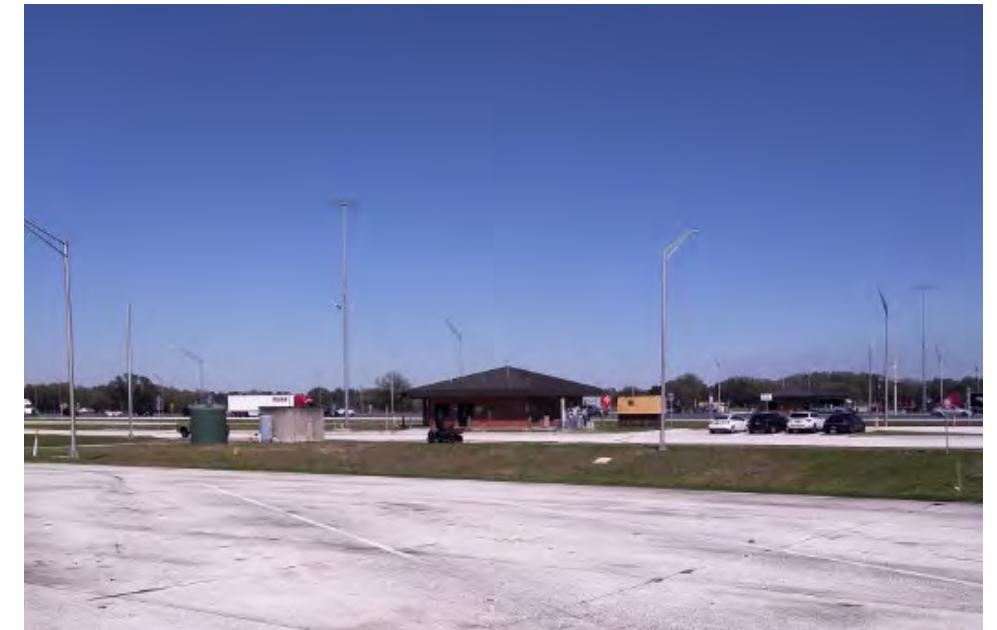
**CONCLUSIONS:** Due to the lack of documented petroleum impacts, this site has been assigned a CRR of **Low**.

Looking east towards the emergency generator (yellow) and belly tank (black).

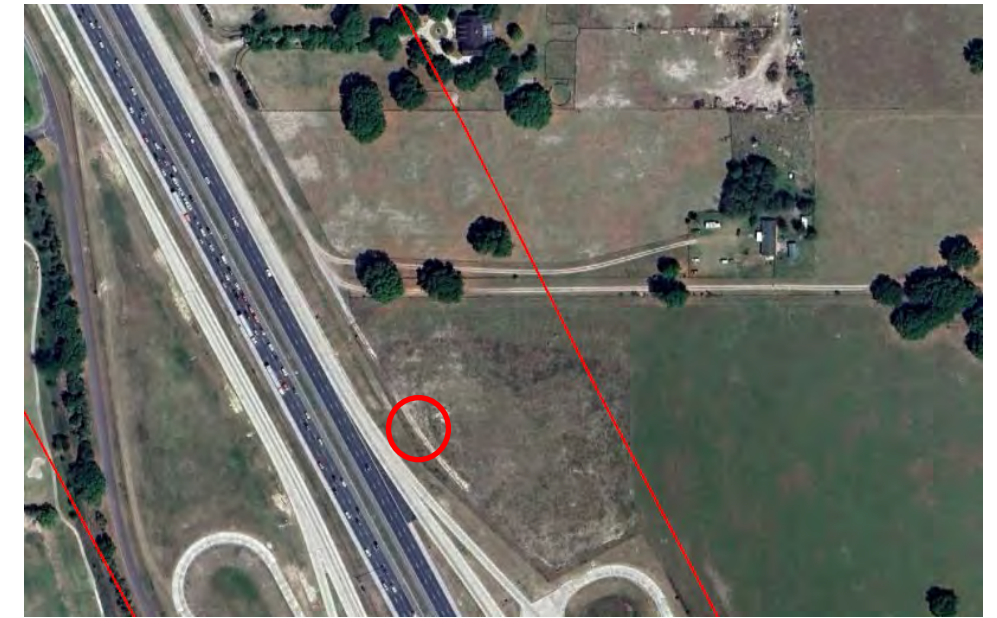
**CONCLUSIONS:** Due to the possibility for petroleum impacts to remain on-site, this site has been assigned a CRR of **Medium**.

View of the area of the spill on a 2023 aerial photograph.

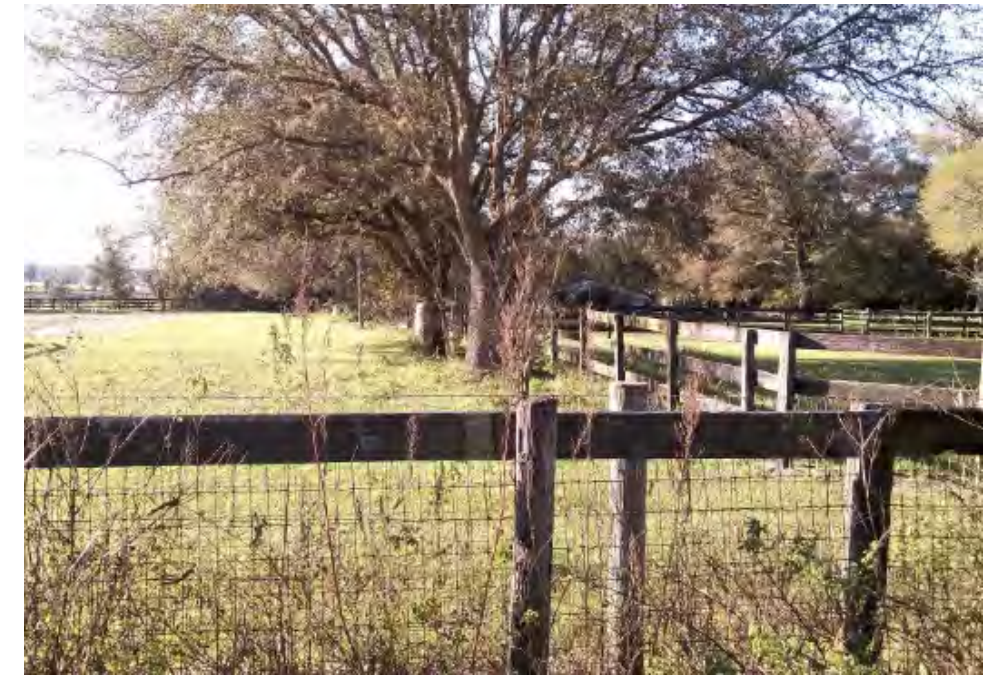
**CONCLUSIONS:** Due to the potential for agricultural chemical impacts at this location, this site has been assigned a CRR of **Medium**. Based on the distance to I-75, this facility is not considered likely to impact construction activities.

Looking east at the approximate area of the former shed location.

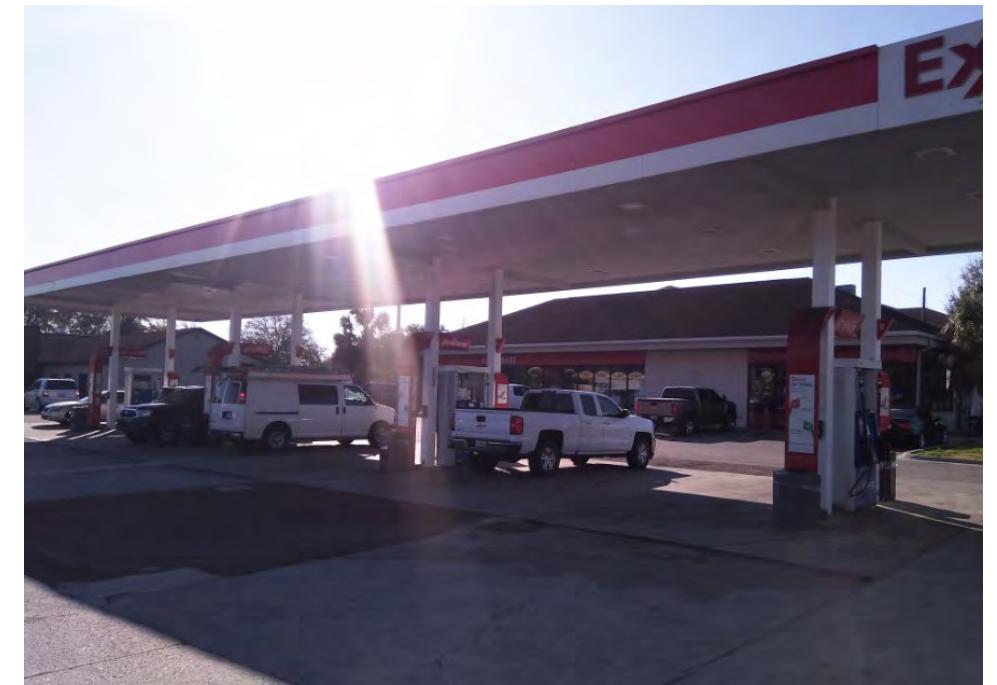
**CONCLUSIONS:** Due to the depth to groundwater and the existing groundwater exceedances, this site has been assigned a CRR of **Medium**. Based on the depth to groundwater in this area being > 30 feet, this area of impacts is not likely to affect this project.

View of the gas station and fueling canopy.

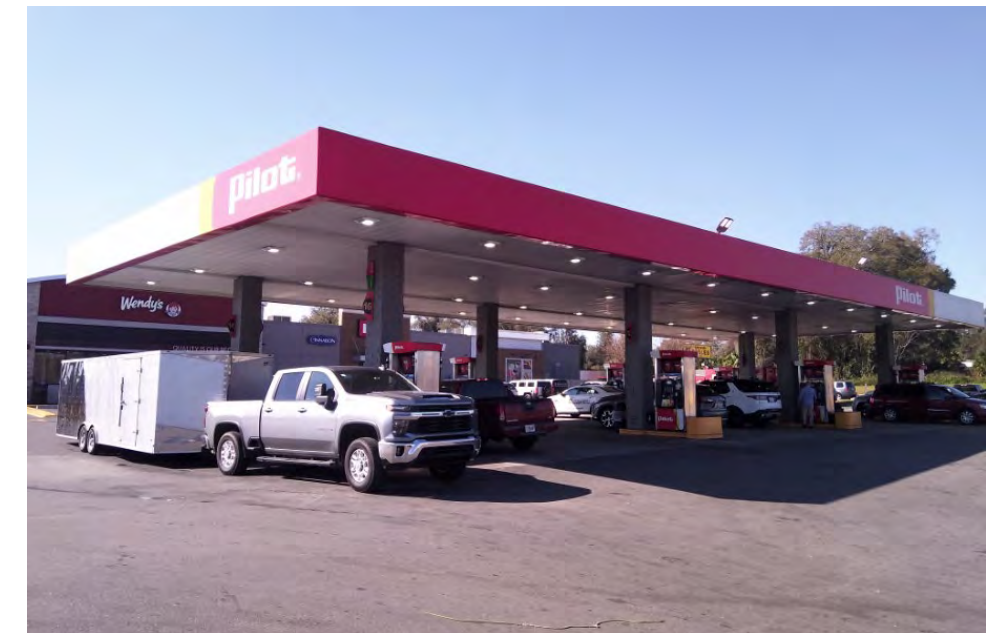
**CONCLUSIONS:** This site received regulatory closure. Due to being an active gas station, this site has been assigned a CRR of **Medium**.

View of the fueling canopy and gas pumps.

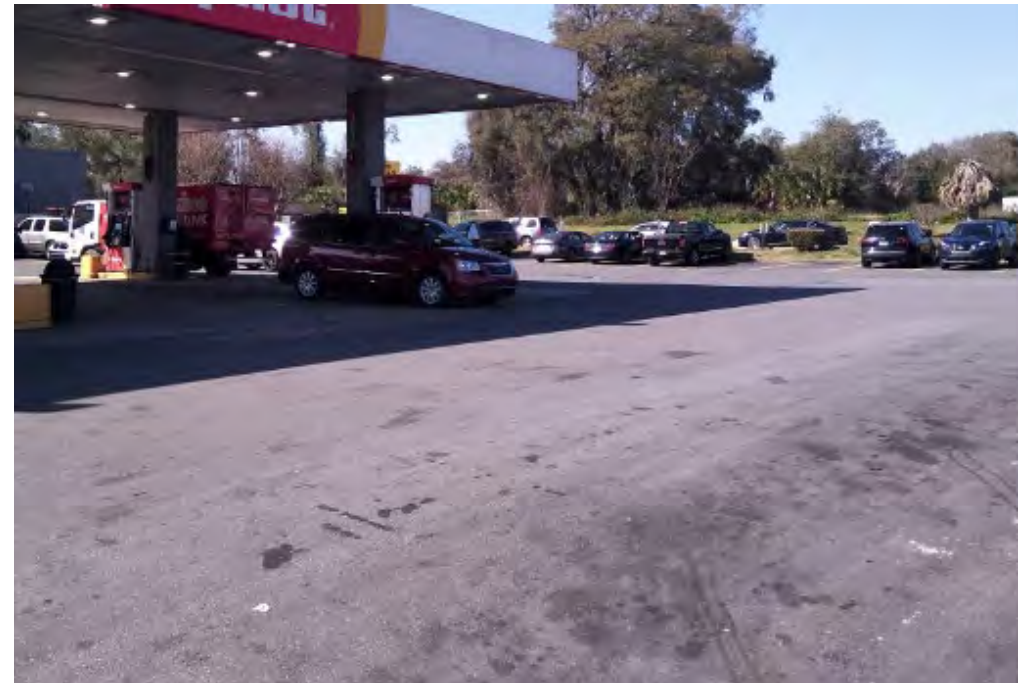
View of an area of de minimis oil staining.

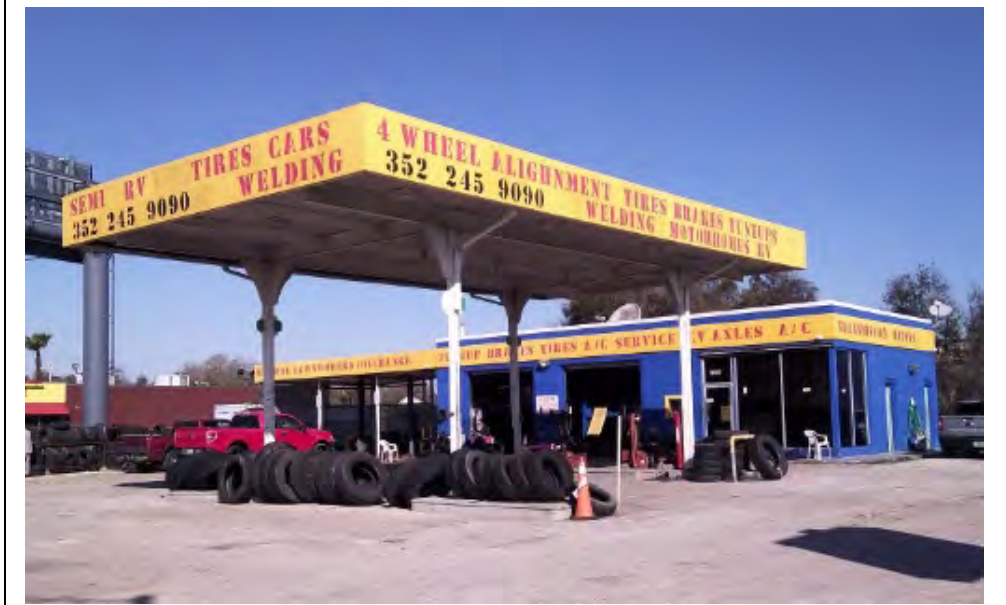
**CONCLUSIONS:** Due to the depth to groundwater, the lack of groundwater impacts, and the distance from I-75, this site has been assigned a CRR of **Low**.

Looking north at the former gas station fueling canopy.

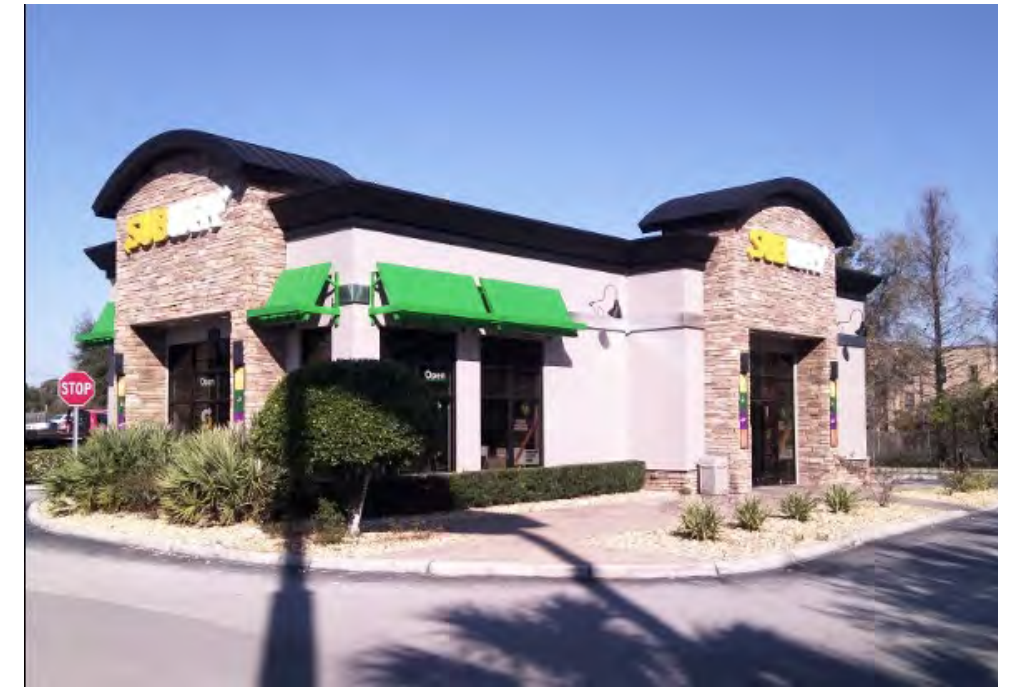
**CONCLUSIONS:** Due to receiving regulatory closure, this site has been assigned a CRR of **Low**.

Looking northwest at the current restaurant building.

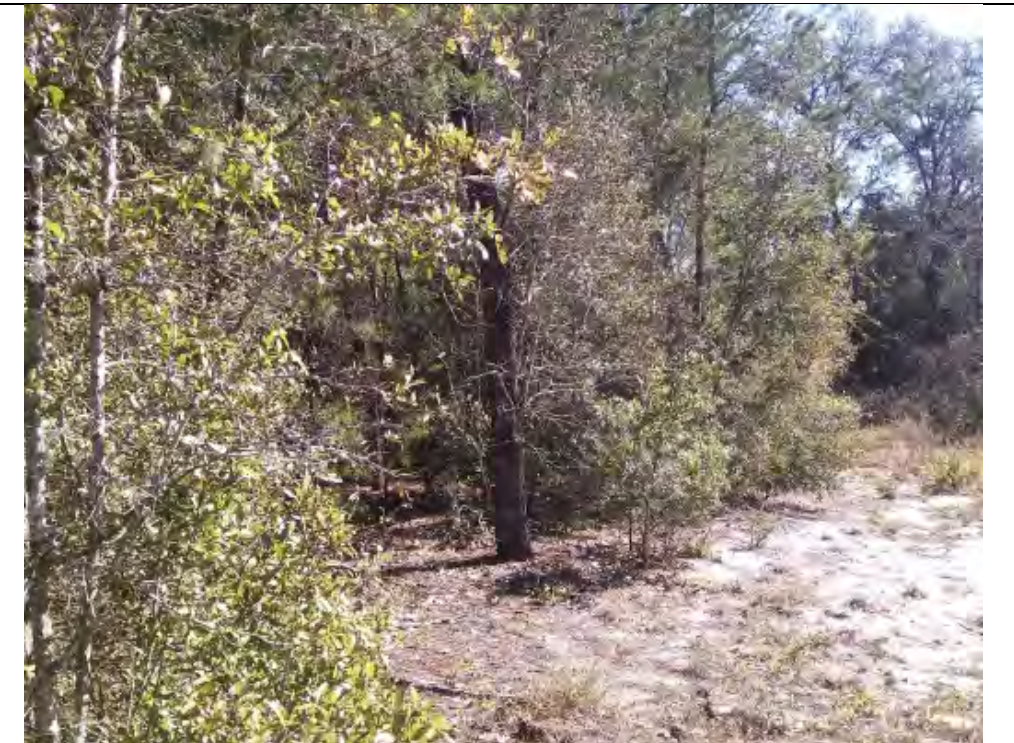
**CONCLUSIONS:** Due to the lack of documented site use or recorded contamination impacts, this site has been assigned a CRR of **Low**.

Typical view of a wooded area on-site.

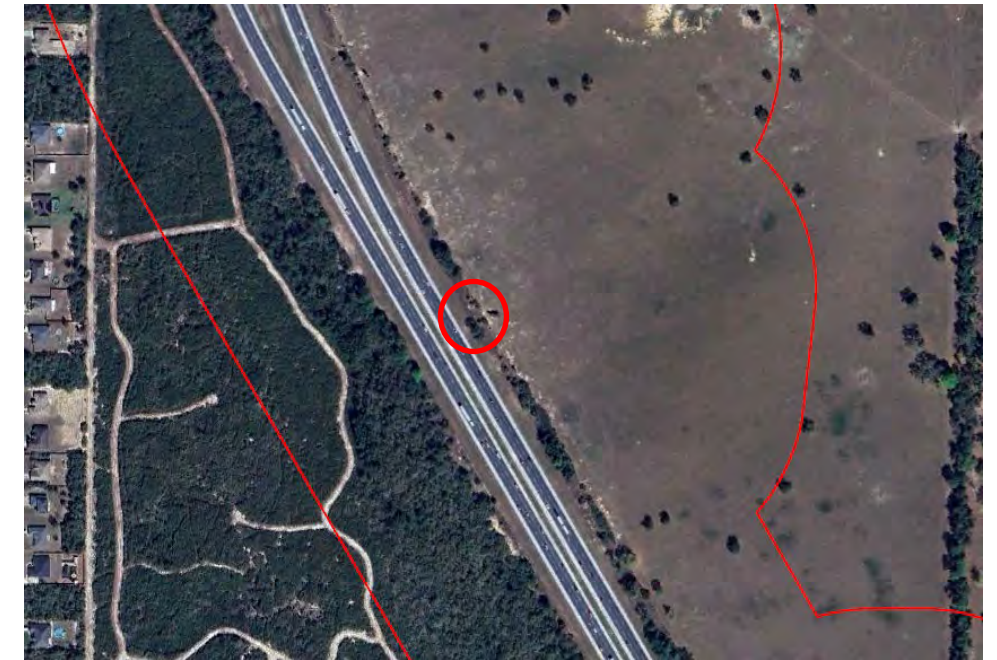
**CONCLUSIONS:** Due to the potential for petroleum impacts, this site has been assigned a CRR of **Medium**.

View of the approximate area of the oil spill on the 2023 aerial photograph.

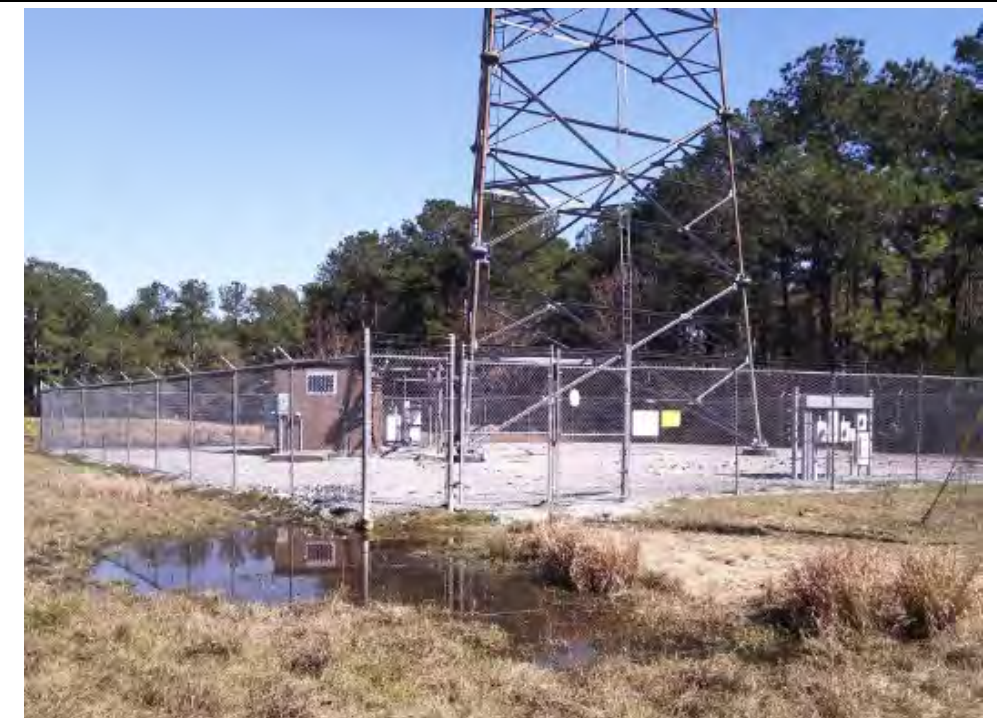
**SITE OBSERVATIONS:** An emergency generator tank was not observed.

**CONCLUSIONS:** Due to the lack of visible generator or tank and no recorded contamination impacts, this site has been assigned a CRR of **Low**.

View of the radio tower enclosure.

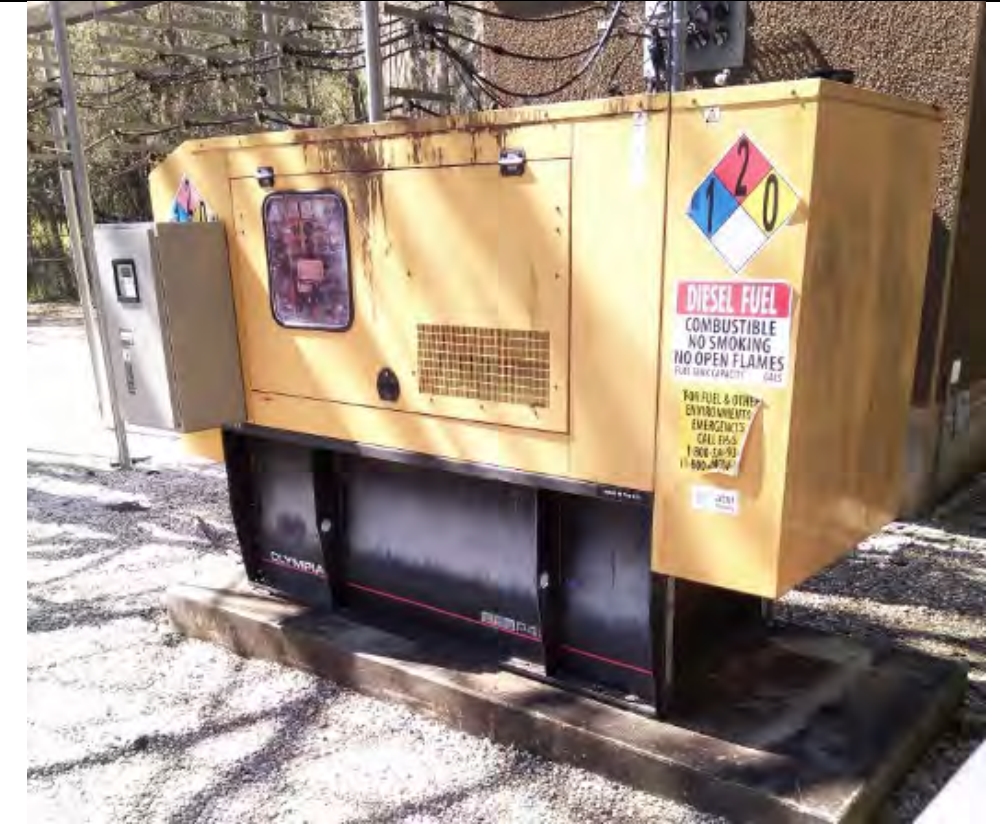
**CONCLUSIONS:** Due to the small size of the tanks and lack of recorded contamination impacts, this site has been assigned a CRR of **Low**.

View of first emergency generator tank on-site.

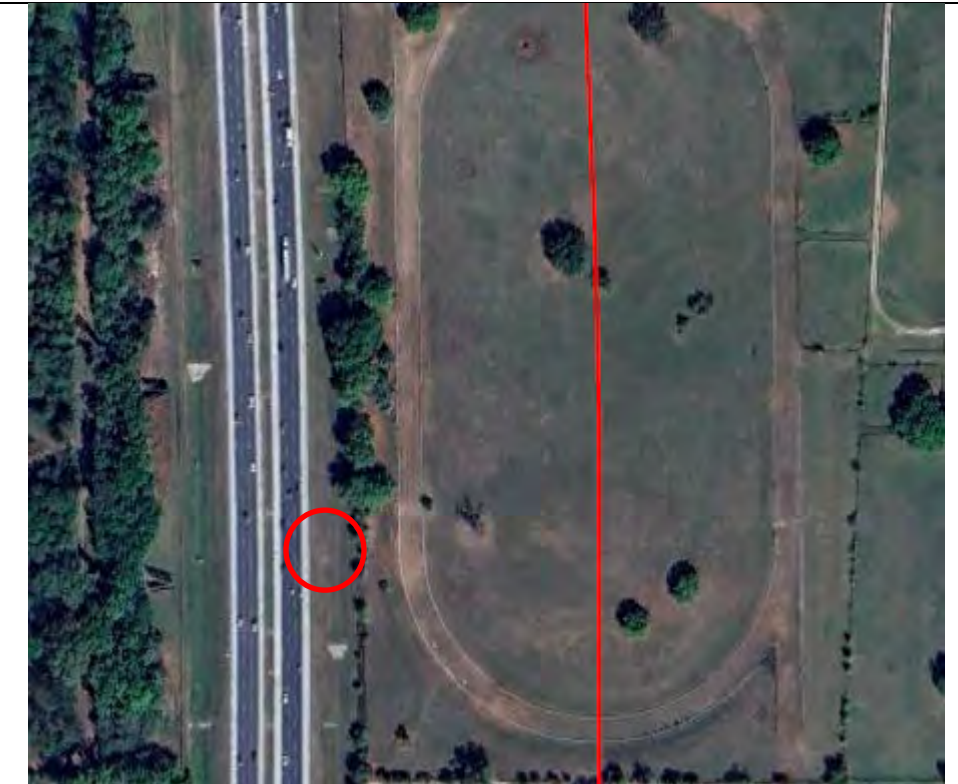
- **Site No. 28** is a 2010 spill location where a tanker truck caught fire. Petroleum impacted soil and groundwater exists within the work area. A conditional closure exists for this location.

**CONCLUSIONS:** Due to the groundwater impacts in MW-1, if dewatering occurs in this area, this site will be assigned a CRR of **Medium**. The depth to groundwater is >25 feet and dewatering is unlikely in this area.

View of the area of the truck spill on the 2023 aerial photograph.

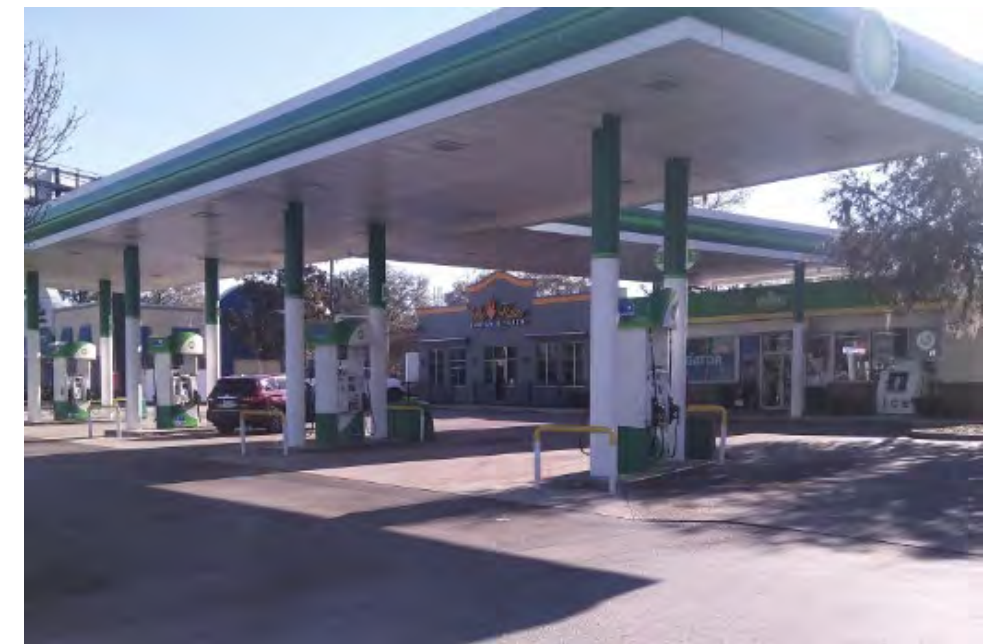
**CONCLUSIONS:** Due to existing groundwater exceedances, and being an active gas station, this site has been assigned a CRR of **Medium**. Based on the depth to groundwater and the distance to I-75, this facility is unlikely to affect the project.

View of the gas station and fueling canopy on-site.

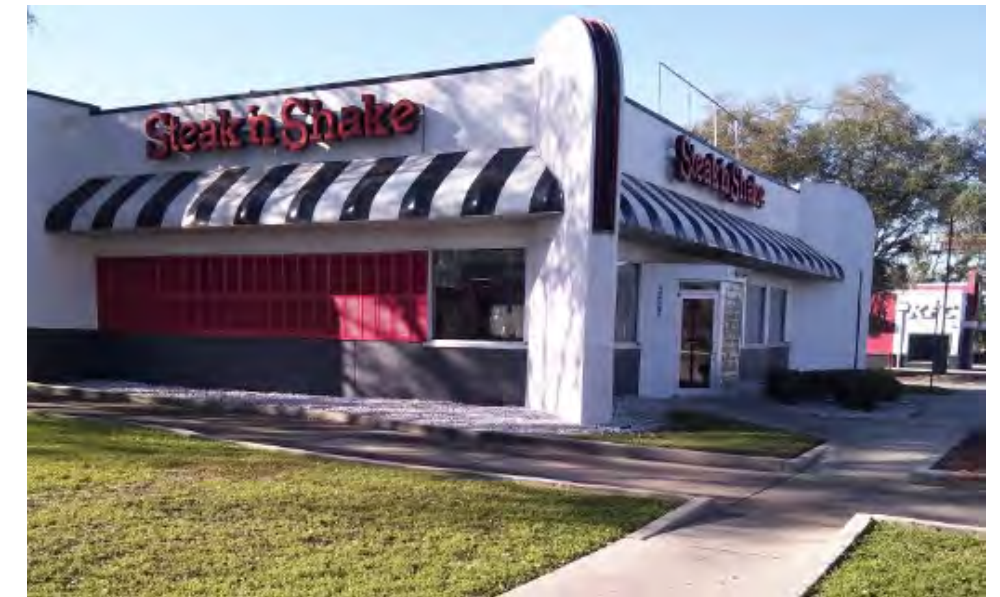
**CONCLUSIONS:** Due to the lack of recorded contamination impacts, this site has been assigned a CRR of **Low**.

View of the current restaurant building.

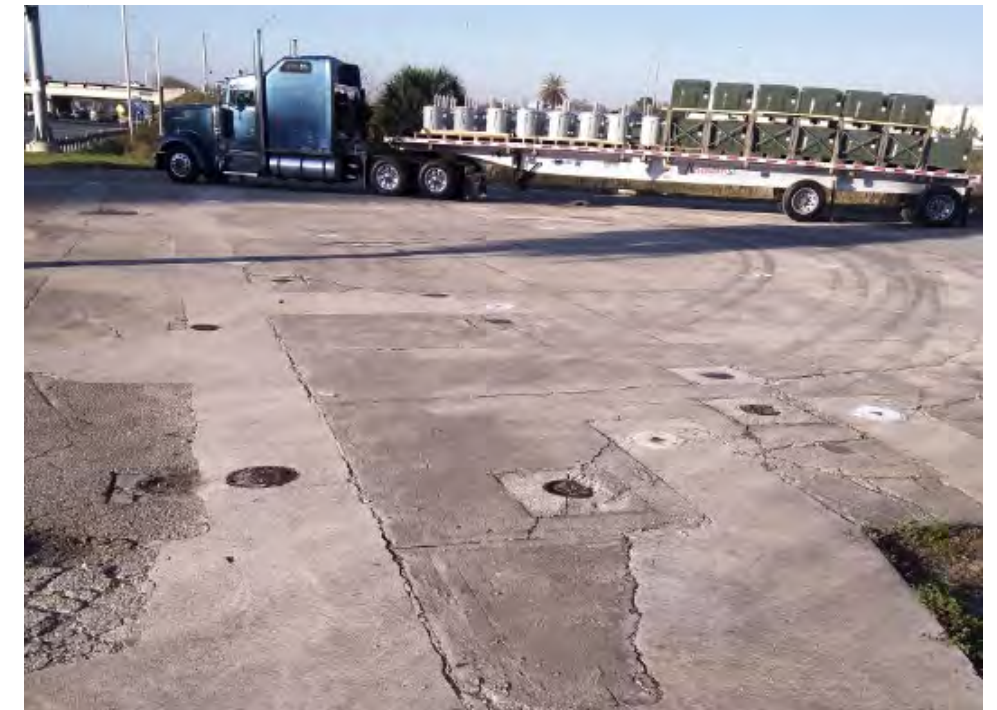
**CONCLUSIONS:** Due to remaining groundwater impacts, this site has been assigned a CRR of **Medium**. Based on the depth to the groundwater and the distance to I-75, this facility is unlikely to affect the project.

View of an area of monitoring wells.

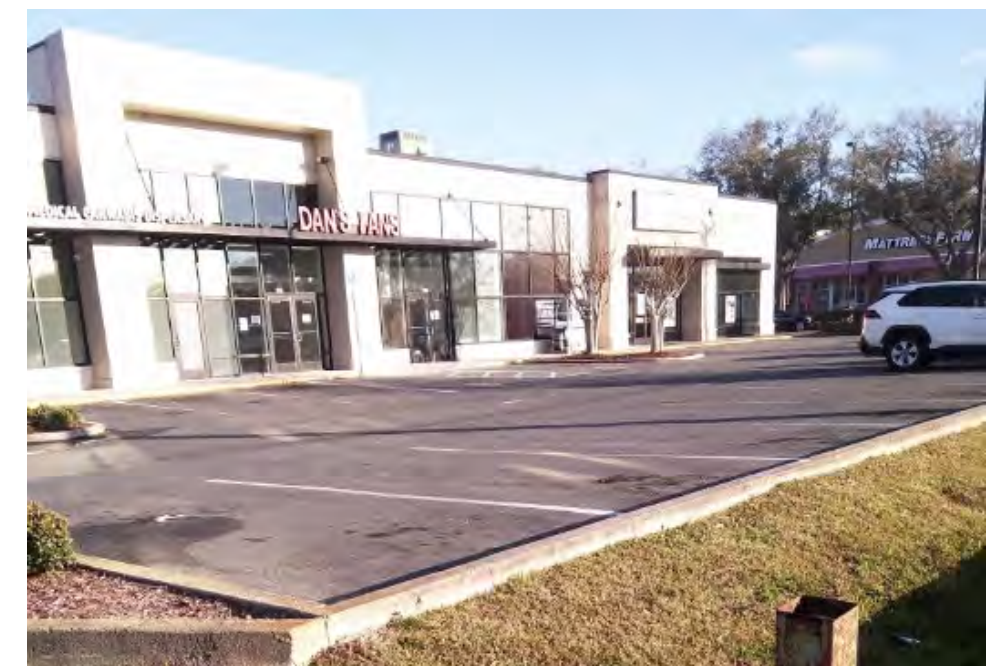
**CONCLUSIONS:** Due to the Site Rehabilitation Completion Order, this site has been assigned a CRR of **Low**.

Looking north at the area of the former gas station.

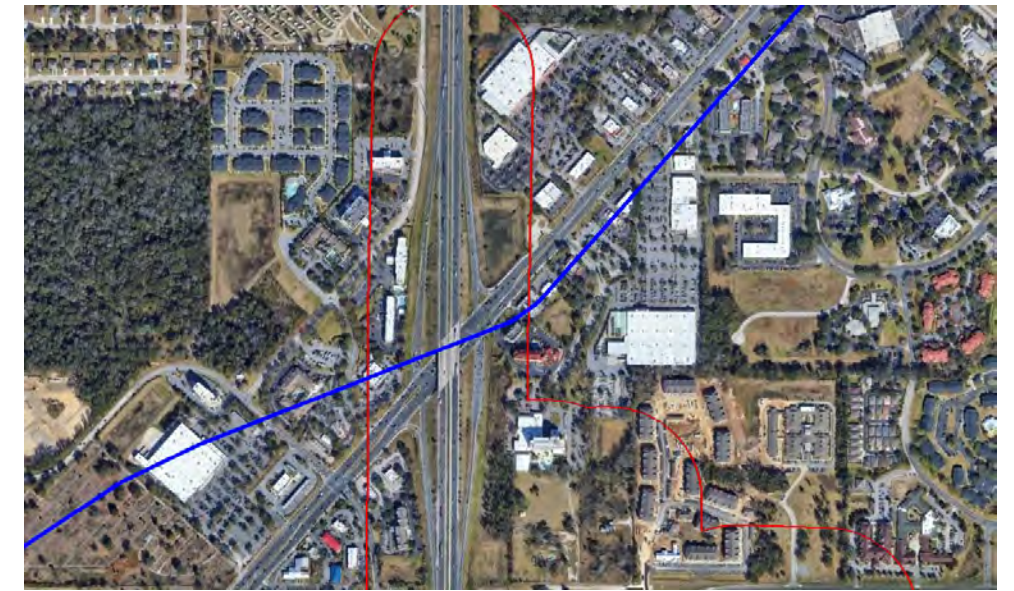
**CONCLUSIONS:** Due to the area of the historical railroad being redeveloped with commercial facilities, SR 200, and I-75, this site has been assigned a CRR of **Low**.

View of the historical railroad corridor, represented by the blue line, on the 2023 aerial photograph.

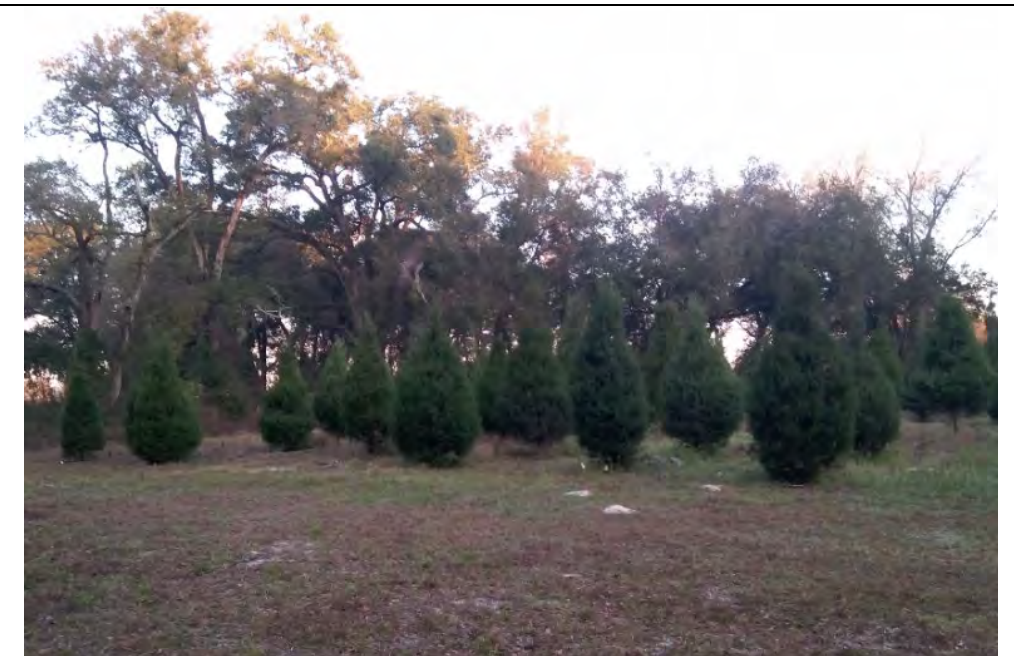
Agricultural land and tree farms typically have environmental concerns associated with them. These concerns include pesticide/herbicide storage and usage, tractor and equipment maintenance and fueling, underground and aboveground fuel storage tanks, irrigation pumps and maintenance, and asbestos irrigation lines. Two tree nurseries were observed in the study area, to the east and west of I-75, containing rows of planted trees. The agricultural land use is discussed as **Site No. 38** in **Table 1**.

**CONCLUSIONS:** Due to the roadway improvements being proposed to the inside, and within the existing I-75 right-of-way, the agricultural land use has been assigned a CRR of **Low**.

View of a tree farm located to the west of I-75.

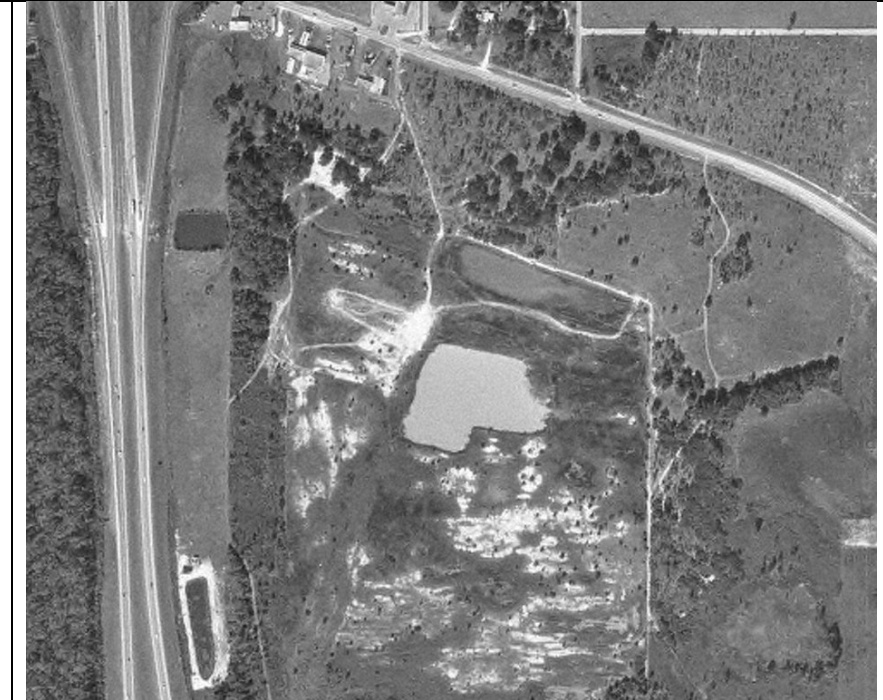
**CONCLUSIONS:** Due to the possibility of encountering debris or hazardous materials while excavating several potential ponds, these areas have been assigned a CRR of **Medium**.

View of an area of excavation located southeast of the I-75 and SR 44 interchange, on the 1973 aerial photograph.
