US 1 Corridor Planning Study
 from Pineda Causeway (SR 404)
 to Park Avenue
 Brevard County, Florida
 Financial Project ID: 433604-1-12-01
 Federal Project No. n/a

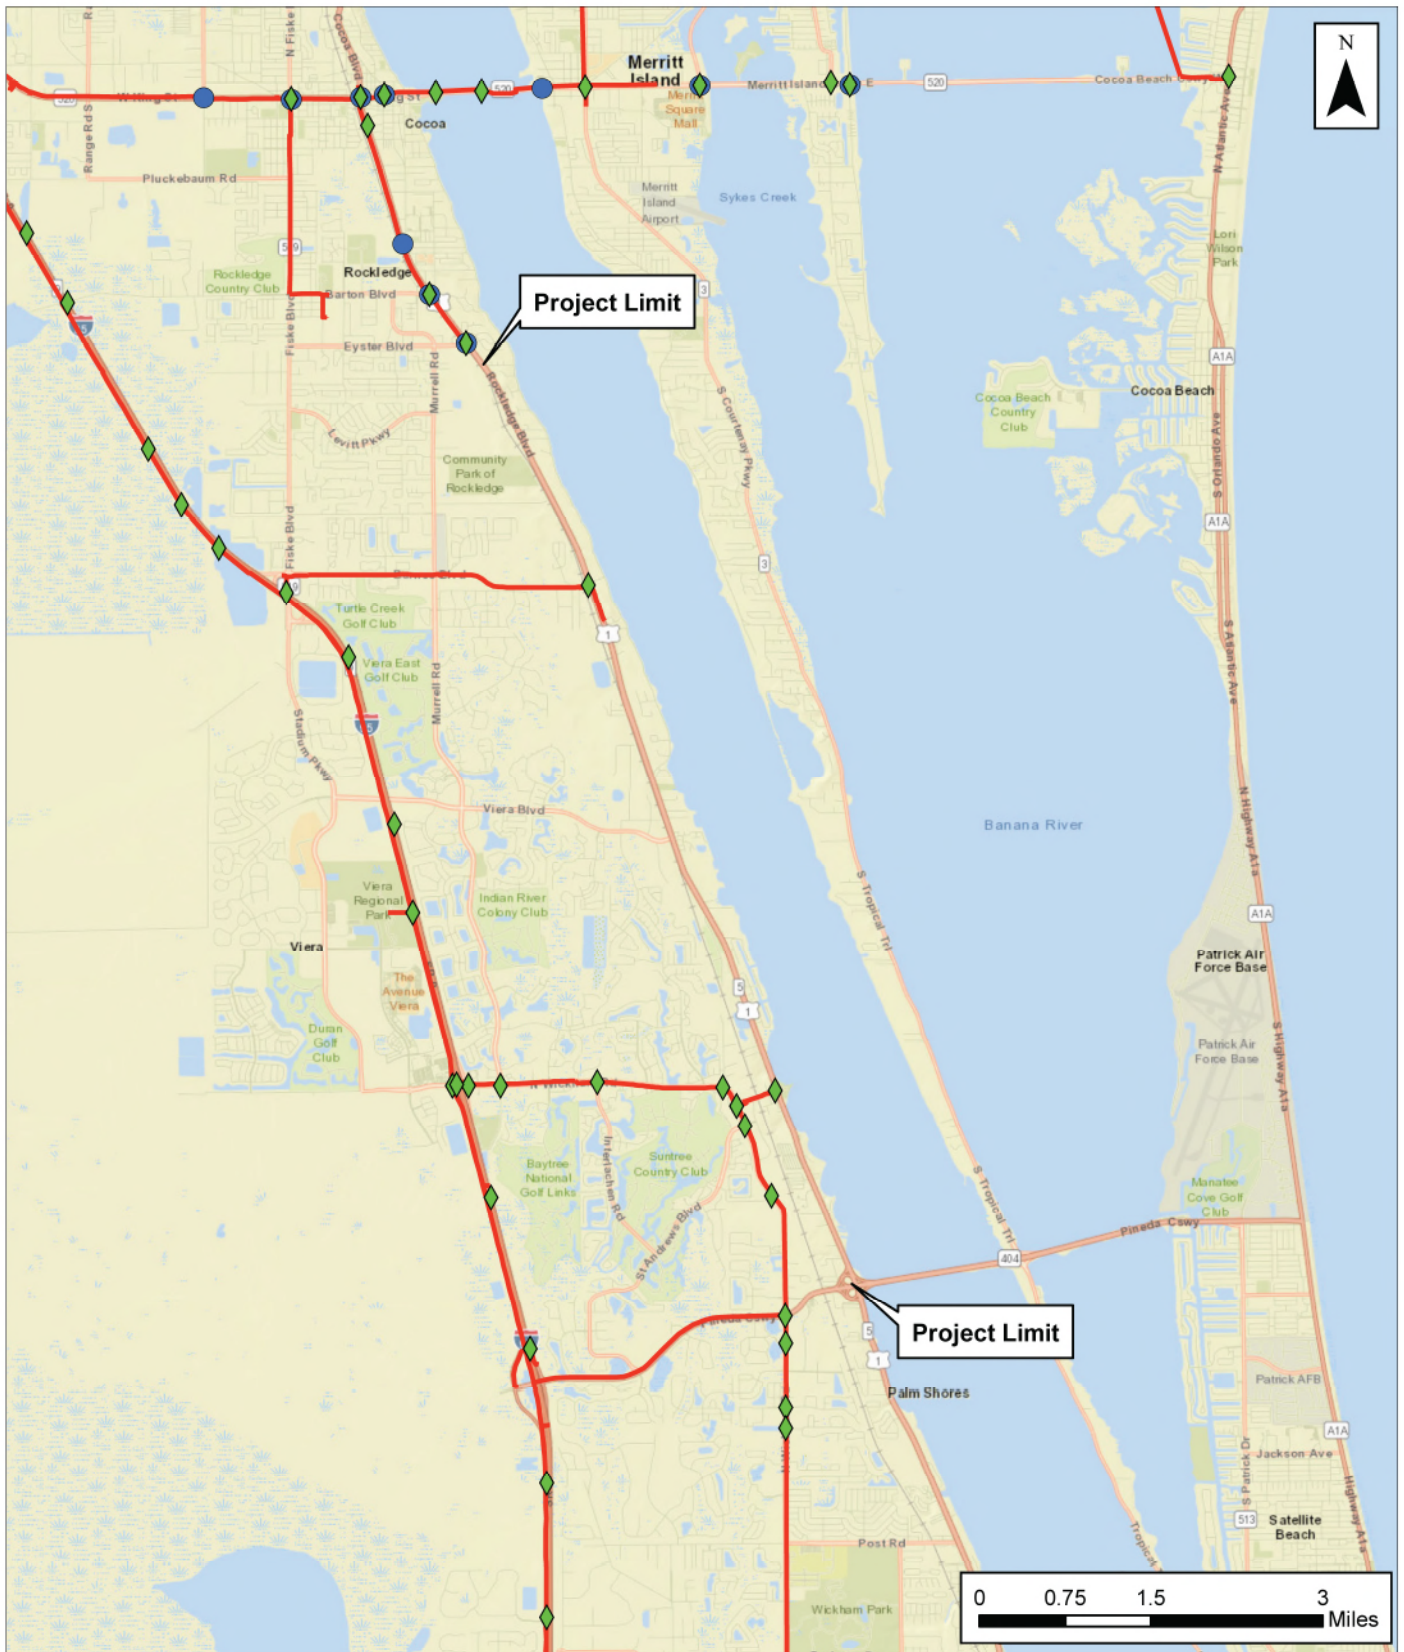
Figure 14
Existing ITS

Fiber optic cable, closed-circuit television, and Bluetooth device locations are shown on **Figure 14**.

- Along US 1 from Coquina Road to McIver Lane
- Along US 1 from Suntree Boulevard to approximately 250 feet north of intersection
- Along North Wickham Road from I-95 to Suntree Boulevard, and
- Along Suntree Boulevard from North Wickham Road to US 1

- At US 1 and Barnes Boulevard
- At US 1 and Suntree Boulevard
- At US 1 and Eyster Boulevard (immediately north of US 1 study limits)
- At US 1 and Barton Boulevard (approximately 4,000 feet north of US 1 study limits)
- At several intersections along North Wickham Road, including at Suntree Boulevard

- Along US 1 at Eyster Boulevard (immediately north of US 1 study area)
- Along US 1 at Barton Boulevard (approximately 4,000 feet north of US 1 study area)
- Along US 1 at Florida Avenue (approximately 1.25 miles north of US 1 study area)

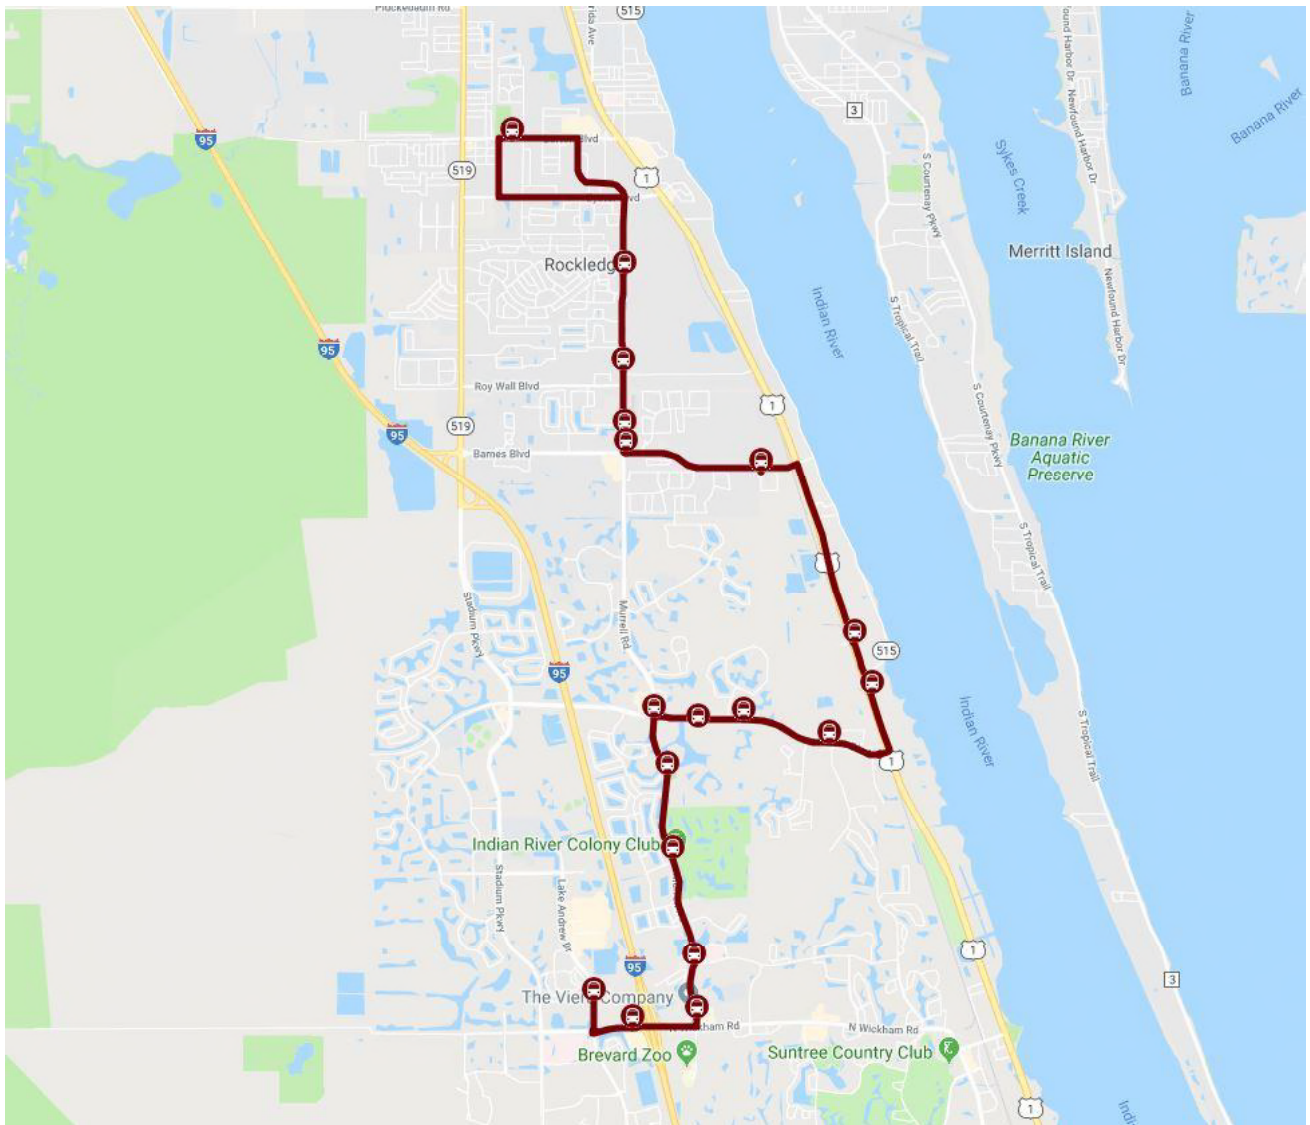
Figure 15
Space Coast Area Transit Route 7

Space Coast Area Transit (SCAT) has one route within the proposed corridor, Route 7-Rockledge/Viera, which runs along US 1 from Viera Boulevard to Coquina Road, as shown in **Figure 15**.

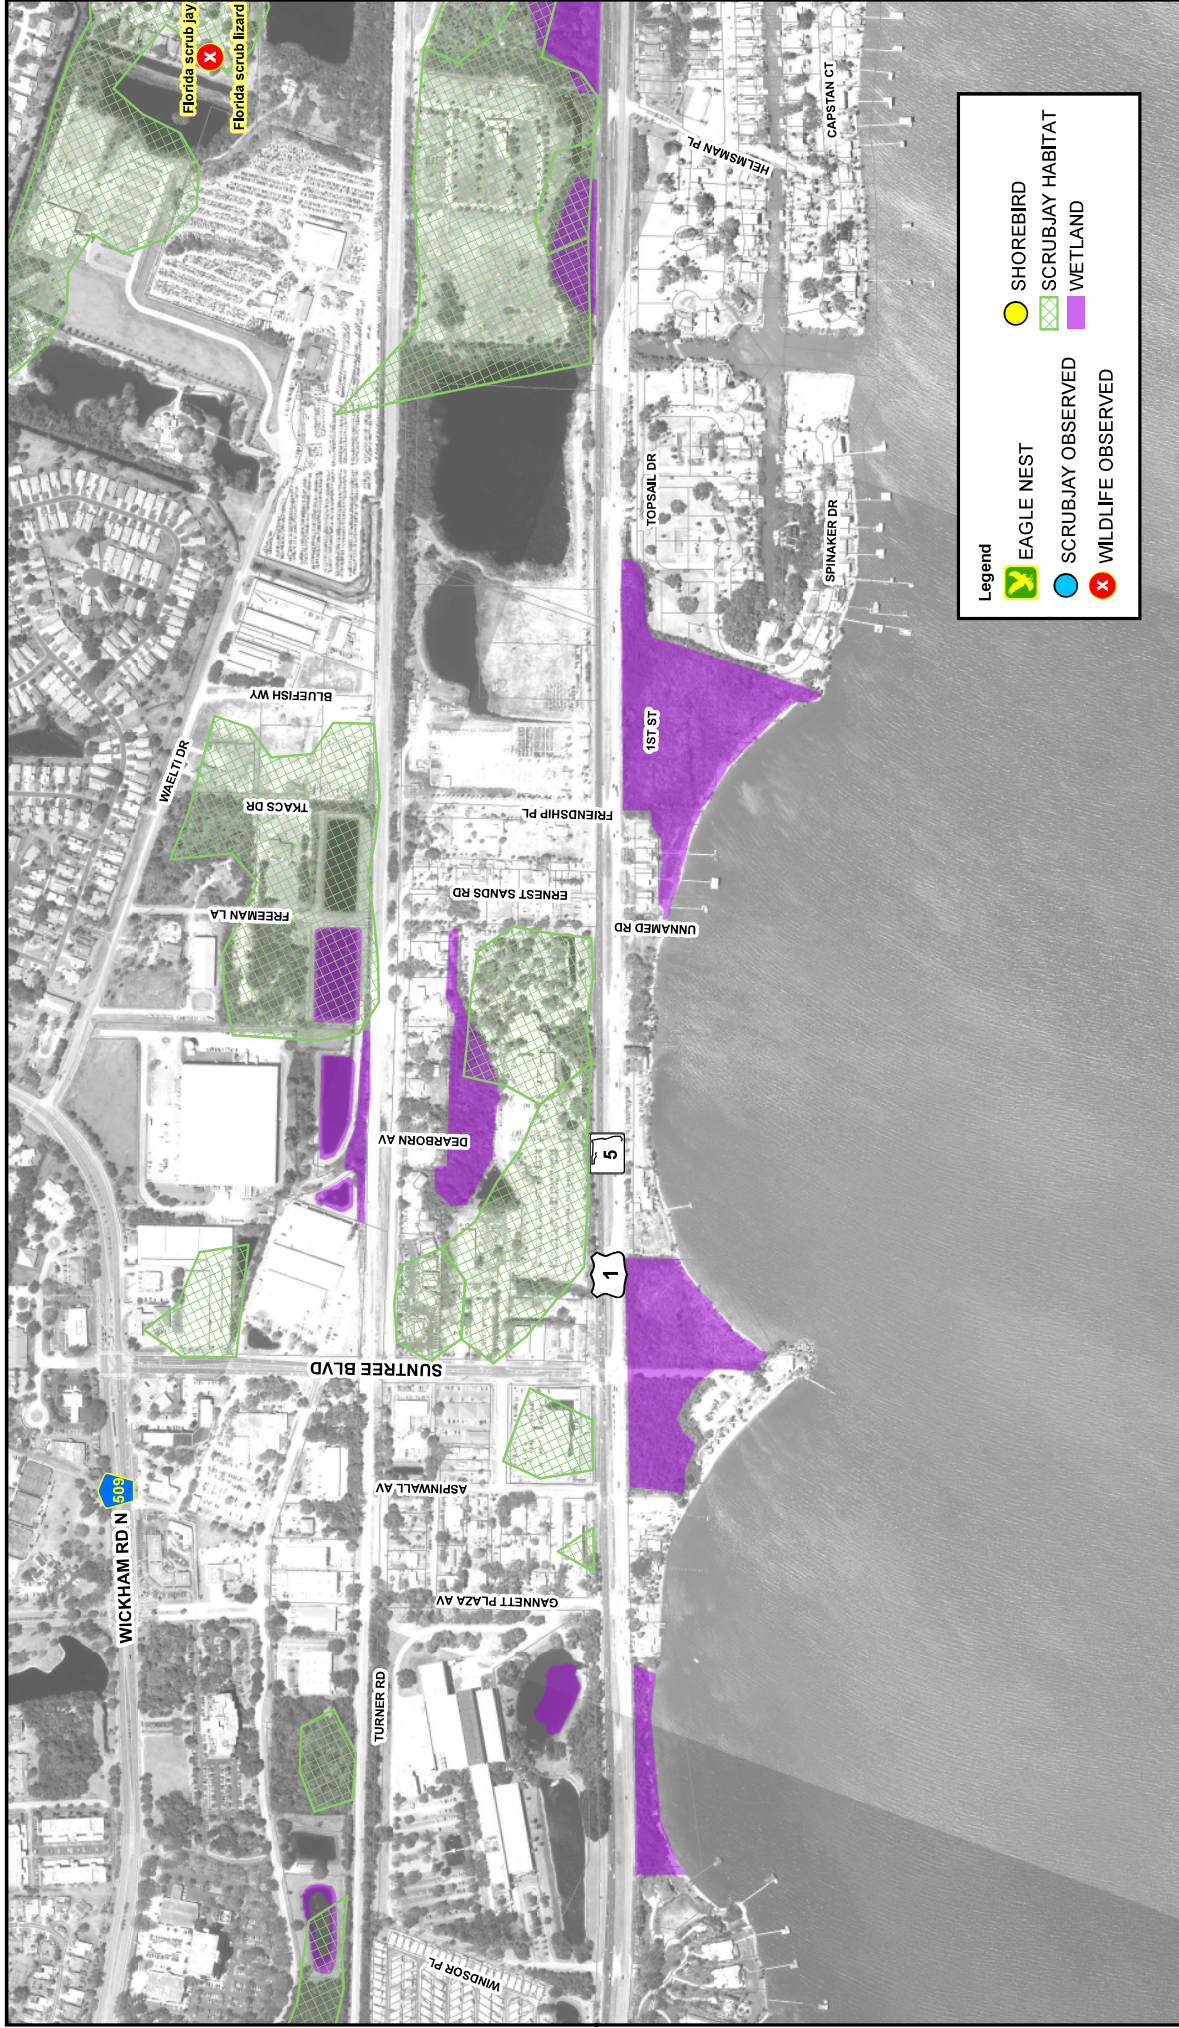
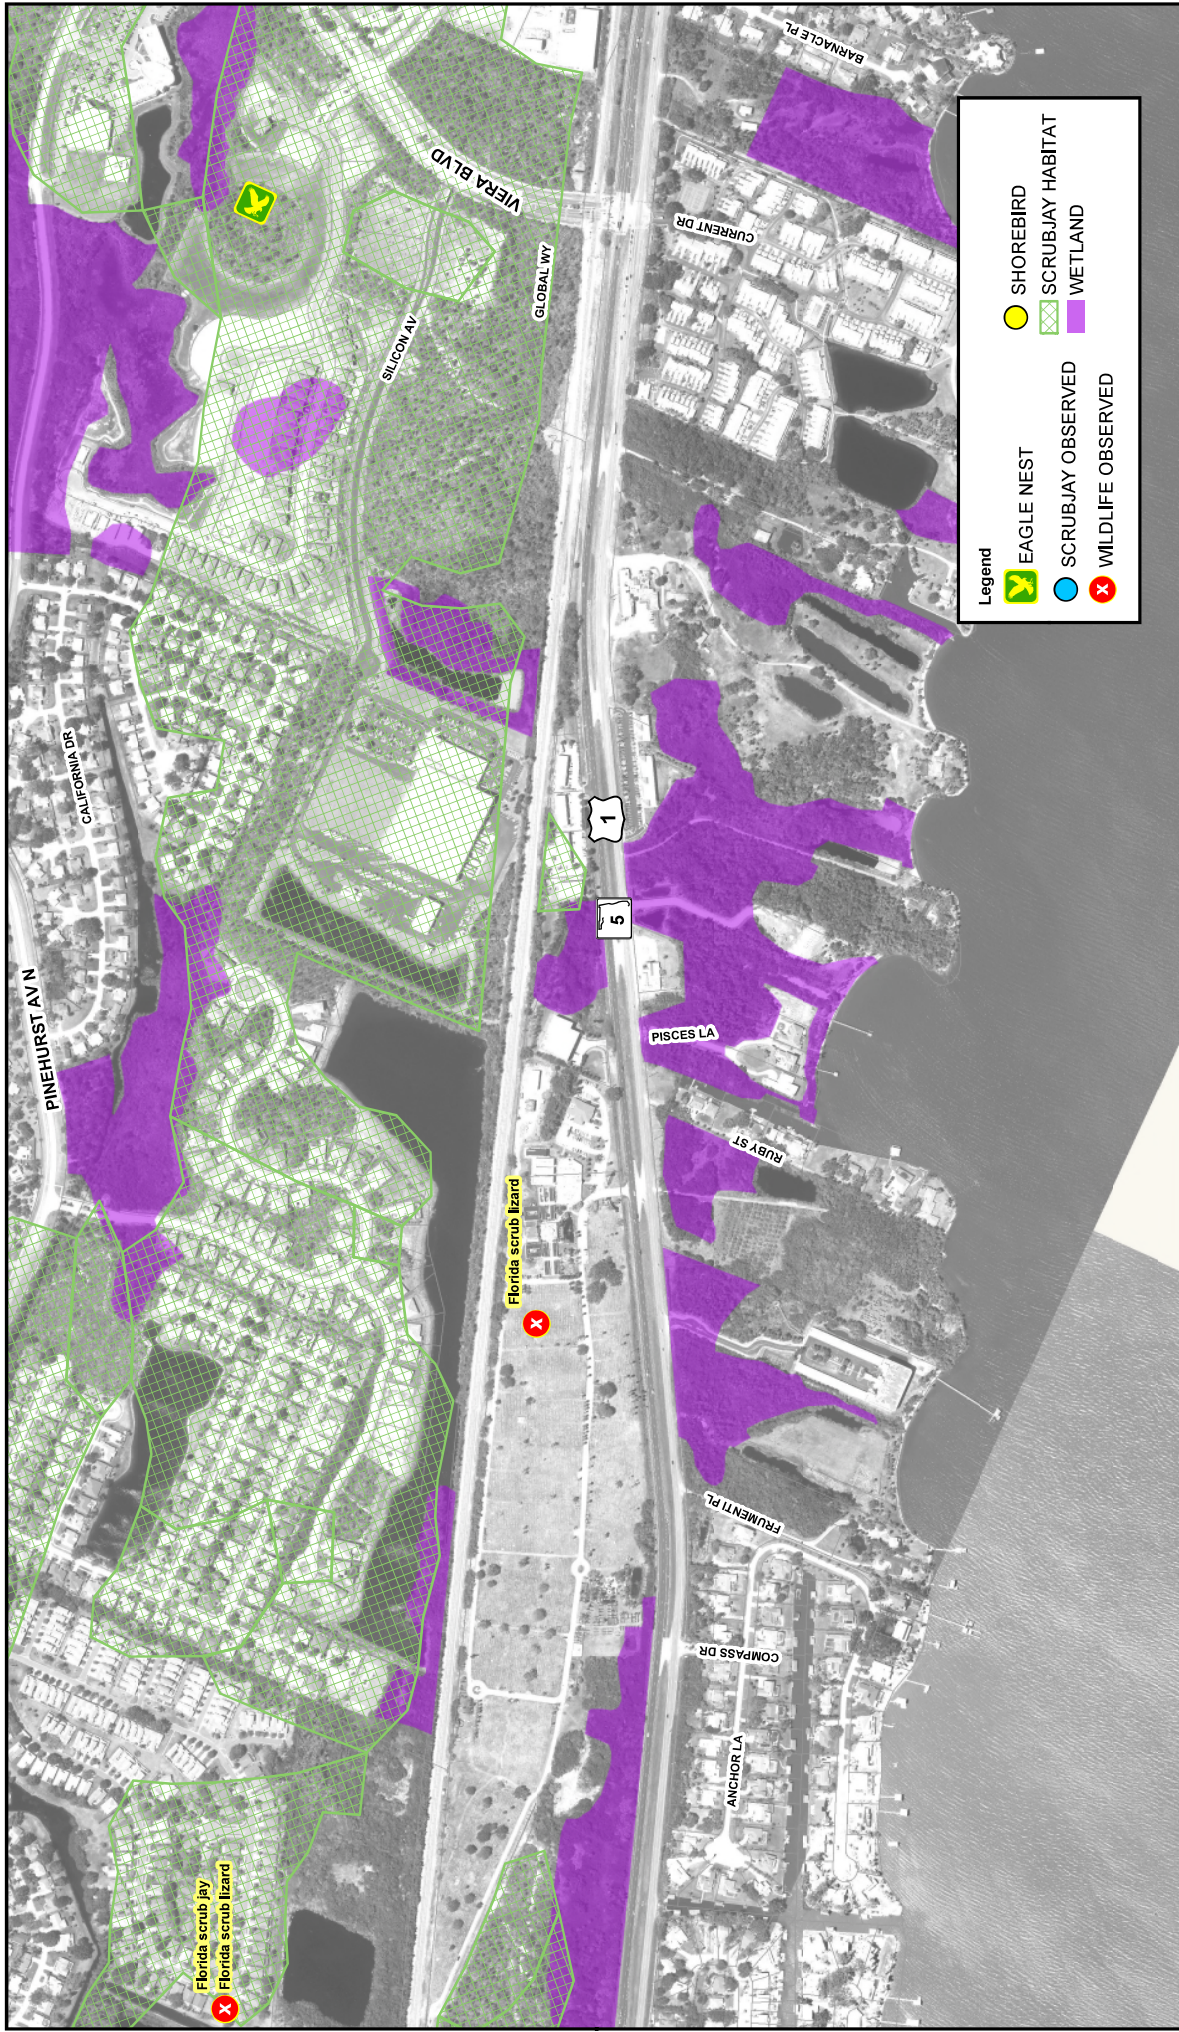
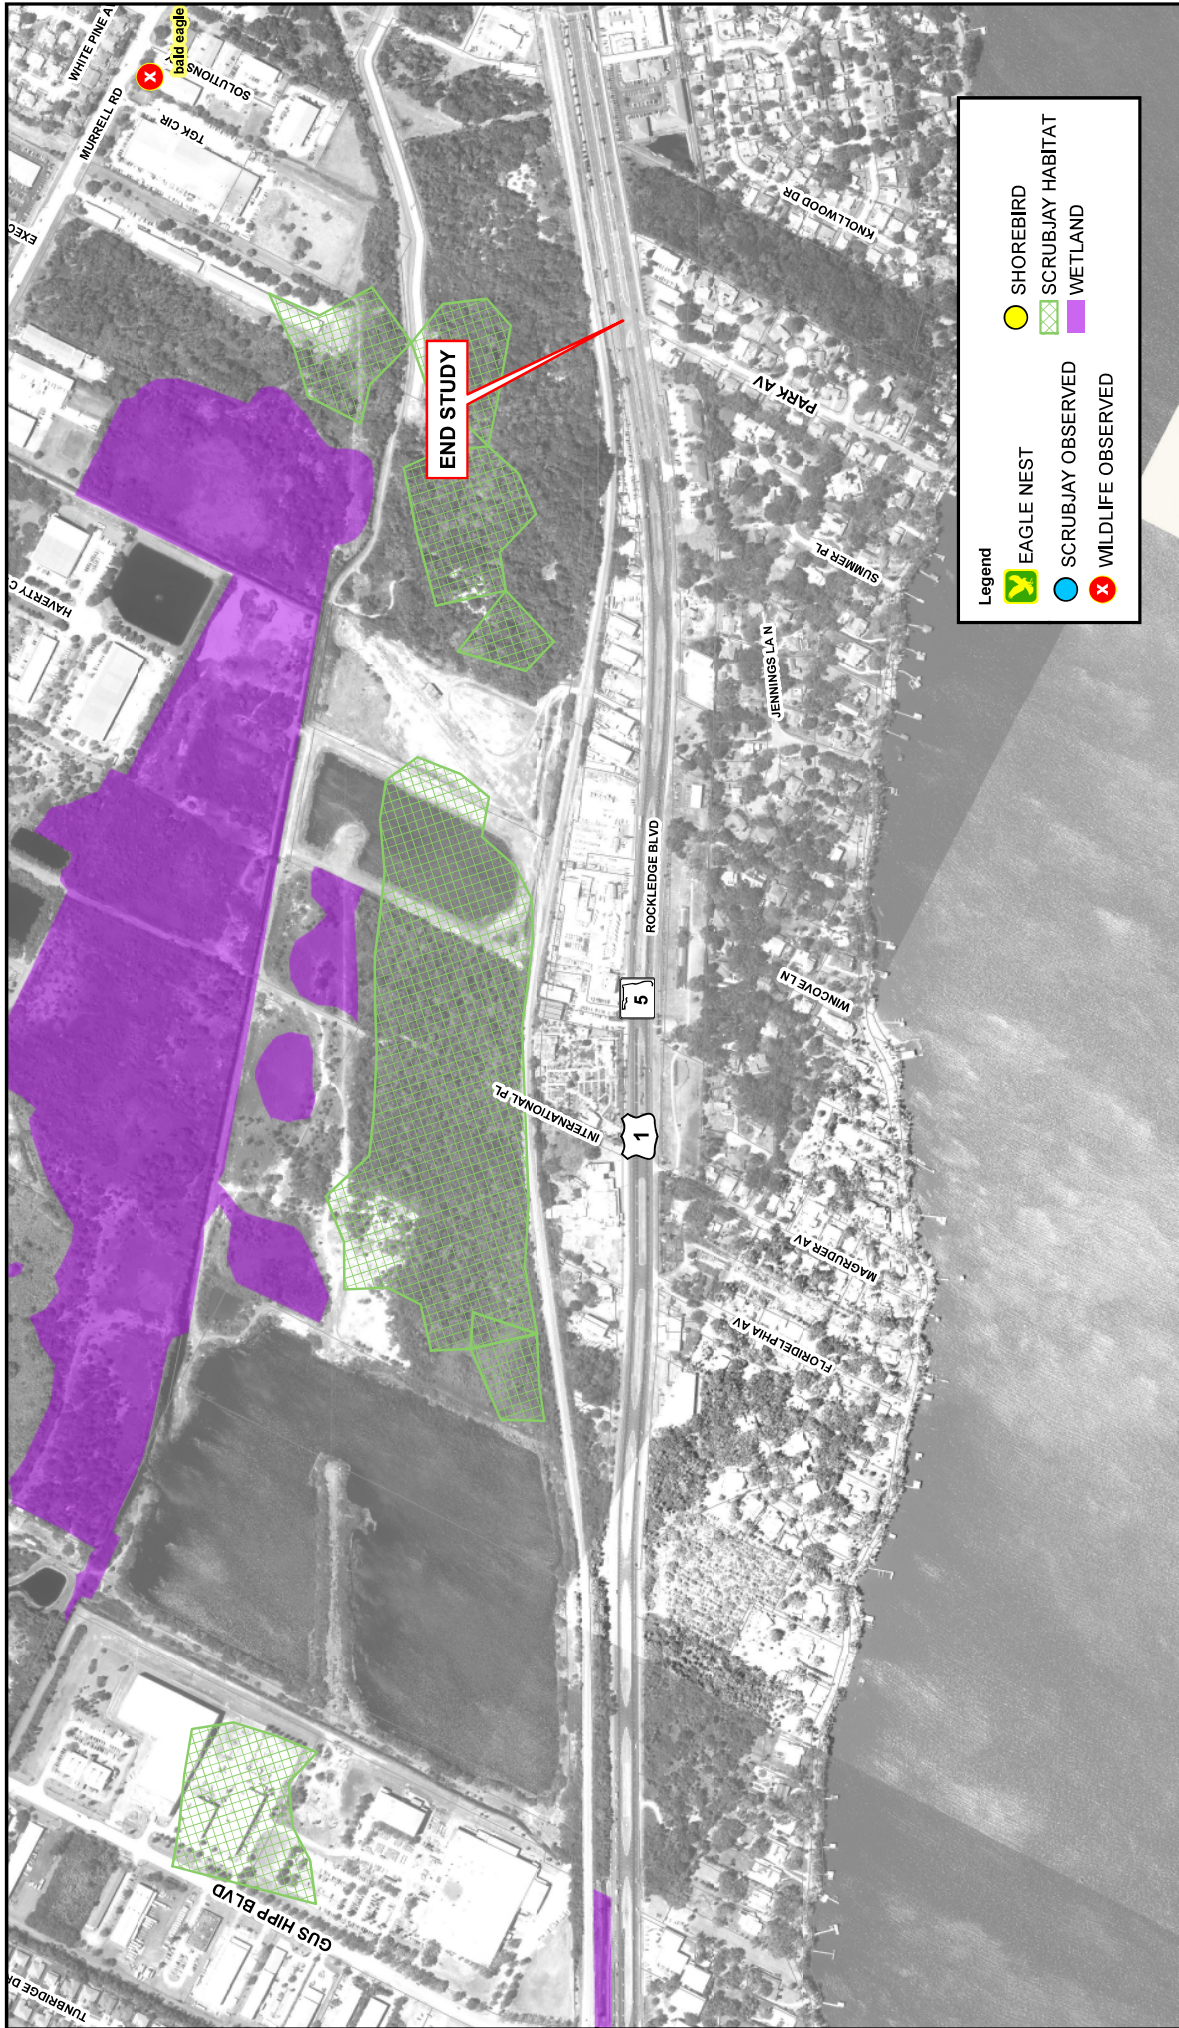
FIGURE 16
WETLAND and WILDLIFE

We assessed whether protected species or their critical habitat(s) have been documented along the project corridor. The U.S. Fish and Wildlife Service (USFWS) designated the Indian River Lagoon (IRL) as critical habitat for the West Indian manatee. While the project corridor does not occur in the IRL, any new proposed discharge structures from US 1 may require coordination with the USFWS and standard protection measures, including grates on discharge structures accessible by manatees. The project corridor also falls within several USFWS Consultation Areas: Audubon's crested caracara, Florida scrub-jay, piping plover, and red-cockaded woodpecker. However, the project corridor only contains remnant habitat for and documented sightings of Florida scrub-jay. Proposed actions within potential scrub habitat would require additional coordination with the USFWS and potentially surveys using established protocols. The project corridor is located within USFWS core foraging habitat for five wood stork rookeries: Lake Poinsett, SW Lake Washington, Lake Washington, US 192 East, and US 192 West. Potential impacts to surface waters, including swales and ditches, would require additional coordination with the USFWS. Finally, the project corridor is not located within 660 feet of a bald eagle nest; and only the remnant uplands may contain state-listed species, particularly the gopher tortoise. Additional surveys using established protocols may be required for work in these areas. Wetlands and wildlife within the project area are shown on **Figure 16**.

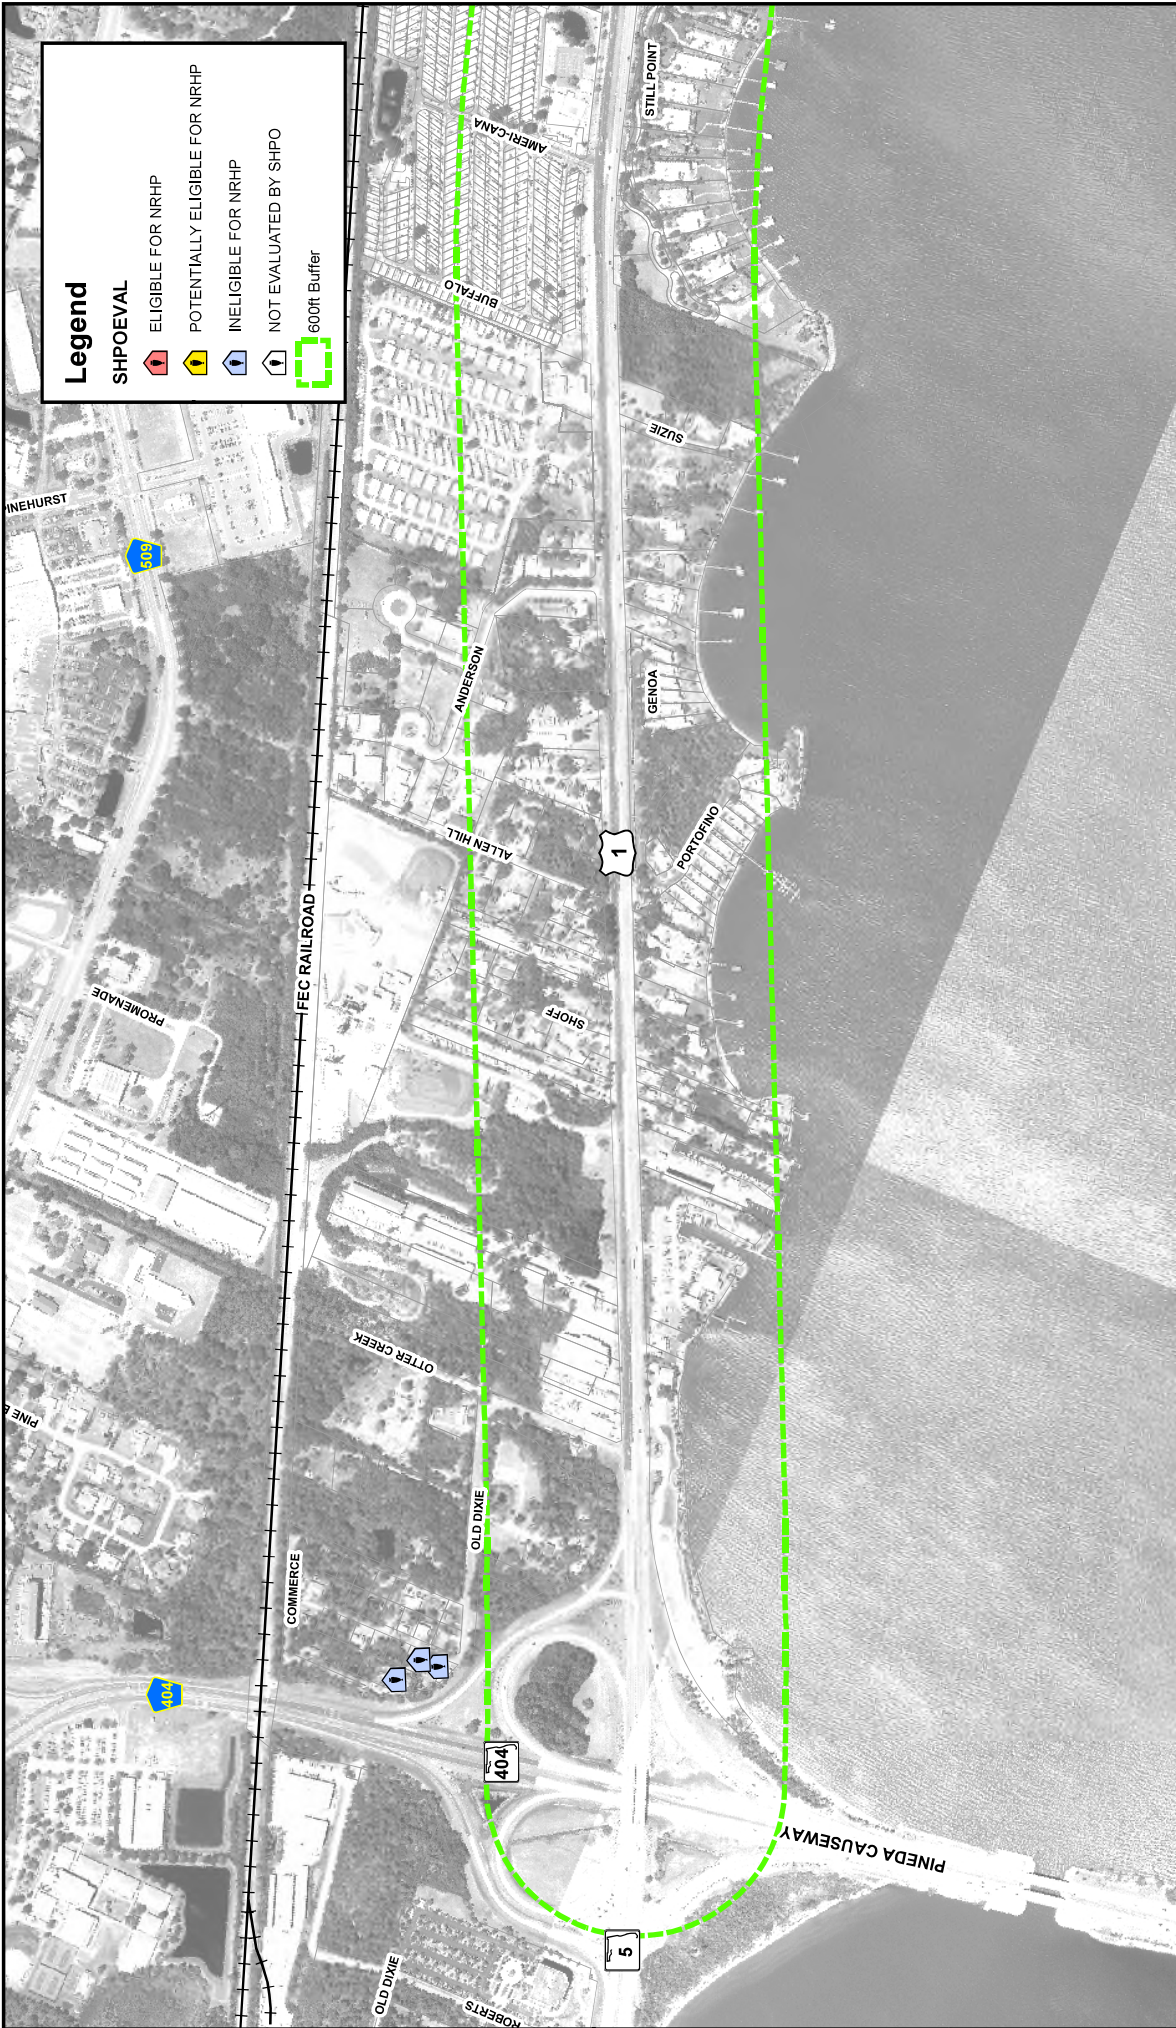
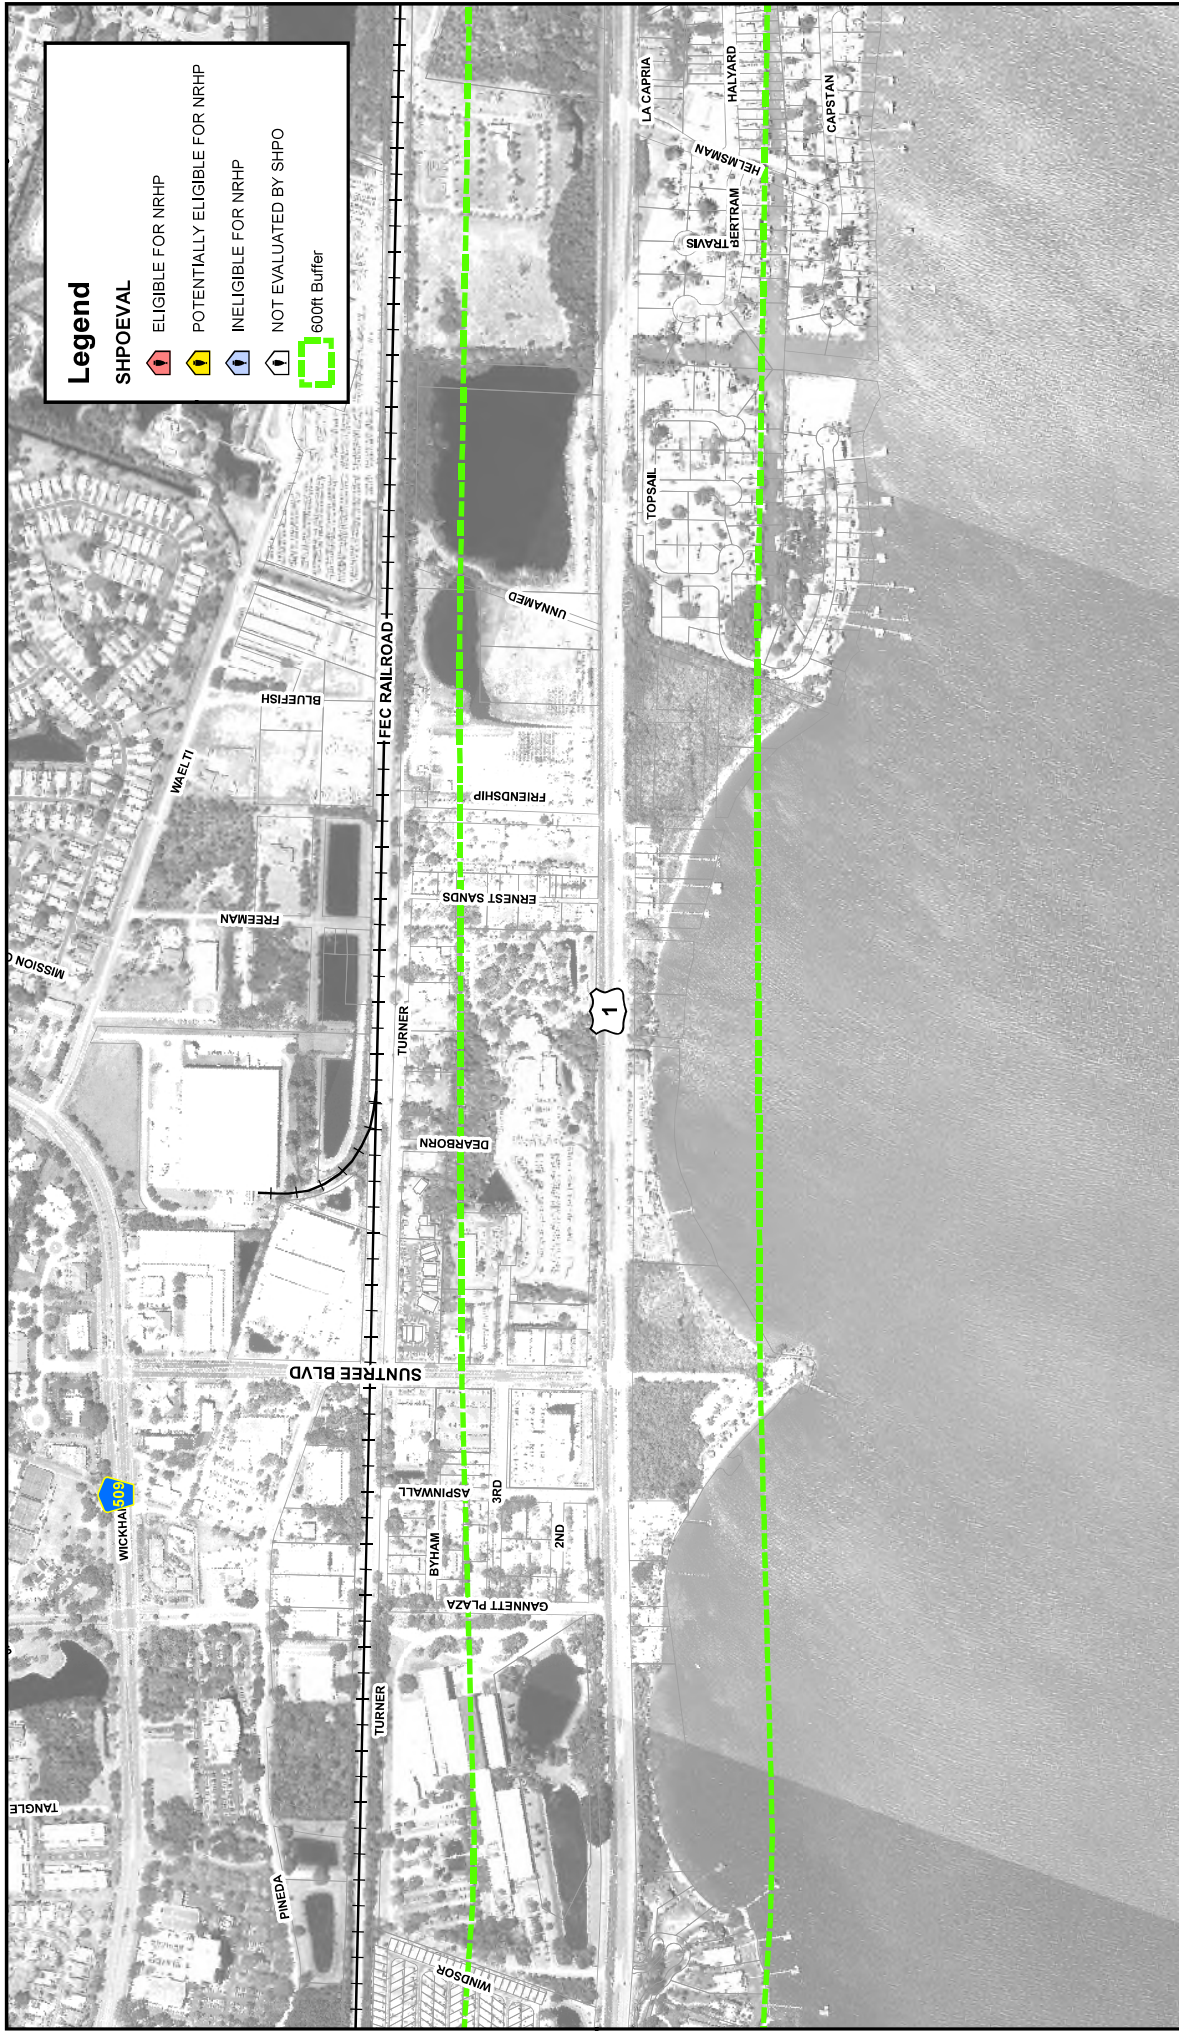
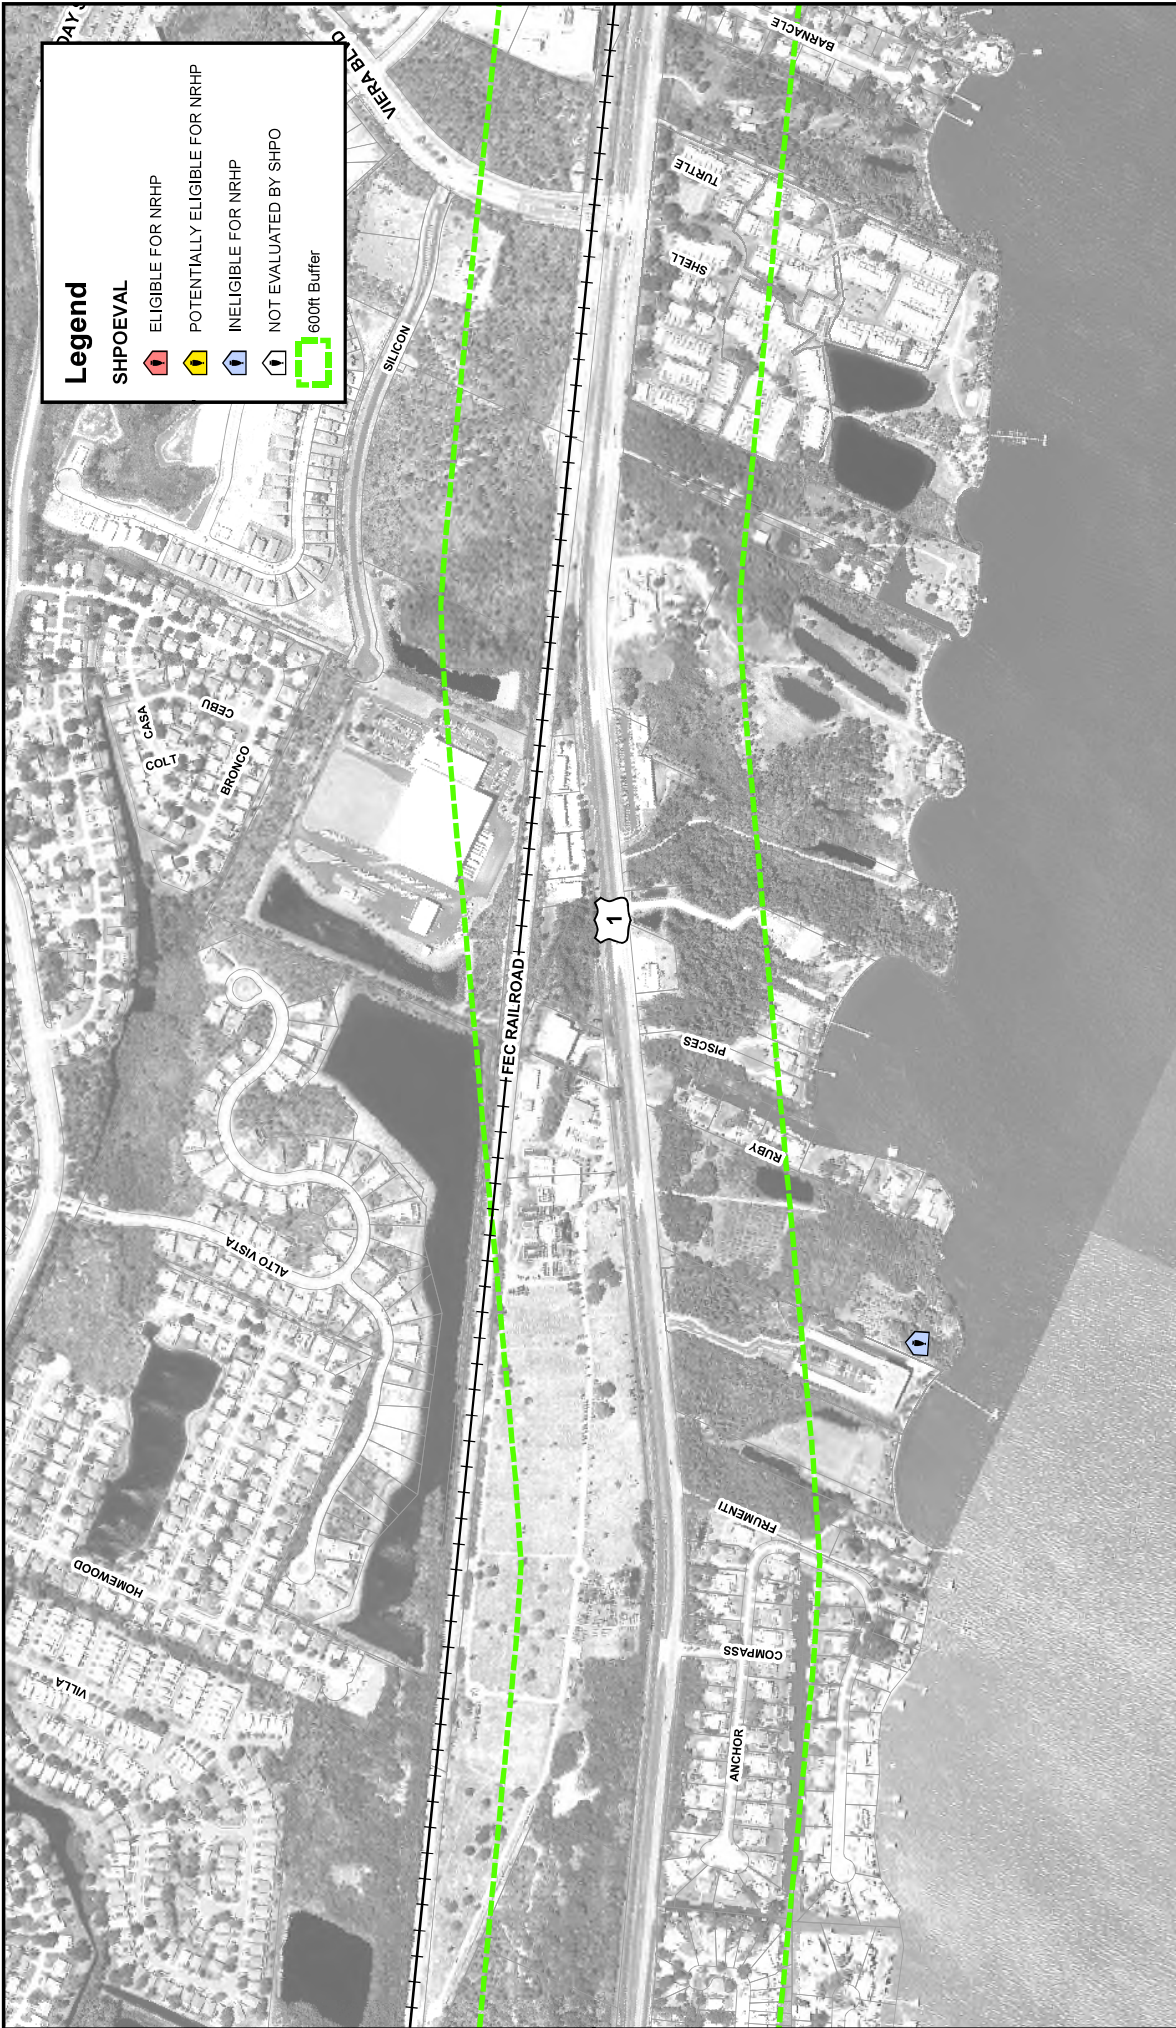
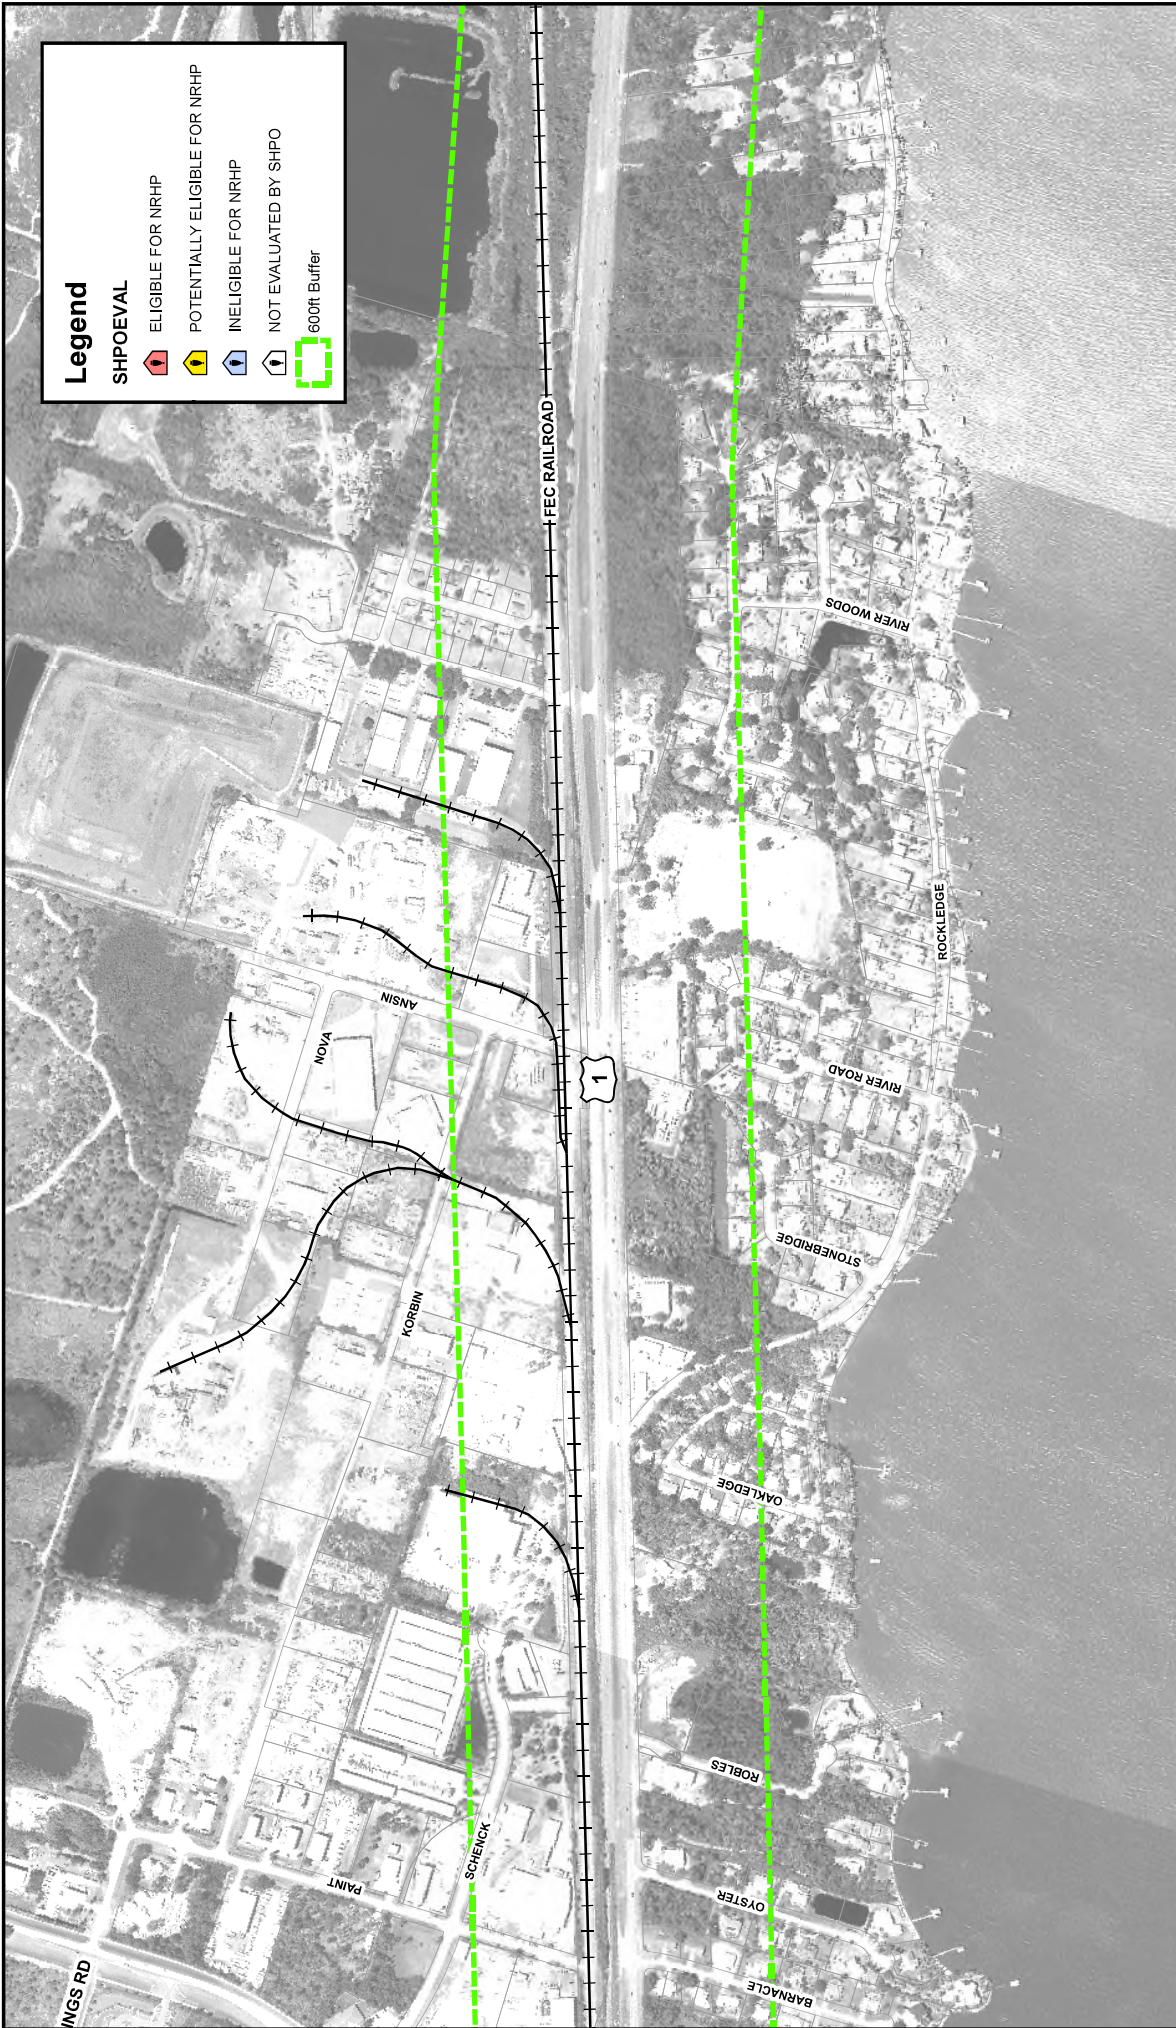
FIGURE 17

There are several historic structures along the corridor greater than 50 years of age; however, only three of these structures are eligible for listing on the National Register of Historic Places (NRHP). These resources are presented on **Figure 17** and include Harvey's Groves located at 3700 US 1, Rockledge, Florida 32955; Victory Groves located at 2273 US 1, Rockledge, Florida 32955; and an unnamed wooden structure at Rockledge Gardens located at 2153 US 1, Rockledge, Florida 32955.

HISTORIC STRUCTURES
