US 92/International Speedway Blvd (ISB) Pedestrian Connectivity & Safety Assessment Study - Phase II

Field Evaluation Report

Prepared for:
Florida Department of Transportation District 5, DeLand, FL
Contract No. C9F27 TWO 74

September 2016

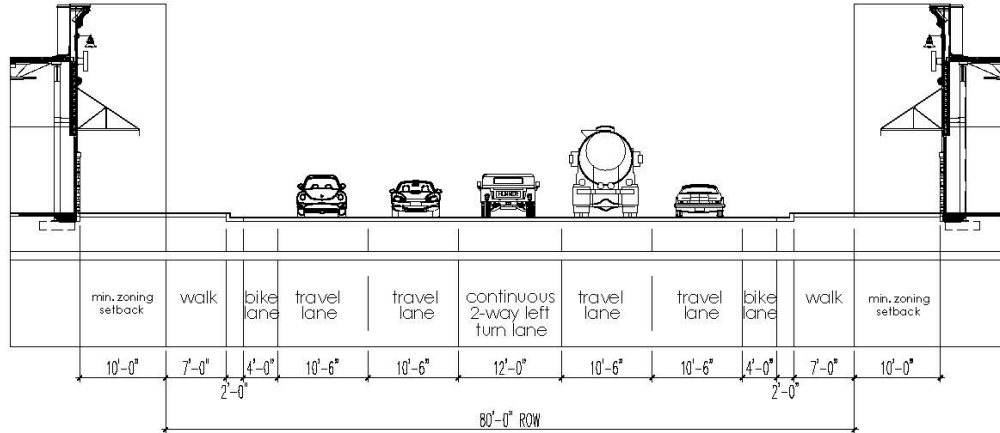
Figure 2: US 92/SR 600/ISB Typical Cross Section (SR 5A/Nova Rd to US 1/Ridgewood Ave)

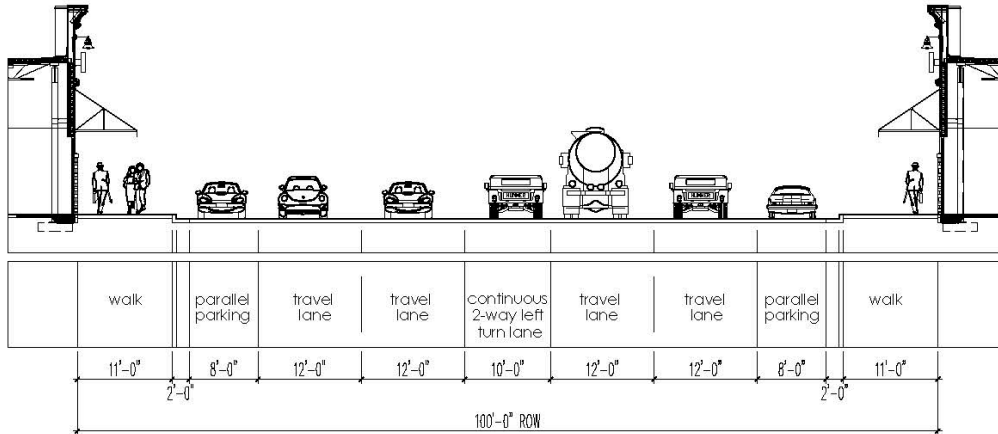
Figure 3: US 92/SR 600/ISB Typical Cross Section (US 1/Ridgewood Ave to Beach St)

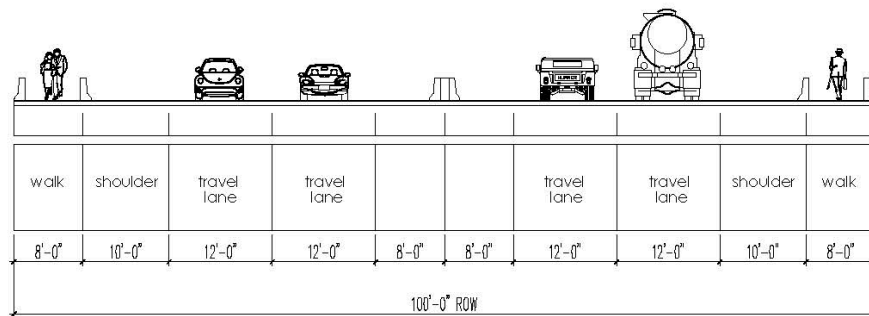
Figure 4: US 92/SR 600/ISB Typical Cross Section (Halifax River Bridge)

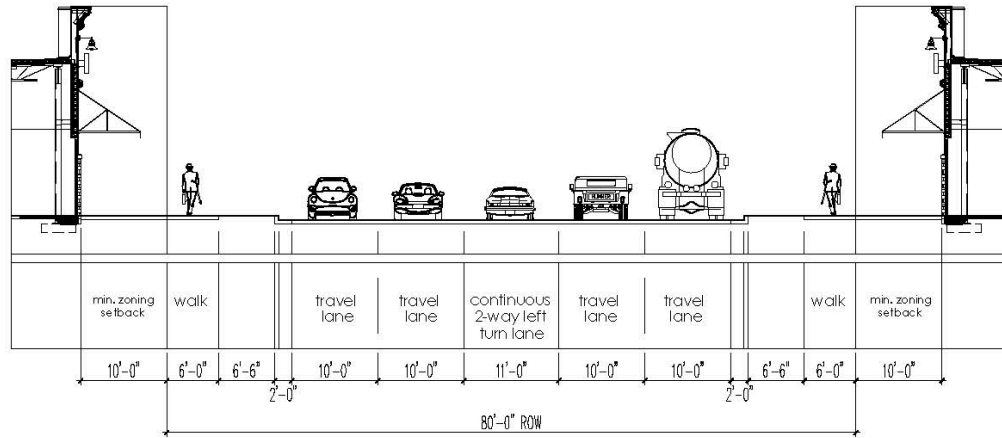
Figure 5: US 92/SR 600/ISB Typical Cross Section Halifax River to SR A1A/Atlantic Ave

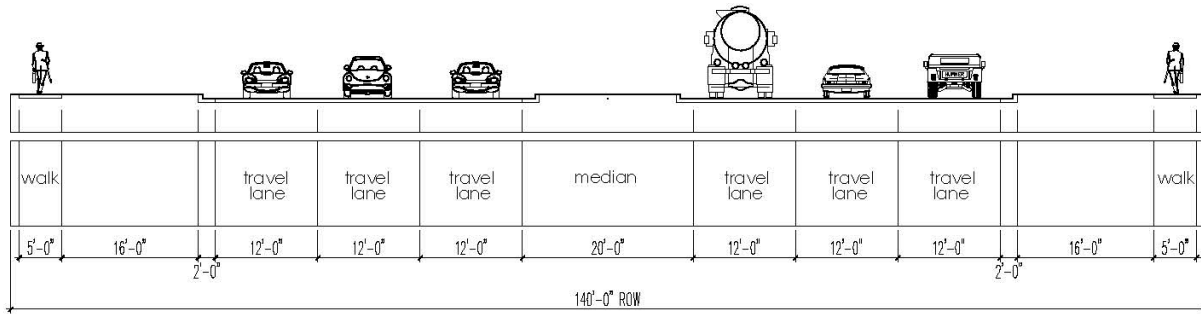
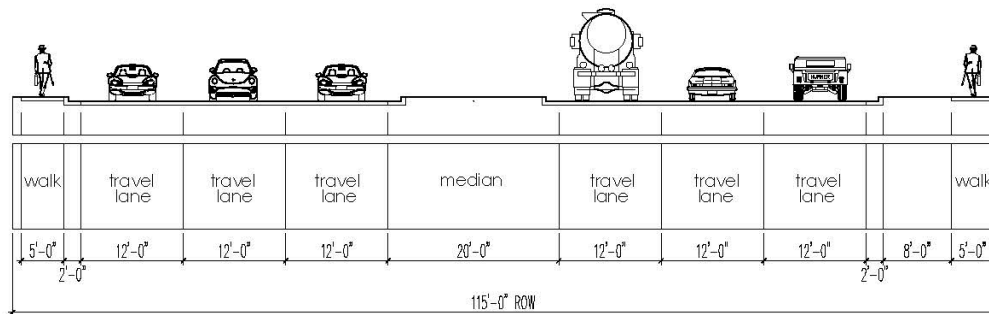
The typical cross section for SR 5A/Nova Road is depicted in Figures 6 and 7. This facility features a six-lane urban section with a grass median. The right of way within the study area varies with a minimum width of 125 feet. The roadway has six, 12-foot through lanes, a 20-foot grass median and Type F curb and gutter on each side. It also includes 5-foot sidewalks on both sides of the corridor.

Figure 6: SR 5A/Nova Rd Typical Cross Section (George W. Engram Blvd to Dr. Mary McLeod Bethune Blvd)

Figure 7: SR 5A/Nova Rd Typical Cross Section (Dr. Mary McLeod Bethune Blvd to US 92/SR 600/ISB)

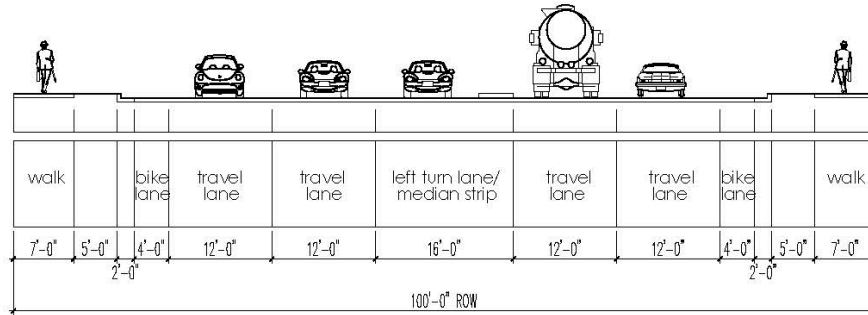
Figure 8: US 1/Ridgewood Ave Typical Cross Section

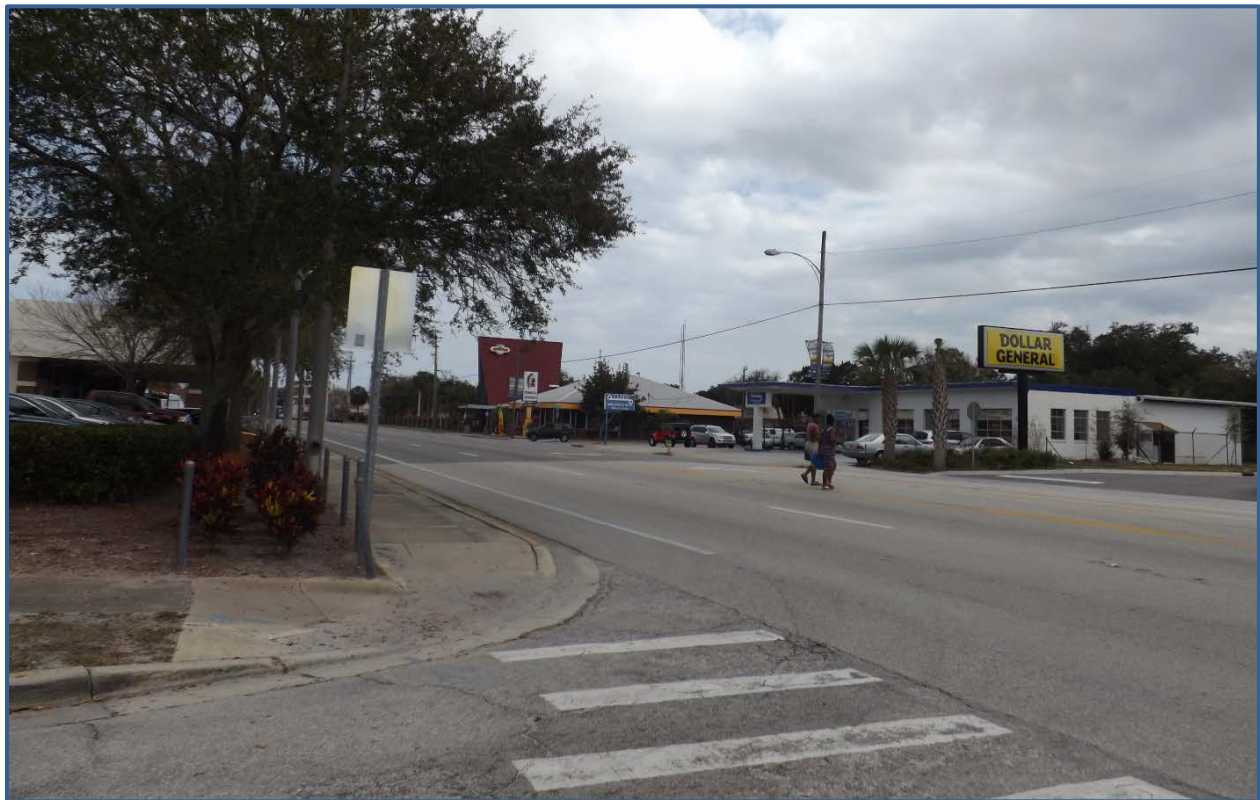
Pedestrians cross US 92/SR 600/ISB at an unmarked location within the study area.

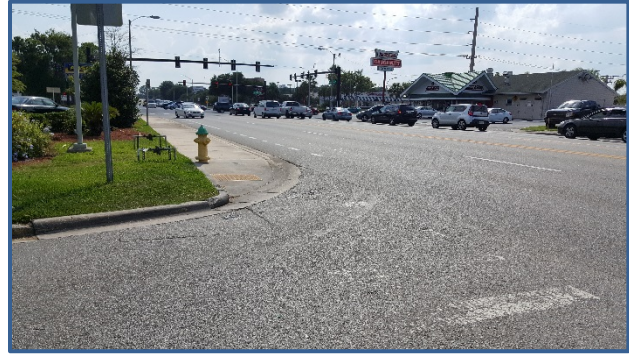
1. On US 92/SR 600/ISB, the existing marked crosswalk paint has faded at the following intersections between SR 5A/Nova Road and US 1/Ridgewood Avenue:

- a) Jean Street (Eastbound)
- b) Harney Street (Westbound)
- c) Lockhart Street (Eastbound)
- d) Seagrave Street (Westbound)

An example of a faded marked crosswalk at US 92/SR 600/ISB and Jean St.

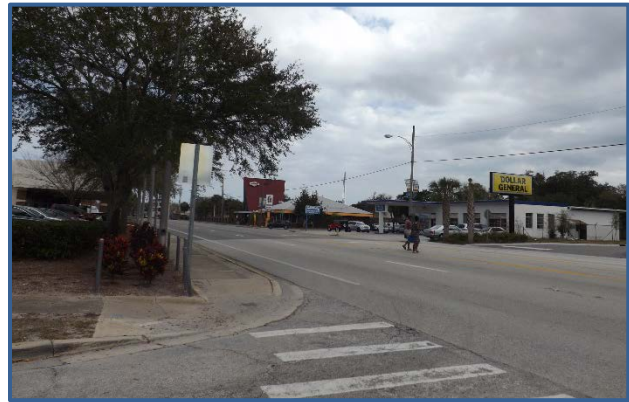
2. There are no marked pedestrian crossings over a 0.36-mile stretch of US 92/SR 600/ISB between Adams Street and Lincoln Street.

There is a lack of marked pedestrian crossings on US 92/SR 600/ISB in this section.

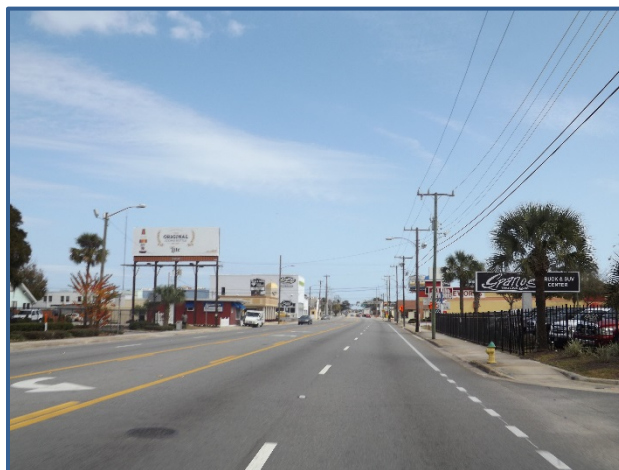
- 6. There are no marked pedestrian crossings across a 0.36-mile stretch of US 92/SR 600/ISB between Dr. MLK, Jr. King Boulevard and US 1/Ridgewood Avenue.

US 92/SR 600/ISB, looking east between Dr. MLK, Jr. Blvd and US 1/Ridgewood Ave.

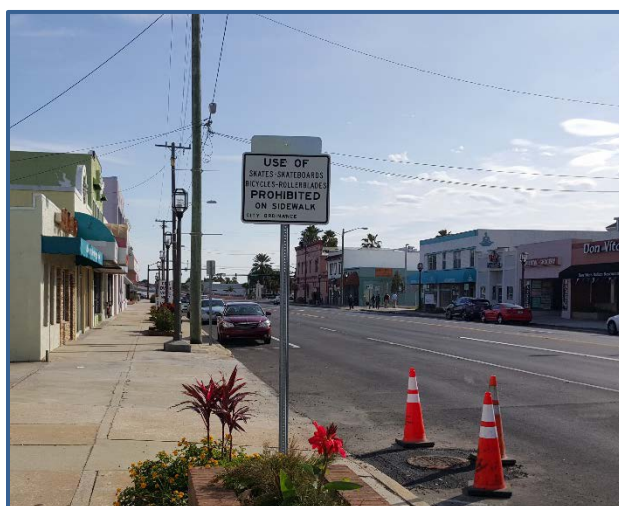
- 8. There is a 0.33-mile gap in the bike lane network, along US 92/SR 600/ISB between Seagrave Street and Beach Street.
- 9. Bicycles are prohibited on sidewalks along US 92/SR 600/ISB between Palmetto Avenue and Beach Street.
- 10. The location of concrete utility poles compromise the usable width of the eastbound sidewalk of US 92/SR 600/ISB just east of Lockhart Street to Dr. MLK, Jr. Boulevard.

Bicycles are prohibited on sidewalks along US 92/SR 600/ISB between Palmetto Ave and Beach St.

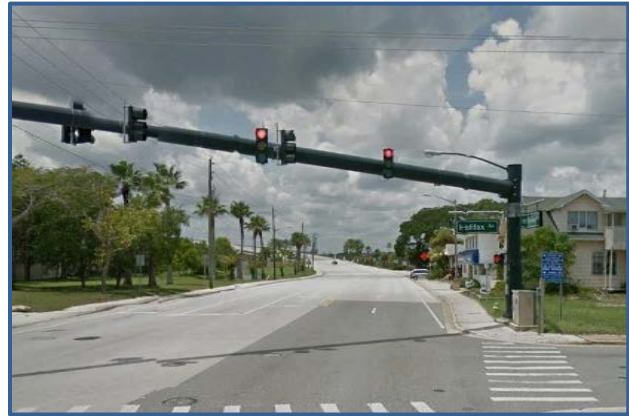
11. The US 92/SR 600/ISB westbound bicycle lane does not extend to Halifax Avenue.
12. There are no bicycle facilities along US 92/SR 600/ISB between Halifax Avenue and SR A1A/Atlantic Avenue.

*The US 92/SR 600/ISB westbound bicycle lane at Halifax Ave.
Photograph courtesy of Google Streetview.*

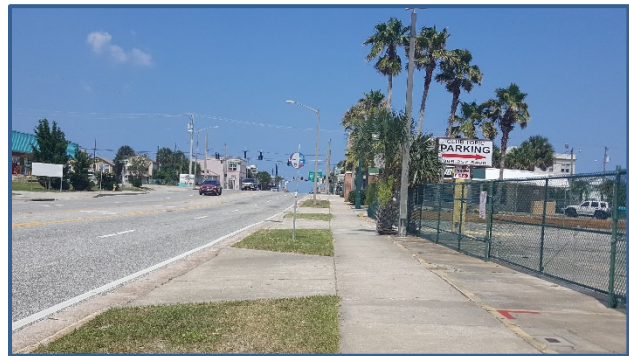
13. Several bus stops located along US 92/SR 600/ISB between SR 441/Peninsula Drive and SR A1A/Atlantic Avenue are not ADA compliant.

An eastbound bus stop along US 92/SR 600/ISB at Wild Olive Ave.

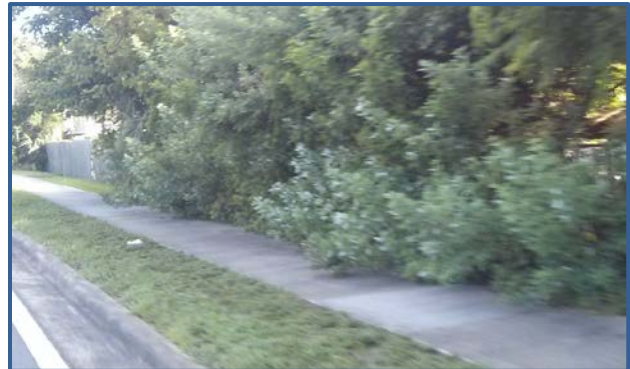
15. On the east side of SR 5A/Nova Road, between George Engram Boulevard and Dr. Mary McLeod Bethune Boulevard, vegetation obstructs the sidewalk. Trees, bushes, and other vegetation should be maintained such that pedestrian movement is not impeded.

Vegetation reduces the useable width of sidewalks on SR 5A/Nova Rd.

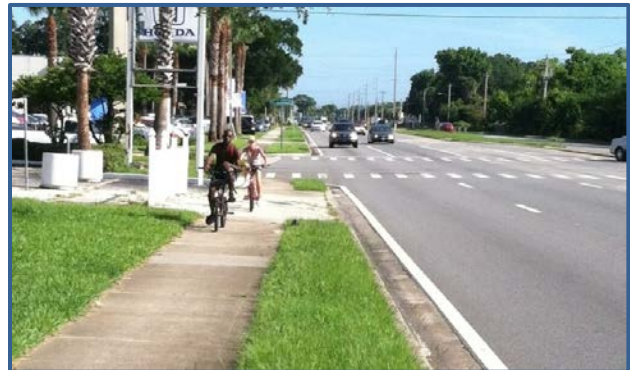
16. There are no bicycle facilities along SR 5A/Nova Road within the study area north of US 92/SR 600/ISB. Due to high automobile speeds within the corridor, cyclists frequently utilize the sidewalks rather than travelling on the roadway, creating a potential conflict with pedestrians.

Cyclists ride on the sidewalk along SR 5A/Nova Rd.

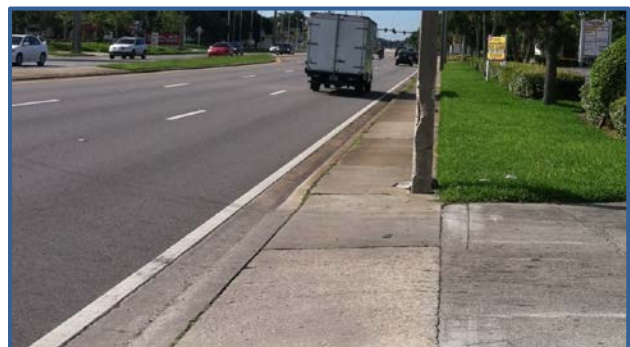
17. Street lights are located within the sidewalks between George Engram Boulevard and Orange Avenue. Although it appears that its location exceeds the ADA minimums, consideration should be given to relocating the pole outside of the sidewalk in the event of a future roadway project.

A utility pole located in the sidewalk at Midtown Plaza on SR 5A/Nova Rd.

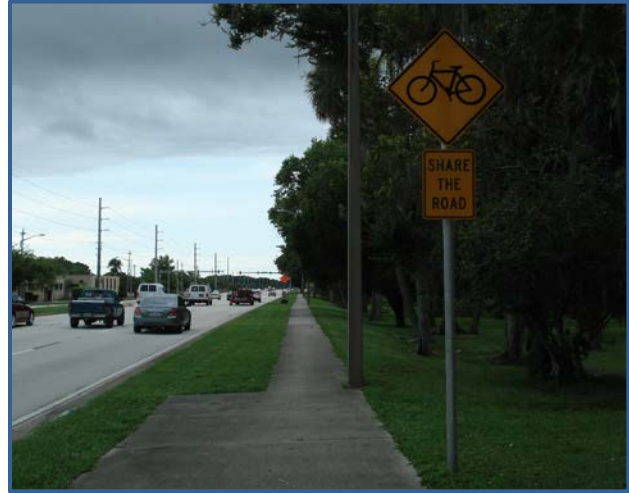
The sidewalk width on the west side of SR 5A/Nova Rd varies.

18. The sidewalk on the west side of SR 5A/Nova Road, varies width in front of Tuscawilla Park, just south of US 92/SR 600/ISB. Consideration should be given to widening the existing sidewalk into a shared use path for both cyclists and pedestrians.

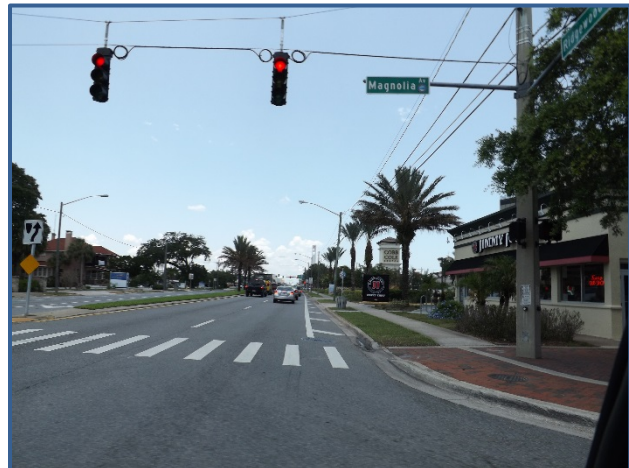
20. There is a gap in the bicycle facilities along US 1/Ridgewood Avenue between Bay Street and Magnolia Avenue.

The northbound bicycle lane on US 1/Ridgewood Ave ends at Magnolia Ave.

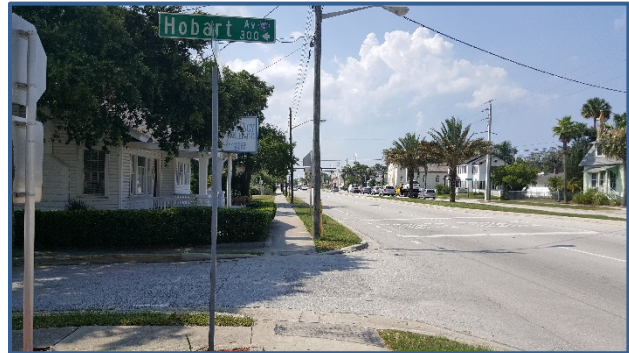
21. There are no marked crosswalks on US 1/Ridgewood Avenue at the following intersection locations within the study area:

- a) Hobart Avenue (Southbound)
- b) First Avenue (Northbound and Southbound)
- c) San Juan Avenue (Northbound and Southbound)
- d) Third Avenue (Northbound)
- e) Live Oak Avenue (Northbound and Southbound)

An unmarked crossing at US 1/Ridgewood Ave and Hobart Ave.

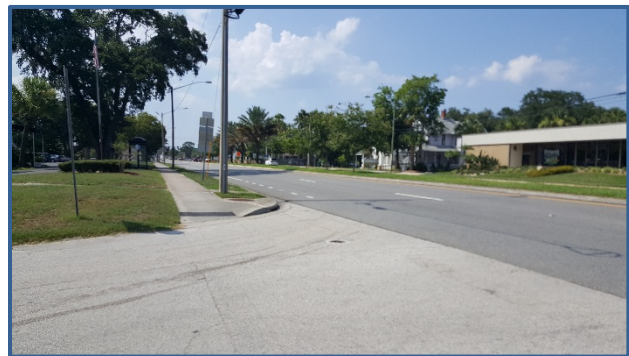
22. US 1/Ridgewood Avenue, the existing marked crosswalk paint has faded at the following intersections within the study area:

- a) Dowling Court (Northbound)
- b) Loomis Avenue (Northbound)

A faded crosswalk at the intersection of US 1/Ridgewood Ave and Loomis Ave.

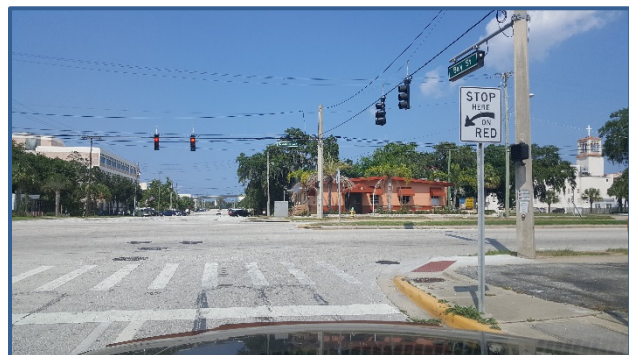
23. There is no eastbound crosswalk at the signalized intersection of US 1/Ridgewood Avenue and Bay Street.

The intersection of US 1/Ridgewood Ave and Bay St lacks a crosswalk on the south side.

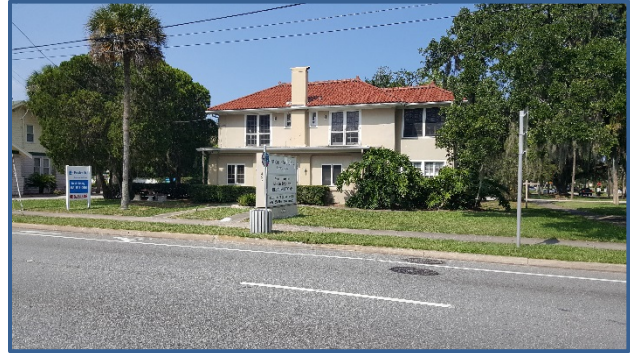
24. Several bus stops located along US 1/ Ridgewood Avenue between US 92/SR 600/ISB and Loomis Avenue are not ADA compliant.

A non ADA compliant bus stop on US 1/Ridgewood Ave.

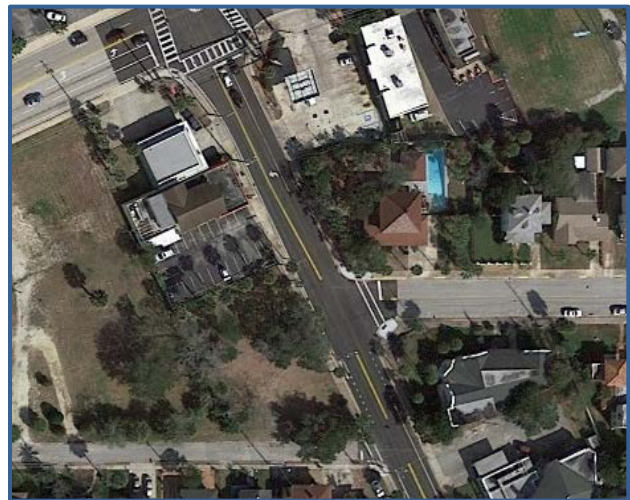
25. There is a gap in the bicycle facilities along SR 441/Peninsula Drive between US 92/SR 600/ISB and Vermont Avenue.

Bike facilities on SR 441/Peninsula Dr end one block south of US 92/SR 600/ISB. February 2016 aerial courtesy of Google Earth.

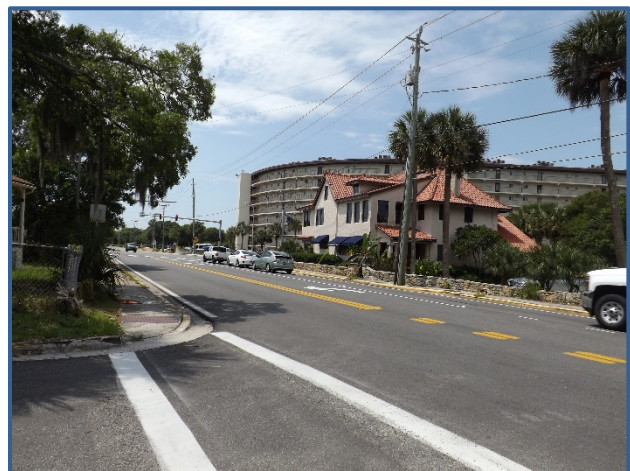
26. There is a gap in the bicycle facilities along SR 441/Peninsula Drive between Phoenix Avenue and Silver Beach Avenue.

There are no bicycle facilities on SR 441/Peninsula Dr between Phoenix Ave and Silver Beach Ave.

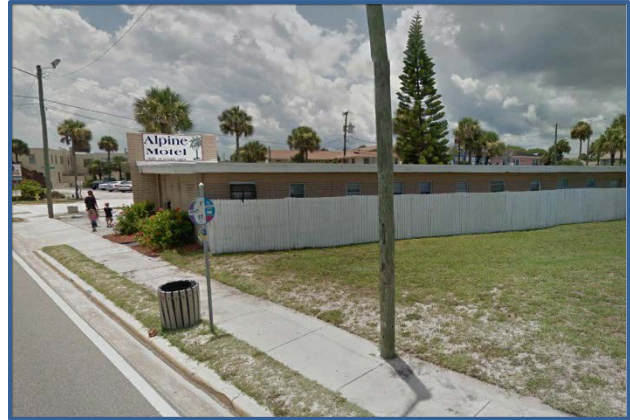
27. Several southbound bus stops located along SR A1A/Atlantic Avenue between US 92/SR 600/ISB and Silver Beach Avenue are not ADA compliant and lack amenities.

A southbound non-ADA compliant bus stop on SR A1A/Atlantic Ave. July 2015 photograph courtesy of Google Streetview.

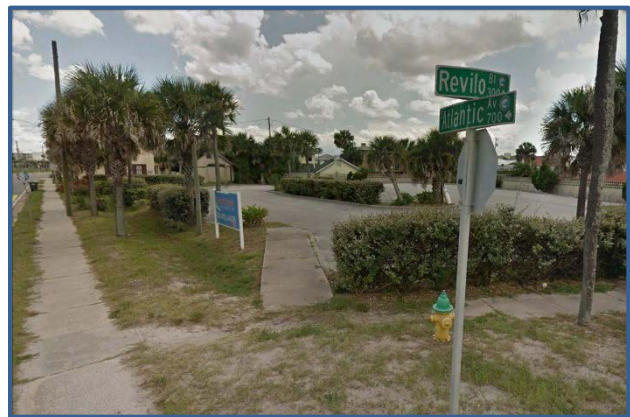
28. There is a gap in the sidewalk network at the intersection of SR A1A/Atlantic Avenue and Revilo Boulevard.

A cattle trail in the sidewalk network at SR A1A/Atlantic Ave and Revilo Blvd. July 2015 photograph courtesy of Google Streetview.

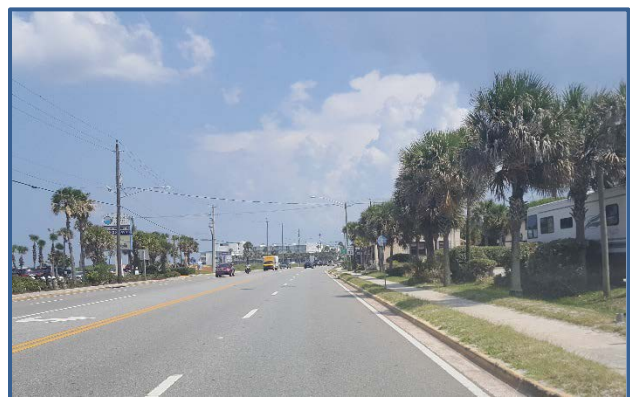
29. There are no marked pedestrian crossings along a 0.42-mile stretch of SR A1A/Atlantic Avenue from just north of Revilo Boulevard to Silver Beach Avenue.

SR A1A/Atlantic Ave does not have marked pedestrian crossings between Revilo Blvd and Silver Beach Ave.

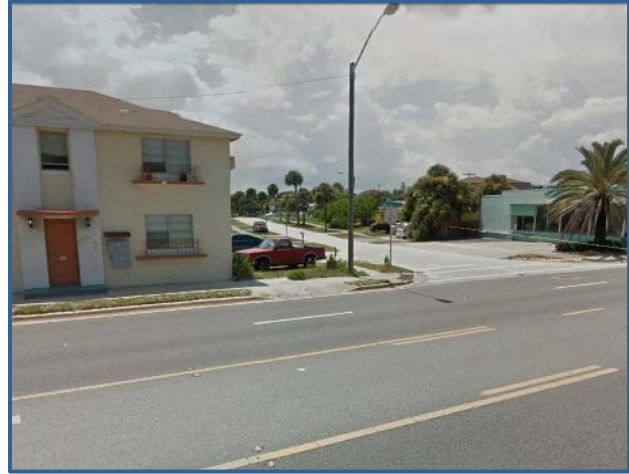
31. There are ADA accessible ramps along SR A1A/Atlantic Avenue at Ribault Avenue, suggesting that a mid-block crossing may have once been considered or existing at this location. This location is the mid-point between an existing mid-block crossing just north of Revilo Boulevard and Silver Beach Avenue.

An ADA accessible sidewalk ramp at Ribault Ave without a marked crosswalk. July 2015 photograph courtesy of Google Streetview.

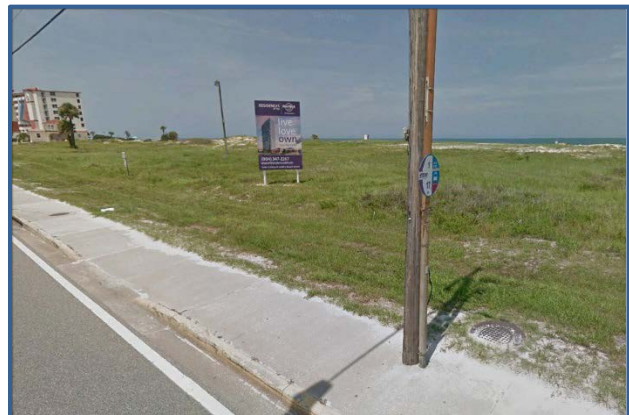
32. Several northbound bus stops located along SR A1A/Atlantic Avenue between US 92/SR 600/ISB and Silver Beach Avenue lack amenities.

A northbound bus stop without amenities at SR A1A/Atlantic Ave and Revilo Blvd. July 2015 photograph courtesy of Google Streetview.

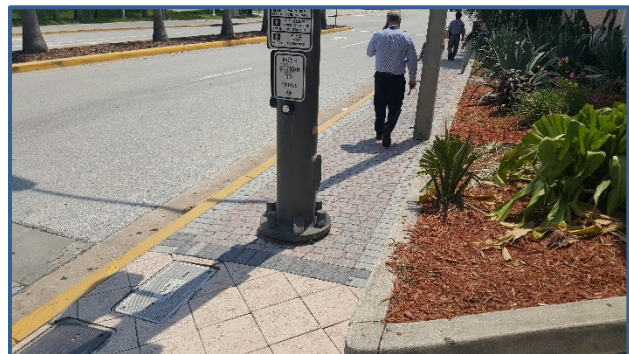
34. A traffic signal obstructs the sidewalk on the north side of Earl Street at SR A1A/Atlantic Avenue.

A traffic signal impacts the sidewalk width on Earl St.

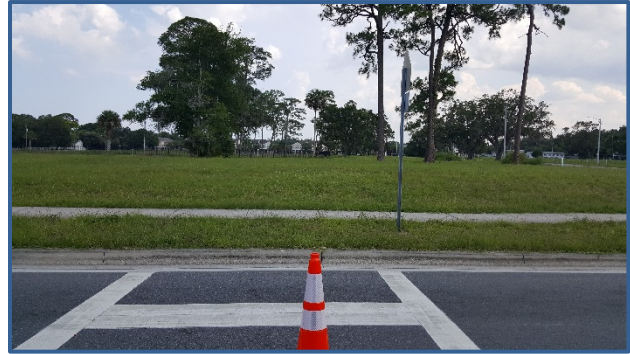
35. At Chiles Academy School, the sidewalk on the south side of George W. Engram Boulevard does not connect with the marked mid-block crossing just east of Laura Street. Consideration should be given to providing an ADA compliant connection at this location.

Consideration should be given to providing an ADA compliant connection at Chiles Academy School.

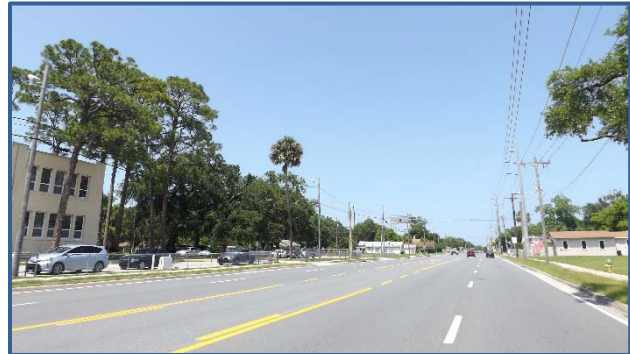
36. There are no marked pedestrian crossings over a 0.45-mile stretch of George W. Engram Boulevard between Chiles Academy School and Dr. MLK, Jr. Boulevard.

George W. Engram Blvd is a wide roadway with limited opportunities for pedestrians to cross between SR 5A/Nova Road and Dr. MLK, Jr. Blvd.

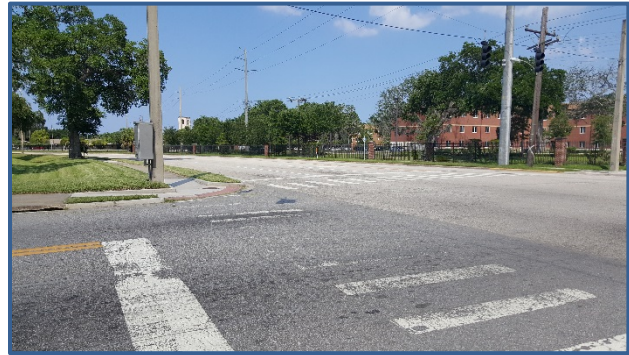
38. On George W. Engram Boulevard, the existing marked crosswalk paint has faded at the following intersections between SR 5A/Nova Road and US 1/Ridgewood Avenue:

- a) Lincoln Street (North side)
- b) Model Street (North and South sides)
- c) Pleasant Street (North side)
- d) Dr. MLK, Jr. Boulevard (North side)

A faded existing marked crosswalk at Dr. MLK, Jr. Blvd.

39	George W. Engram Blvd at Lincoln St, Model St and Pleasant St	Existing marked crosswalk paint has faded	Volusia County	Repaint crosswalks
40	George W. Engram Blvd at Seagrave St	There is no marked crosswalk on the north side of intersection	Volusia County	Install marked crosswalk
41	George W. Engram Blvd at Rose Ave	There is a gap in sidewalk connection at Rose Ave	Volusia County	Construct sidewalk
42	Fairview Ave 100' east of US 1/ Ridgewood Ave	The north sidewalk is less than 3' wide	Volusia County	Repair sidewalk
43	Fairview Ave from US 1/Ridgewood Ave to Beach St	Excluding the Central Manor Apartments bus stop, all bus stops lack amenities	City of Daytona Beach	Add bus stop amenities where feasible
44	Fairview Ave at Beach St	There are no crosswalks on the north, west and east sides of intersection. On the north side of the street, there are no curb ramps.	Volusia County	Install marked crosswalks and curb ramps

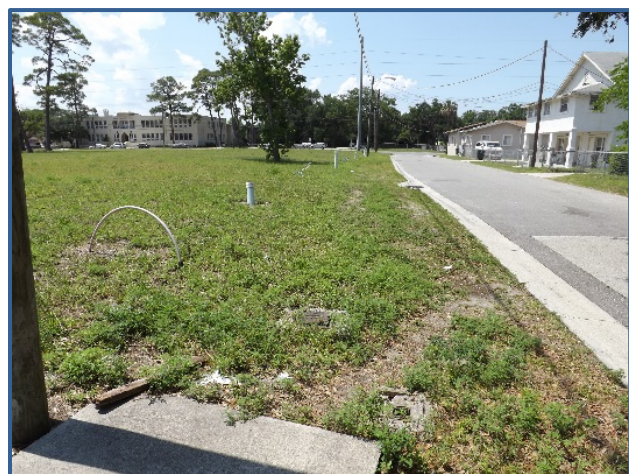
40. There is a gap within the sidewalk network on Rose Avenue just south of George W. Engram Boulevard.

This sidewalk on Rose Ave abruptly ends 280' south of George W. Engram Blvd.

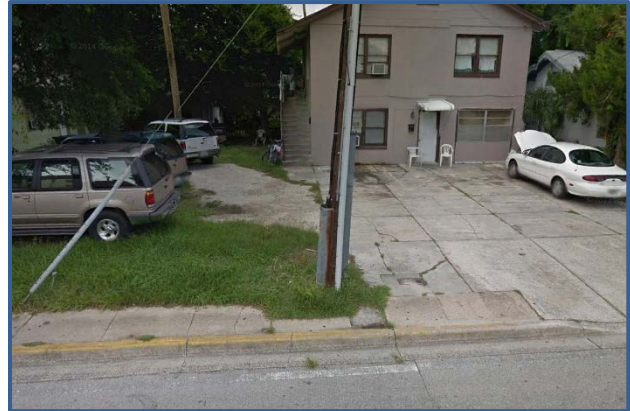
41. The sidewalk on the north side of Fairview Avenue is less than 3' wide, 100' east of US 1/Ridgewood Avenue.

Just east of US 1/Ridgewood Ave, the sidewalk width on the north side of Fairview Ave is not ADA compliant.

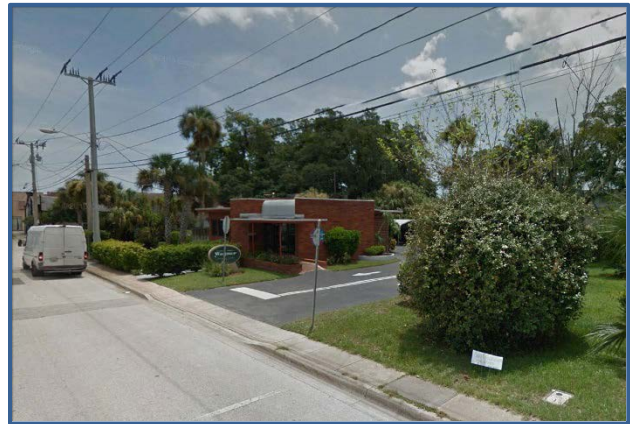
42. Excluding the Central Manor Apartments bus stop on the north side of Fairview Avenue, all bus stops between US 1/Ridgewood Avenue and Beach Street lack amenities.

A bus stop with no amenities at Fairview Ave and Daytona Street. July 2015 photograph courtesy of Google Streetview.

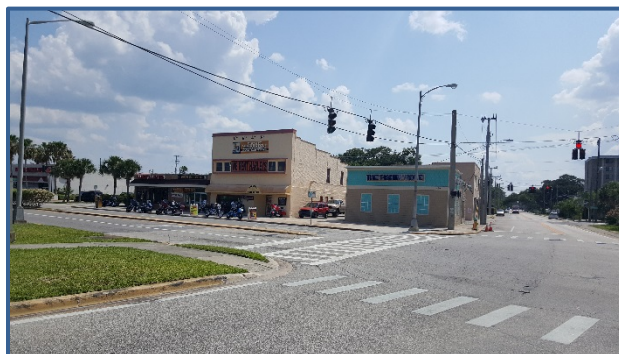
- 44. The sidewalks on the west side of the Fairview Avenue/Ballough Road intersection lack ADA accessible sidewalk ramps. In addition, the crosswalk on the south side of Fairview Avenue does not align with existing ADA accessible sidewalk ramps.

The intersection of Fairview Ave and Ballough Rd.

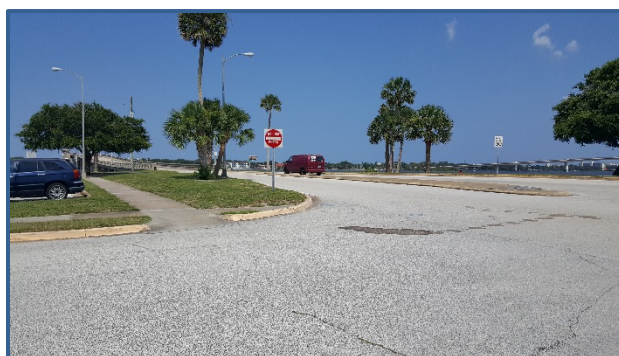
- 45. There is no marked crosswalk on the north side of Fairview Avenue at Bowman Avenue.

There is no marked crosswalk at Fairview Ave and Bowman Ave.

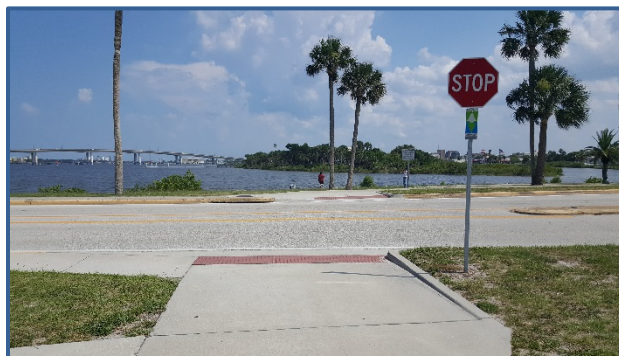
- 46. Despite the presence of ADA accessible sidewalk ramps, there is no marked crossing for the Halifax River Greenway where it crosses Fairview Avenue.

The Halifax River Greenway multi-use path at Fairview Ave.

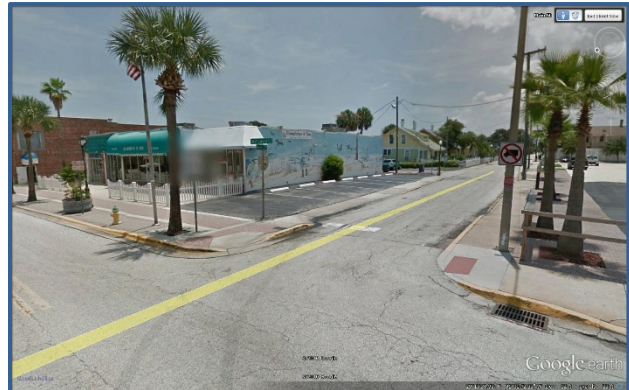
47. There are no marked crosswalks on Main Street at the following intersections:
- a) Hollywood Avenue South
 - b) Hollywood Avenue North

The intersection of Main St and Hollywood Ave does not have a marked crosswalk.

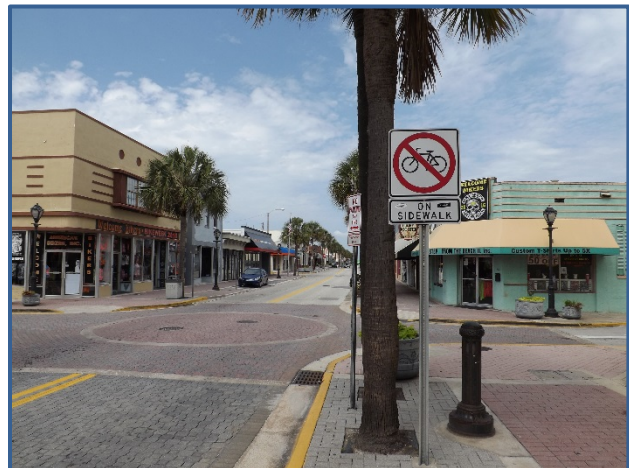
48. On Main Street, the use of bicycles on sidewalks is prohibited despite the corridor lacking dedicated bicycle facilities.

Bicycles are not allowed on Main St.

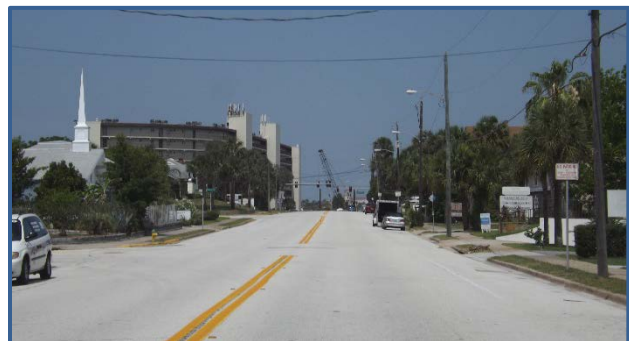
49. Despite the existing width of the street, there are no bicycle facilities on Silver Beach Avenue, between the Veterans Memorial Bridge and SR A1A/Atlantic Avenue.

Silver Beach Ave looking west towards SR 441/Peninsula Ave.

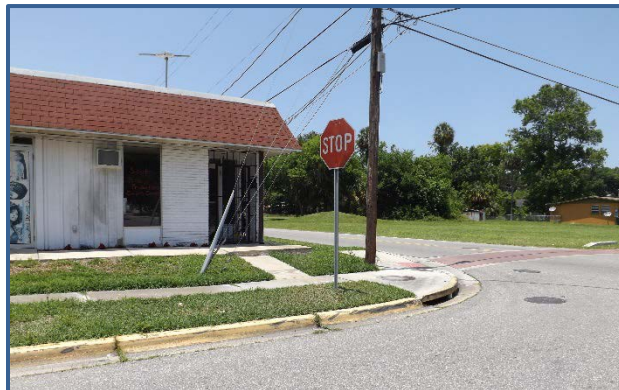
50. The sidewalk connection on the west side of Jean Street at Magnolia Avenue lacks ADA accessible sidewalk ramps.

There are no ADA accessible ramps on the west side of the Jean St and Magnolia Ave intersection.

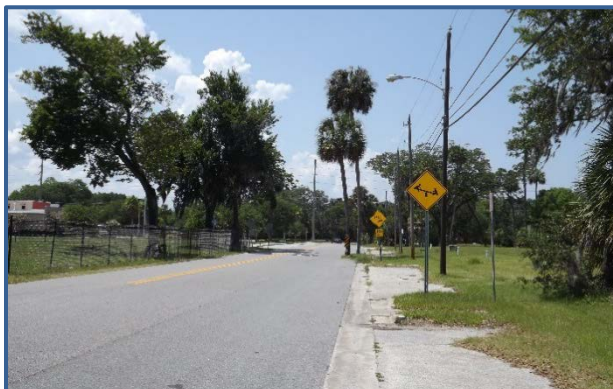
51. There is a gap in the sidewalk connection on the east side of Keech Street between George W. Engram Boulevard and Pinehaven Drive.

A gap in the sidewalk network on Keech St, north of Pinehaven Dr.

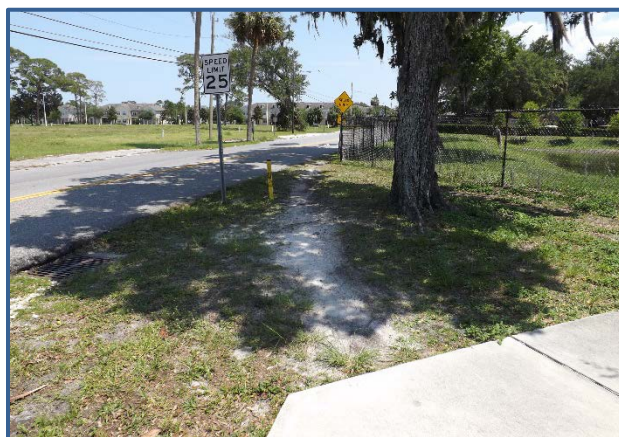
52. There are no sidewalk facilities on the west side of Keech Street between Dr. Mary McLeod Bethune Boulevard, despite the presence of transit service, Cypress Park and Chiles Academy School. Consideration should be given to the development of ADA compliant bus stops and sidewalk connections where “cattle trails” exist.

A cattle trail to a non ADA compliant bus stop on Keech St.

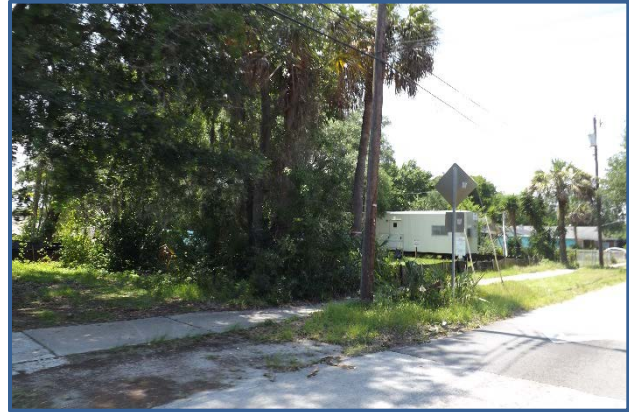
53. Vegetation is obstructing the sidewalk on the west side of Keech Street just north of Oak Street. Trees, bushes and other vegetation should be maintained such that pedestrian movement is not impeded.

Vegetation obstructs the sidewalk on Keech St.

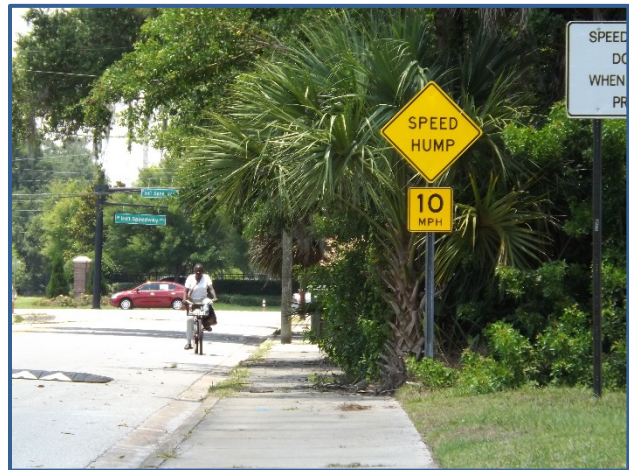
54. Vegetation is obstructing the sidewalk on the west side of Adams Street just north (a) and south (b) of Magnolia Avenue. Trees, bushes and other vegetation should be maintained such that pedestrian movement is not impeded.

Vegetation obstructs the sidewalk on Adams St.

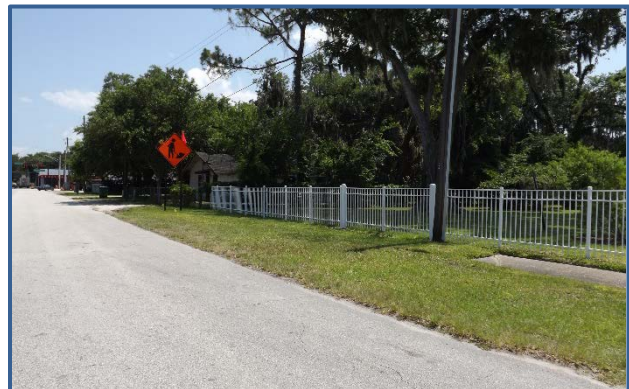
55. There are several sidewalk gaps on the west side of Adams Street in the vicinity of Oak Street.

A sidewalk on Adams St abruptly ends.

56	Adams Street at Oak St	There are several sidewalk gaps on the west side of street	City of Daytona Beach	Construct sidewalk connection
57	Dr. Mary McLeod Bethune Blvd at Desoto St	A utility pole compromises the width of the sidewalk and curb ramp	City of Daytona Beach	Widen sidewalk around utility pole
58	Dr. Mary McLeod Bethune Blvd at Weaver St	A street light fixture that compromises the width and use of curb ramp at the NW corner of intersection	City of Daytona Beach	Reconstruct curb ramp or relocate street light fixture
59	Dr. Mary McLeod Bethune Blvd near Palmetto Ave	Broken sections of sidewalk	City of Daytona Beach	Repair broken sidewalk sections
60	Fulton St at Oak St	No curb ramp	City of Daytona Beach	Install curb ramp
61	Fulton St north of George W Engram Blvd	Vegetation is obstructing the sidewalk on the west side of street	City of Daytona Beach	Maintenance of vegetation
62	Jefferson St between Oak St and Dr. Mary McLeod Bethune Blvd	There is a gap in sidewalk network on west side of street	City of Daytona Beach	Construct sidewalk connection

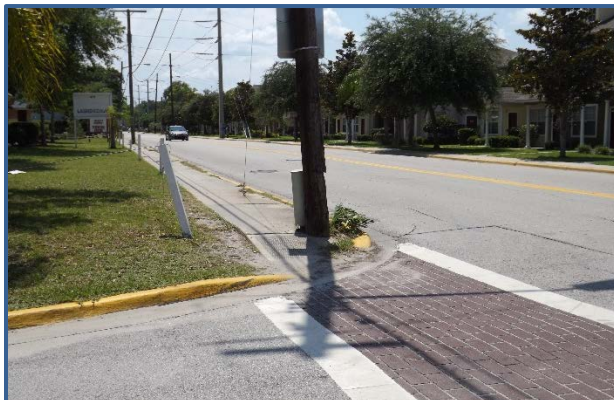
56. There is a utility pole that compromises the width of the sidewalk and ADA accessible sidewalk ramp on Dr. Mary McLeod Bethune Boulevard at Desoto Street.

A utility pole obstructs the sidewalk on Dr. Mary McLeod Bethune Blvd.

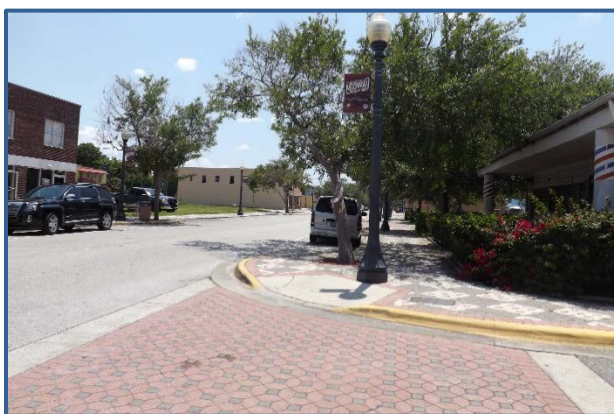
57. There is a utility pole that compromises the width and use of the ADA accessible sidewalk ramp at the northwest corner of Dr. Mary McLeod Bethune Boulevard and Weaver Street.

A streetlight obstructs the sidewalk ramp at Weaver St.

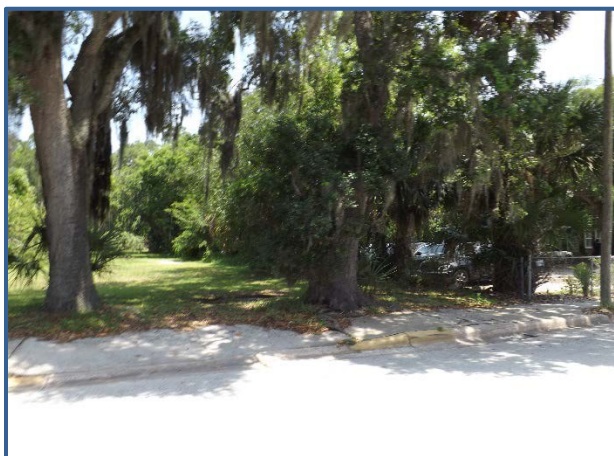
Vegetation obstructs the sidewalk on Keech St.

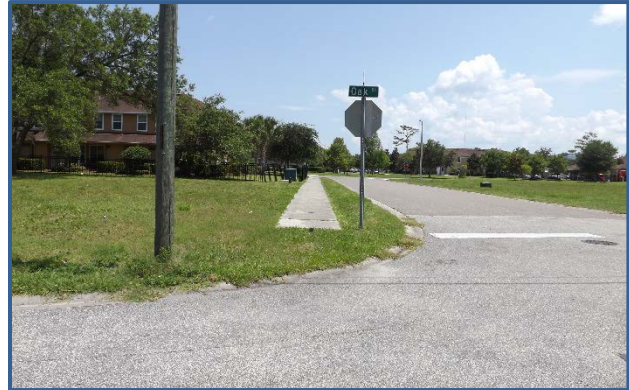
59. The sidewalk at the intersection of Oak Street and Fulton Street lacks an ADA accessible sidewalk ramp.

This sidewalk abruptly ends at Oak St and Fulton St.

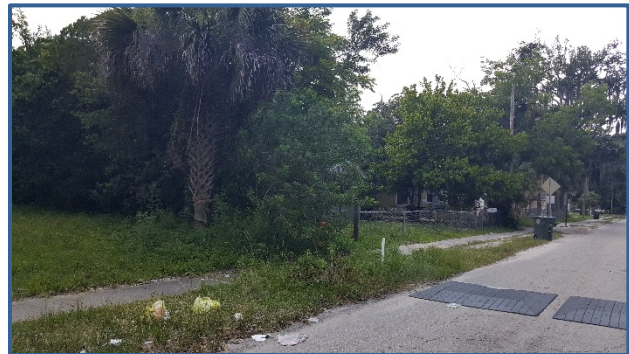
60. Vegetation is obstructing the sidewalk on the west side of Fulton Street adjacent to the Chiles Academy, just north of George W. Engram Boulevard. Trees, bushes and other vegetation should be maintained such that pedestrian movement is not impeded

Vegetation obstructs the sidewalk on Fulton St.

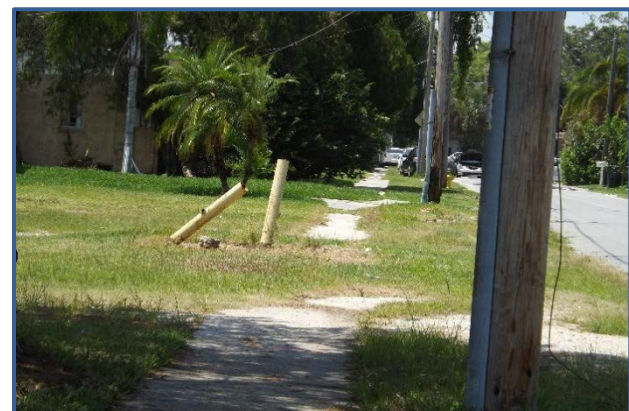
61. There is a gap in the existing sidewalk running on the west side of Jefferson Street between Oak Street and Dr. Mary McLeod Bethune Boulevard.

Sidewalk gaps exist on the west side of Jefferson St.

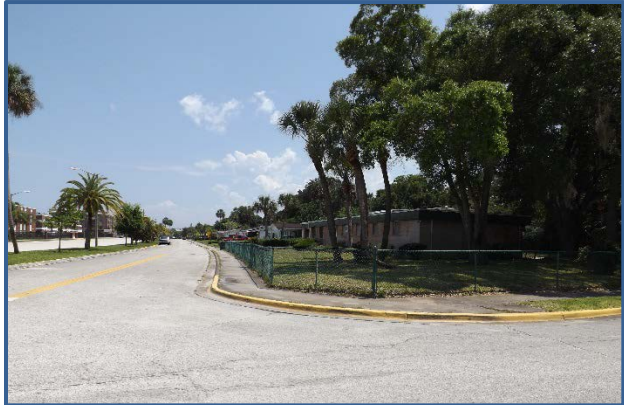
62. At the intersection of Lincoln Street and State Street, the sidewalk connections on the west lack ADA accessible sidewalk ramps.

There are no ADA accessible ramps at the intersection of Lincoln St and State St.

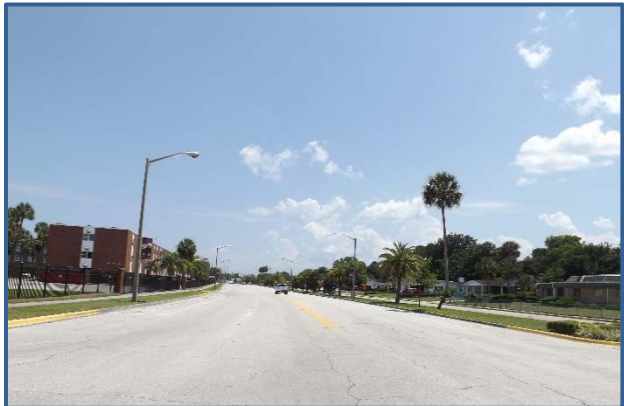
63. Lincoln Street, between George W. Engram Boulevard and US 92/SR 600/ISB does not have adequate bicycle facilities, despite the existing right-of-way being 130 feet in width. The 4-lane corridor also has an Average Annual Daily Traffic (AADT) count of less than 10,000.

Lincoln St is 130' in width near Bethune-Cookman University.

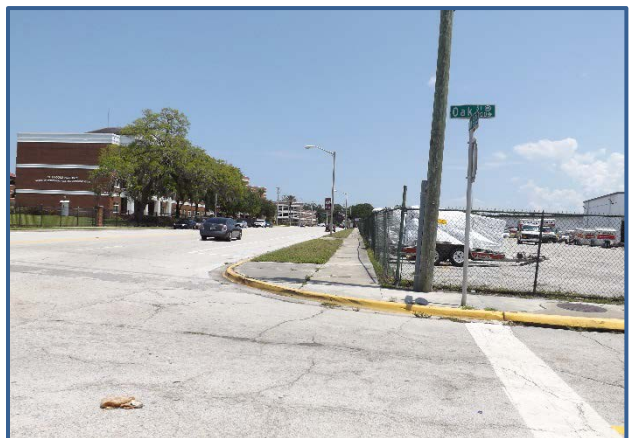
64. There are no ADA accessible sidewalk ramps on the west side of Lincoln Street at Oak Street.

There are no ADA accessible ramps at the intersection of Lincoln St and Oak St.

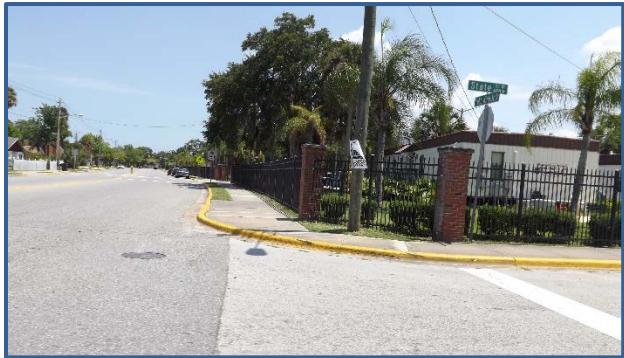
There are no ADA accessible ramps at intersections along State St.

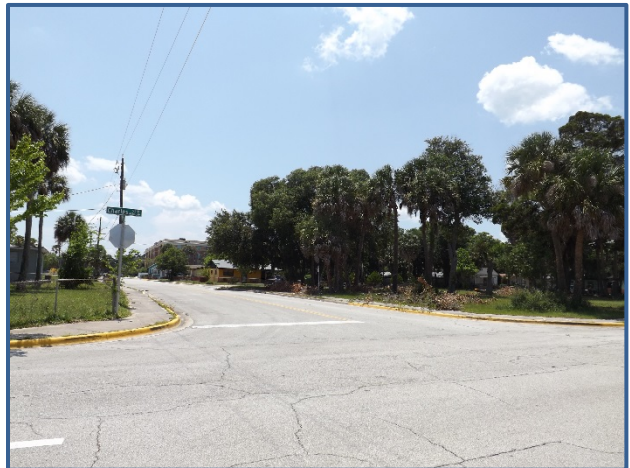
Several intersections along the McLeod Ave corridor lack ADA accessible sidewalk ramps.

Consideration should be given to rectifying this situation as soon as reasonably feasible.

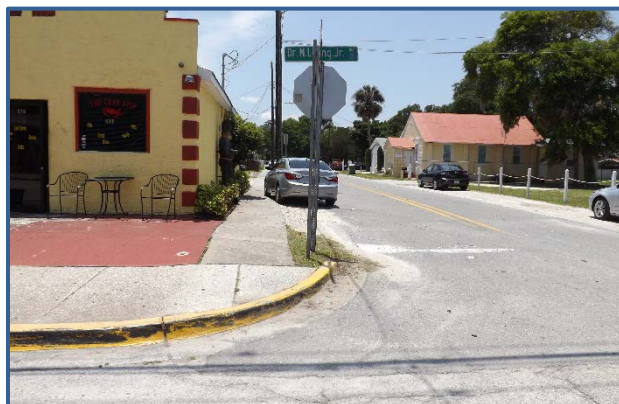
68. There are no ADA accessible sidewalk ramps at the intersection of DR. MLK, Jr. Boulevard and Cherry Street.

There are no ADA accessible ramps at the intersection of Dr. MLK Blvd and Cherry St.

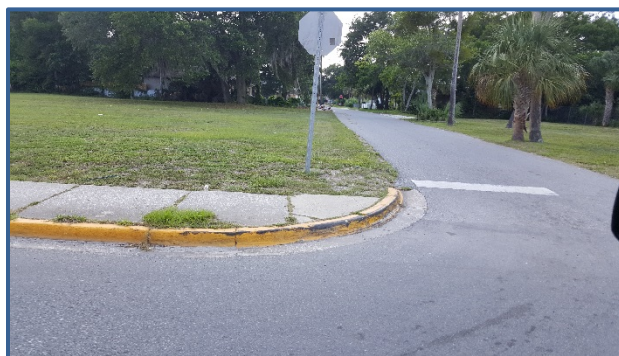
70. There are no ADA accessible sidewalk ramps at the intersection of Dr. MLK, Jr. Boulevard and Verdell Street.

There are no ADA accessible ramps at the intersection of Dr. MLK Blvd and Verdell St.

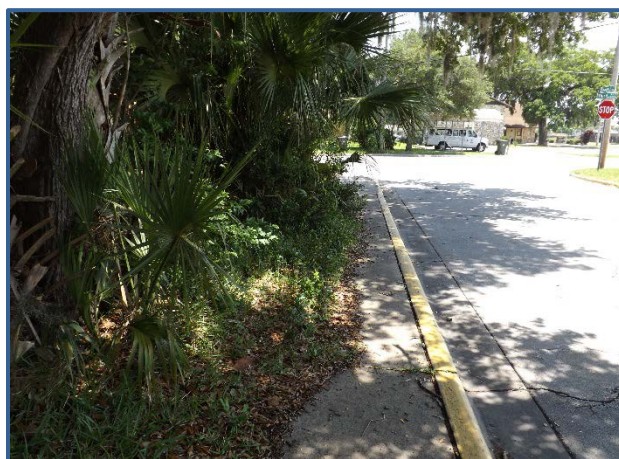
71. Vegetation is obstructing the sidewalk on the east side of Green Street just north of Third Avenue. Trees, bushes and other vegetation should be maintained such that pedestrian movement is not impeded.

Vegetation obstructs the sidewalk on Green St.

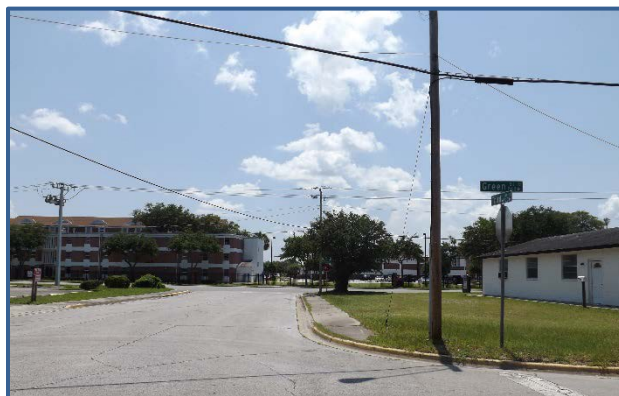
72. There are no ADA accessible sidewalk ramps at the intersection of Green Street and Third Avenue.

There are no ADA accessible ramps at the intersection of Green St and Third Ave.

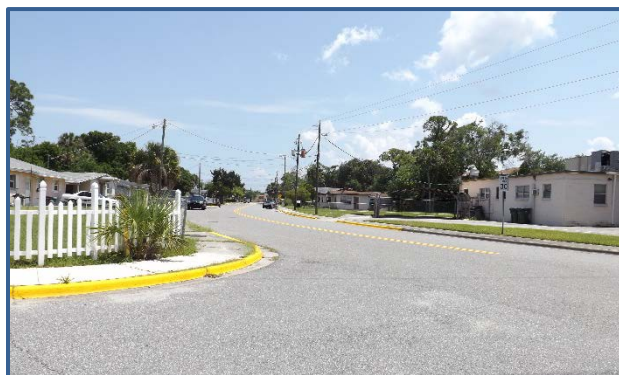
74. There are no ADA accessible sidewalk ramps at the intersection of Walnut Street and Weaver Street.

There are no ADA accessible ramps at the intersection of Walnut St and Weaver St.
