US 92/International Speedway Blvd (ISB) Pedestrian Connectivity & Safety Assessment Study - Phase II

Field Evaluation Report

Prepared for:
Florida Department of Transportation District 5, DeLand, FL
Contract No. C9F27 TWO 74

September 2016

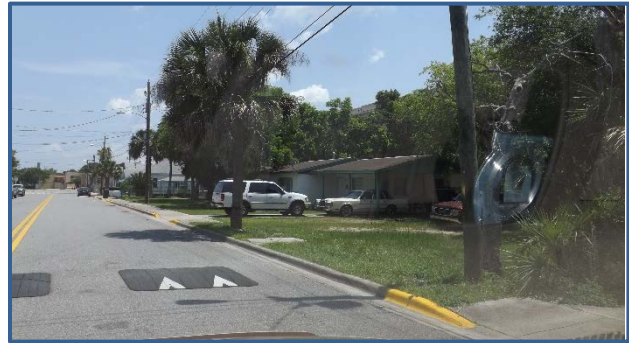
75. There is a gap within the sidewalk network on the west side of Walnut Street midway between Weaver Street and McLeod Avenue.

A gap in the sidewalk network along Walnut St.

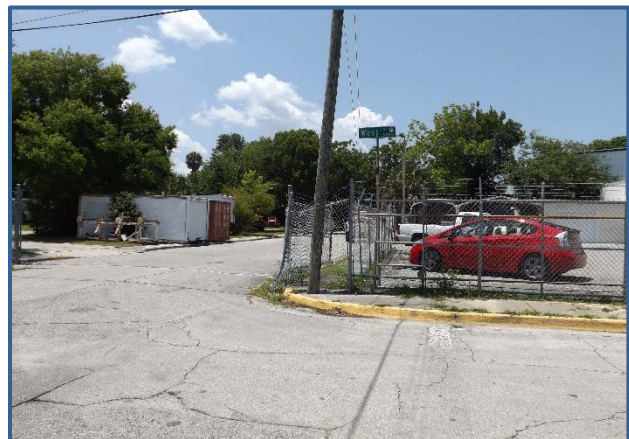
77. There are no ADA accessible sidewalk ramps at the intersection of Emmet Street and West Street.

There are no ADA accessible ramps at the intersection of Emmet and West Sts.

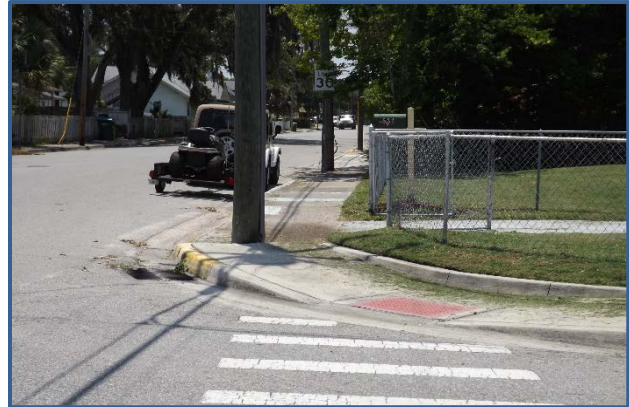
78. There is a utility pole that compromises the width and use of the ADA accessible sidewalk ramp at the intersection of Marion Street and Magnolia Avenue.

A utility pole obstructs the sidewalk on Marion St.

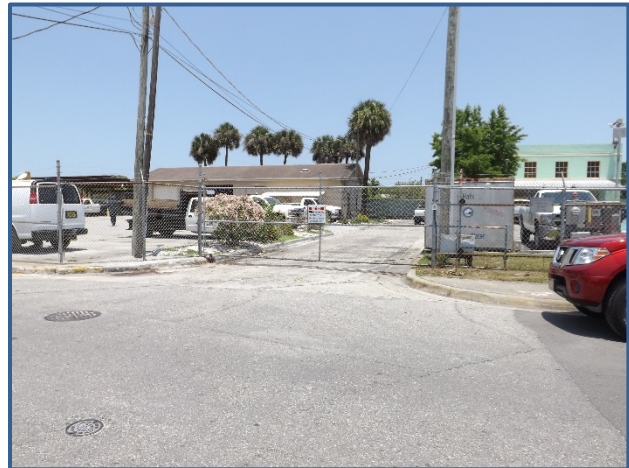
79. There are no ADA accessible sidewalk ramps on the east sidewalk in the 200 block of Marion Street.

There are no ADA accessible sidewalk ramps in the 200 block of Marion St.

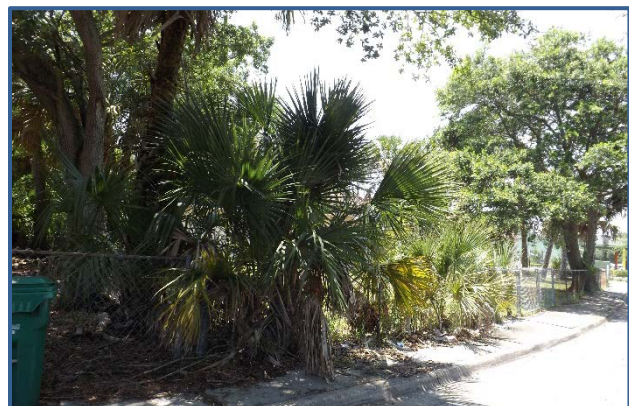
80. Vegetation is obstructing the sidewalk on the west side of Weaver Street just east of Walnut Street. Trees, bushes and other vegetation should be maintained such that pedestrian movement is not impeded.

Vegetation obstructs the sidewalk on Weaver St.

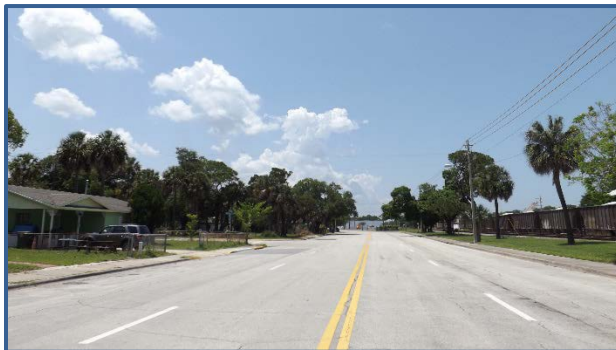
81. Charles Street is a 4-lane thoroughfare with an AADT count of less than 10,000 between George W. Engram Boulevard and Oak Street.

Charles St is a 4-lane thoroughfare with an AADT count of less than 10,000.

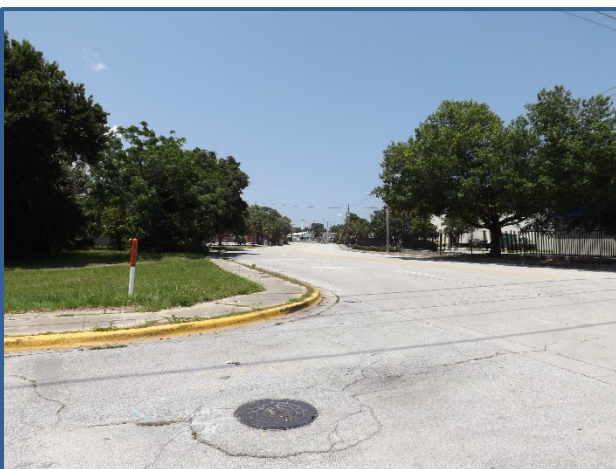
There are no ADA accessible sidewalk ramps at the intersection of Charles St and Weaver St.

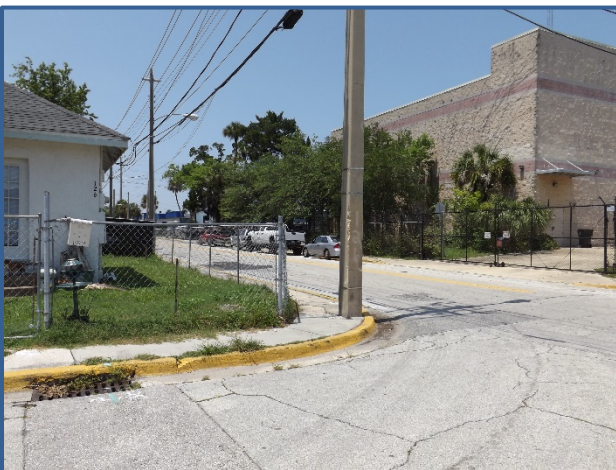
There are no ADA accessible sidewalk ramps at the intersection of Charles St and West St.

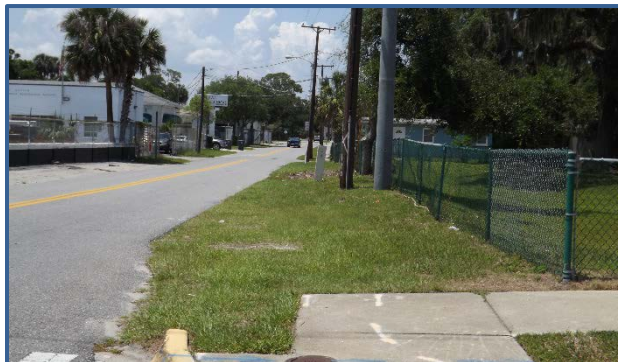
- 85. There is a gap in the sidewalk network on the east side of Seagrave Street between Hobart Avenue and Mulally Street.

A gap in the sidewalk network at Seagrave St and Mulally St.

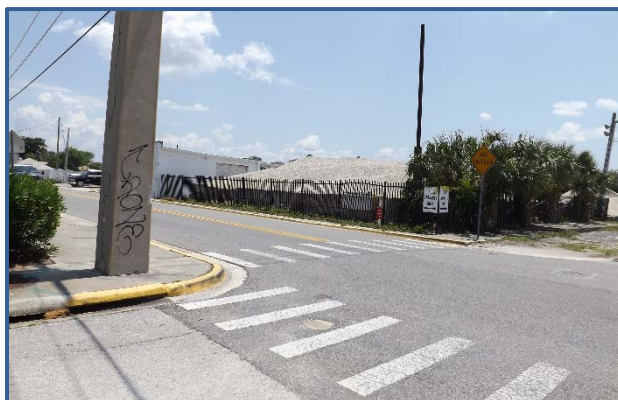
- 86. The intersection of Seagrave Street and Mulally Street lacks ADA accessible sidewalk ramps despite being adjacent to the Basilica School of Saint Paul.

There are no ADA accessible ramps at the intersection of Seagrave St and Mulally St.

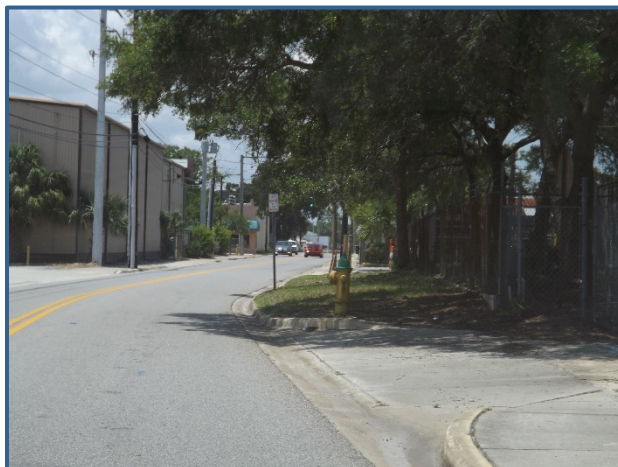
- 87. There is a gap in the sidewalk network on the east side of Seagrave Street between Dr. Mary McLeod Bethune Boulevard and Bay Street.

A gap in the sidewalk network on Seagrave St, just north of Bay St.

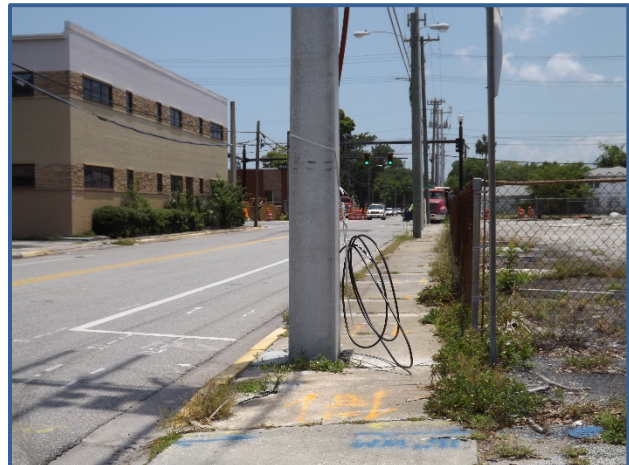
90. Utility pole infrastructure and wiring are obstructing the sidewalk on the west side of Seagrave Street, just north of Orange Avenue.

Utility pole infrastructure and wiring obstructing the sidewalk on Seagrave St.

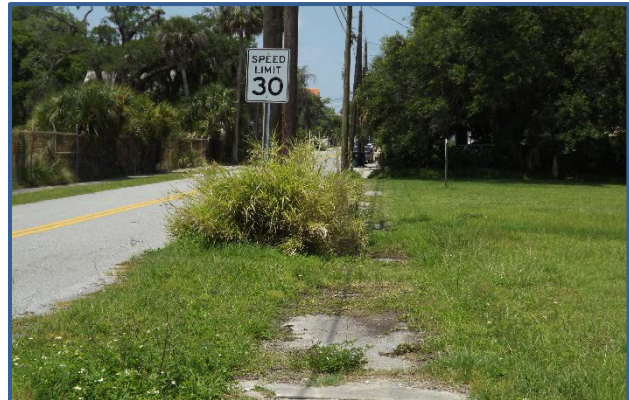
91. Vegetation is obstructing the sidewalks on both sides of Mulally Street between US 1/Ridgewood Avenue and Daytona Street. Trees, bushes and other vegetation should be maintained such that pedestrian movement is not impeded.

Vegetation obstructs the sidewalk on Mulally St.

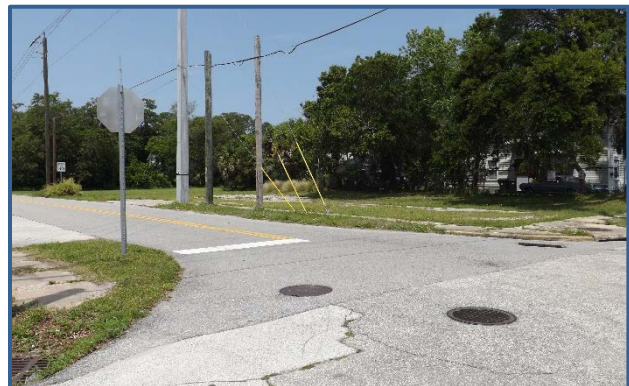
92. There are no ADA accessible sidewalk ramps at the intersection of Mulally Street and Daytona Street.

There are no ADA accessible sidewalk ramps at the intersection of Mulally St and Daytona St.

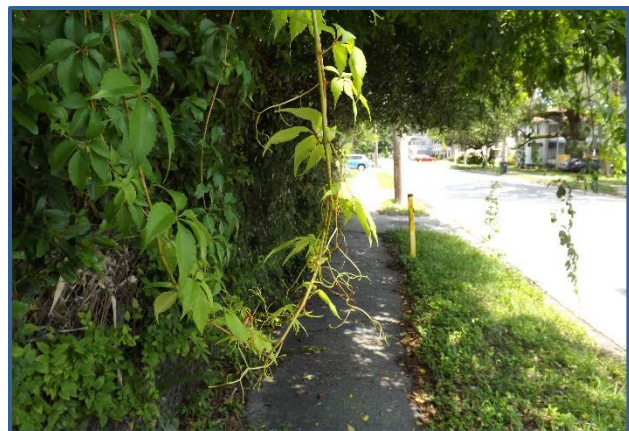
93. Vegetation is obstructing the sidewalk on Daytona Street between Michigan Avenue and Fairview Avenue. Trees, bushes and other vegetation should be maintained such that pedestrian movement is not impeded.

Vegetation obstructs the sidewalk on Daytona St.

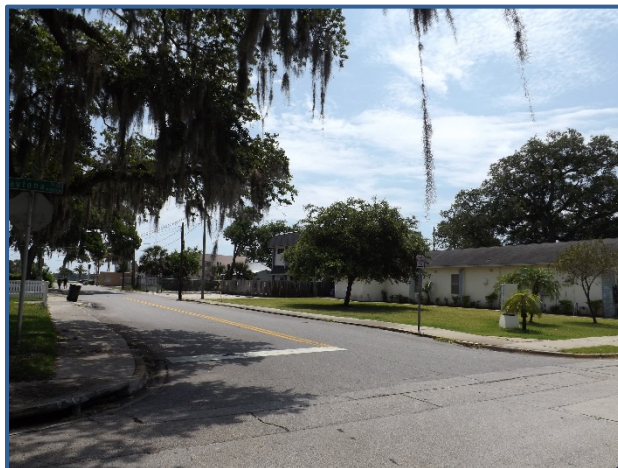
94. There are no ADA accessible sidewalk ramps at the intersection of Daytona Street and Michigan Avenue.

There are no ADA accessible sidewalk ramps at the intersection of Daytona St and Michigan Ave.

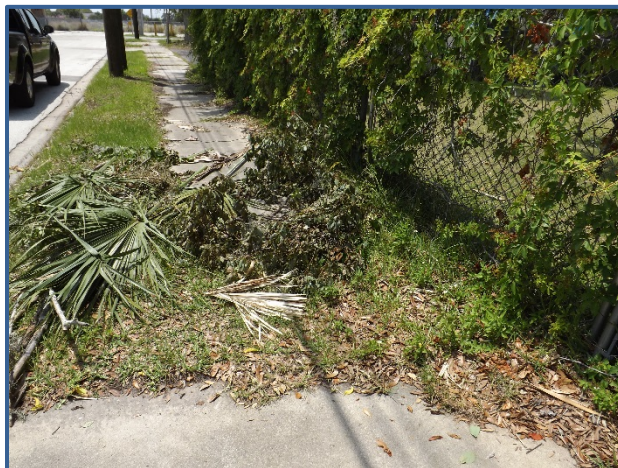
95. There is a small gap in sidewalk connectivity on Daytona Street, just south of Michigan Avenue.

A small sidewalk gap on Daytona St.

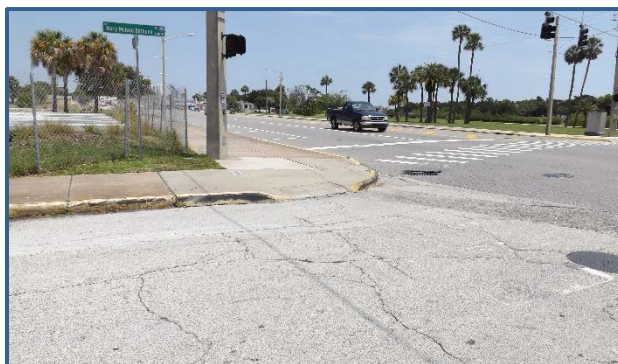
96. At the intersection of Beach Street and Dr. Mary McLeod Bethune Boulevard, the existing marked crosswalk paint has faded.

A faded marked crosswalk at Beach St and Dr. Mary McLeod Bethune Blvd.

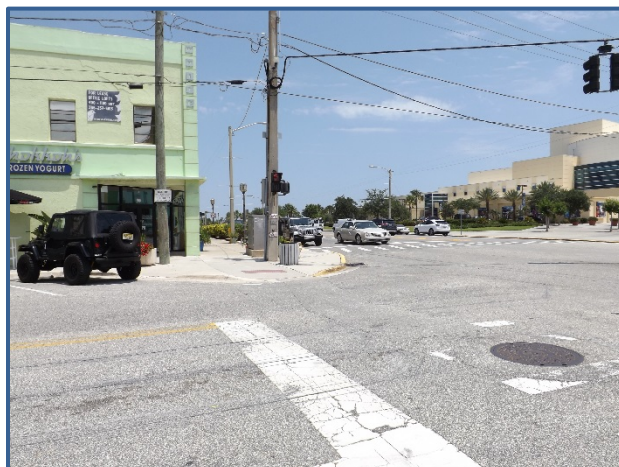
97. At the intersection of Beach Street and Bay Street, the existing marked crosswalk paint has faded.

A faded marked crosswalk at Beach and Bay St.

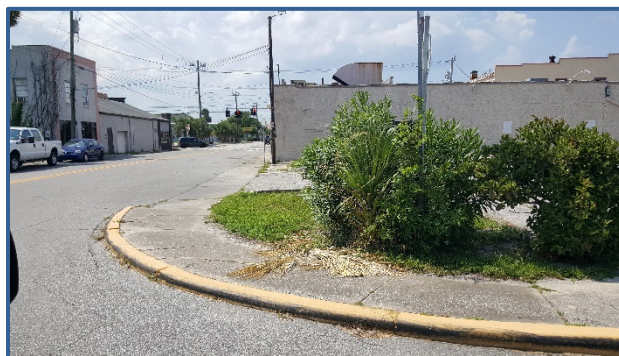
98. There are no ADA accessible sidewalk ramps at the intersection of Beach Street and Michigan Streets.

There are no ADA accessible sidewalk ramps at the intersection of Beach St and Michigan St.

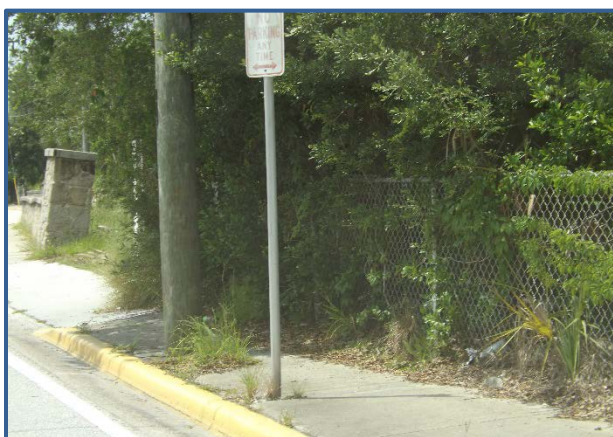
99. Vegetation is obstructing the west sidewalk on Halifax Avenue 400 feet south of Main Street. Trees, bushes and other vegetation should be maintained such that pedestrian movement is not impeded.

Vegetation obstructs the sidewalk on Halifax Ave.

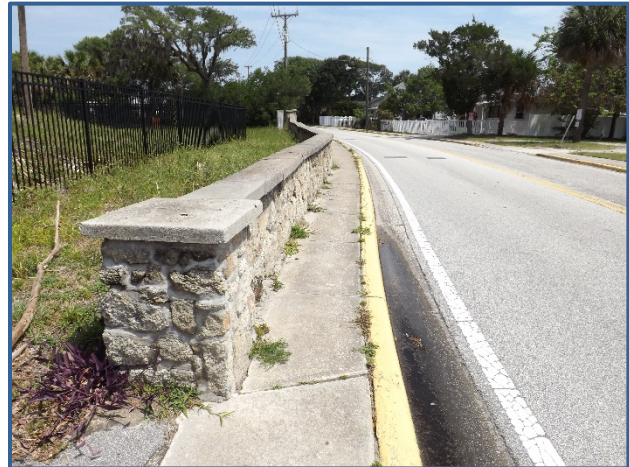
100. Width of west sidewalk on Halifax Avenue is compromised by the location of a masonry retaining wall just north of Harvey Avenue.

A retaining wall compromises the sidewalk width along Halifax Ave.

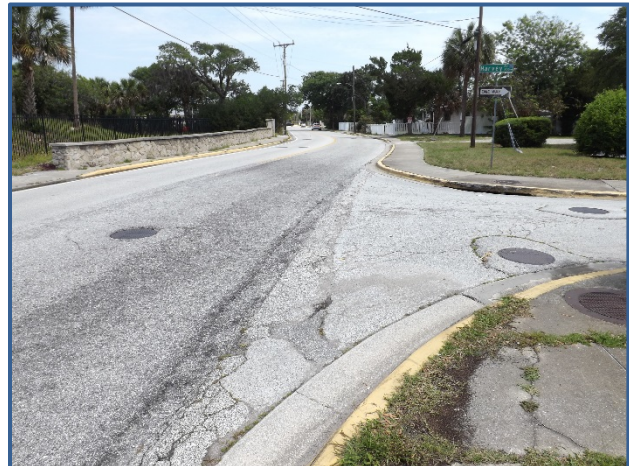
101. There are no ADA accessible sidewalk ramps at the intersection of Halifax Avenue and Harvey Avenue.

There are no ADA accessible sidewalk ramps at the intersection of Halifax Ave and Harvey Ave.

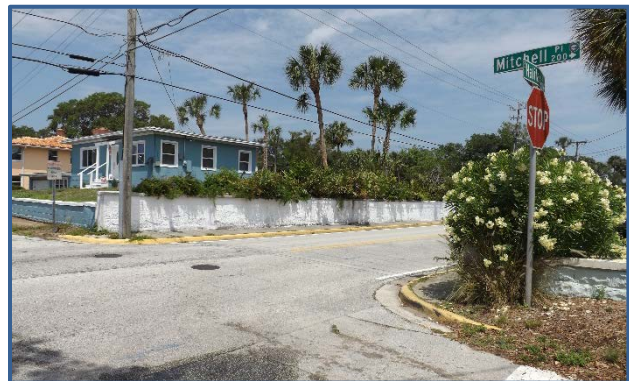
102. There are no ADA accessible sidewalk ramps at the intersection of Halifax Avenue and Mitchell Place.

There are no ADA accessible sidewalk ramps at the intersection of Halifax Ave and Mitchell Pl.

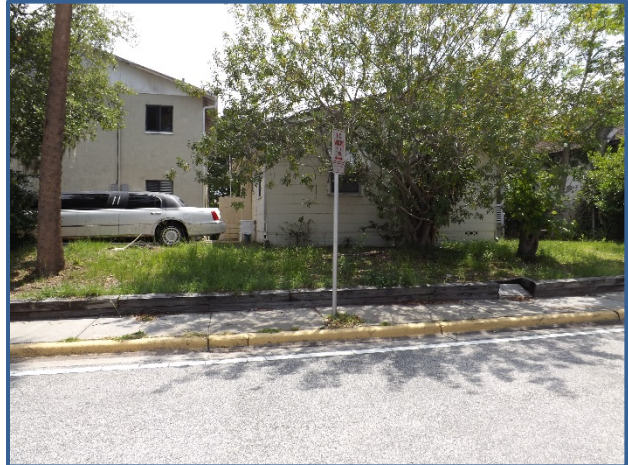
103. The location of a no parking sign compromises ADA accessibility and width of the east sidewalk on Halifax Avenue just south of Mitchell Place.

Street signage compromises the useable width of the sidewalk along Halifax Ave.

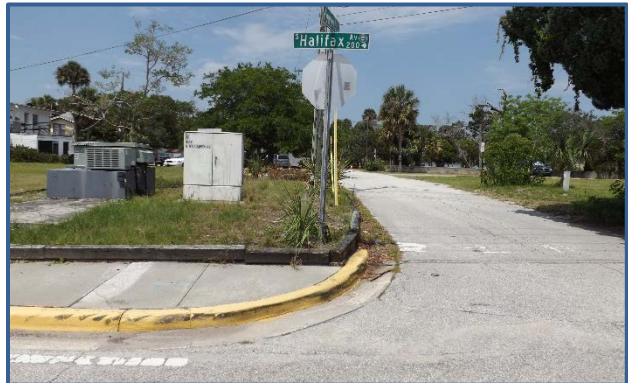
104. There are no ADA accessible sidewalk ramps at the intersection of Halifax Avenue and Hewen Place.

The intersection of Halifax Ave and Hewen Pl lacks ADA accessible sidewalk ramps.

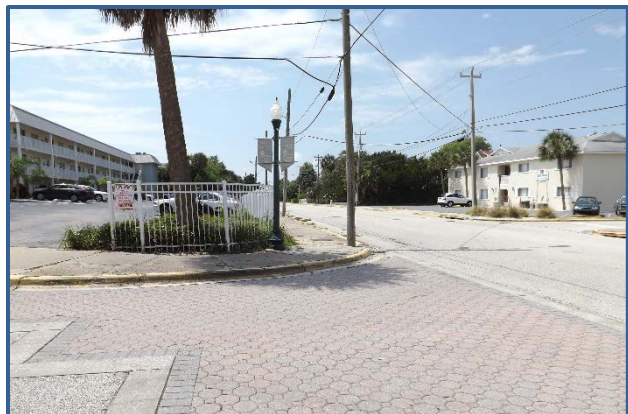
105. There are no ADA accessible sidewalk ramps on Peninsula Drive at the following intersections:
- a) Harvey Avenue
 - b) Mitchell Place

The intersection of Peninsula Dr and Harvey Ave lacks ADA accessible sidewalk ramps.

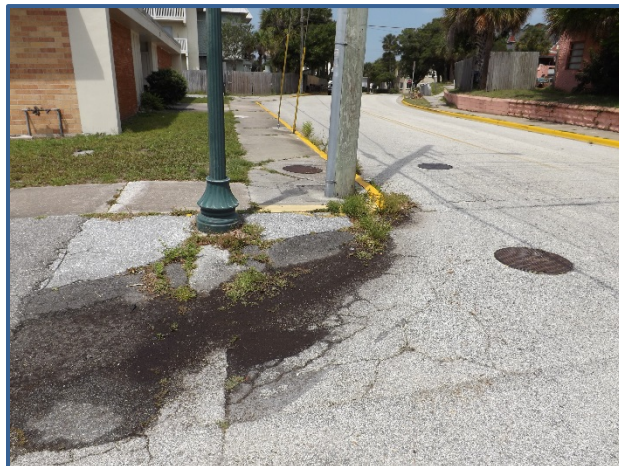
106. The southwest curb of Hollywood Avenue and Harvey Avenue lacks and ADA accessible sidewalk ramp.

The southwest curb of Hollywood Ave lacks an ADA accessible sidewalk ramp at Harvey Ave.

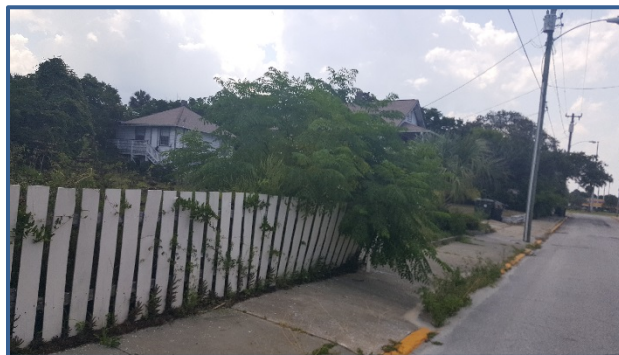
107. Vegetation is obstructing the sidewalks on both sides of Hollywood Avenue between Main Street and Auditorium Boulevard. Trees, bushes and other vegetation should be maintained such that pedestrian movement is not impeded.

Vegetation obstructs the sidewalk on Hollywood Ave.

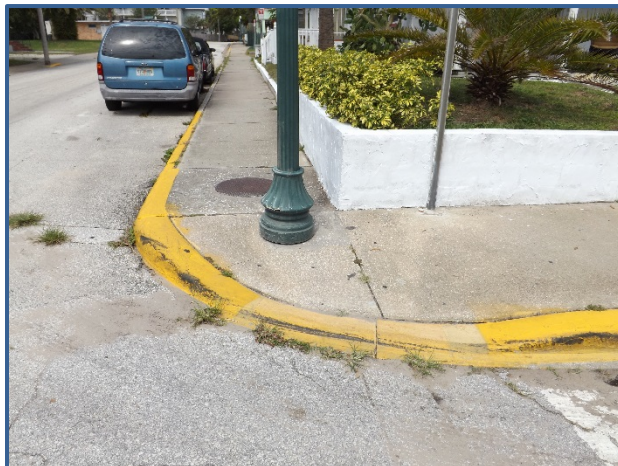
109. The southwest curb of Oleander and Harvey Avenue lacks an ADA accessible sidewalk ramp. The intersection's northeast curb ramp is obstructed by the location of a replica historic street light fixture.
110. Vegetation is obstructing the west sidewalk on Oleander Avenue just north of US 92/SR 600/ISB. Trees, bushes and other vegetation should be maintained such that pedestrian movement is not impeded.

A street light fixture obstructs a sidewalk ramp at Oleander Ave and Harvey Ave.

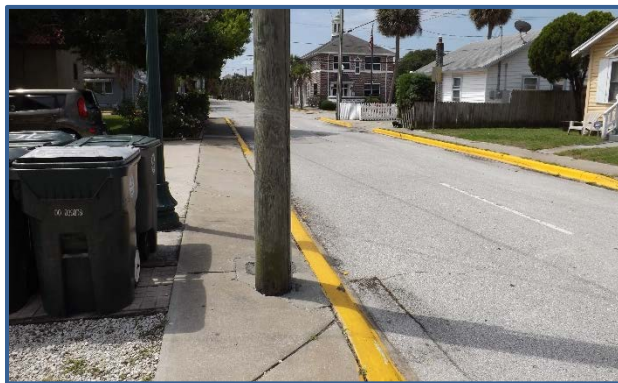
111. The location of a utility pole compromises ADA accessibility and width of the east sidewalk on Wild Olive Avenue between Main Street and Harvey Avenue.

A utility pole obstructs the sidewalk on Wild Olive Ave.

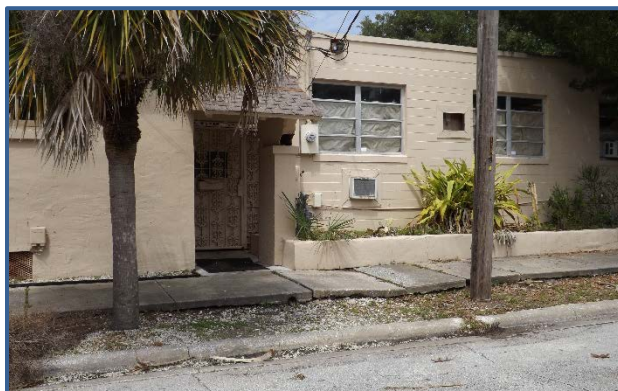
112. Just north of 5th Avenue, there is an edge drop-off from the west sidewalk on Wild Olive Avenue. This creates a potential hazard for pedestrians and could be especially problematic for elderly pedestrians or others with mobility disadvantage. As with roadways, the ground should be brought up flush with the sidewalk travel surface and maintained at that level.

The sidewalk is damaged along Wild Olive Ave.

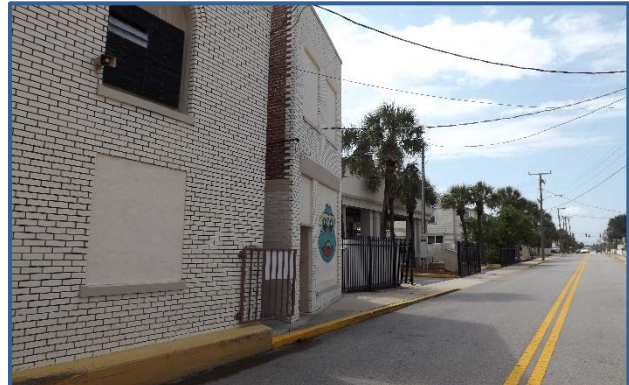
113. The east sidewalk on Grandview Avenue abruptly ends just south Main Street.

The sidewalk abruptly ends on Grandview Ave.

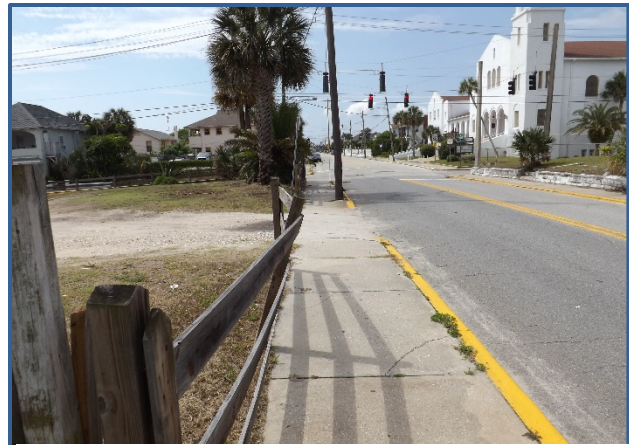
114. A structurally failing fence is obstructing the east sidewalk at the intersection of Grandview Avenue and Harvey Avenue.

A damaged fence obstructs the sidewalk width on Grandview Ave.

114	Grandview Ave at Harvey Ave	A structurally failing fence is obstructing the sidewalk	Private Sector	Remove or repair fence
115	Grandview Ave at Harvey Ave	The existing marked crosswalk paint has faded and there are no curb ramps	City of Daytona Beach	Repaint marked crosswalk and add curb ramps
116	Grandview Ave at 5 th Ave	No curb ramps	City of Daytona Beach	Install curb ramps
117	Grandview Ave at Vermont Ave	No curb ramps	City of Daytona Beach	Install curb ramps
118	Grandview Ave at Goodall Ave	No curb ramps	City of Daytona Beach	Install curb ramps
119	Grandview Ave at Braddock Ave	No curb ramps	City of Daytona Beach	Install curb ramps
120	Grandview Ave at Lenox Ave	No curb ramps	City of Daytona Beach	Install curb ramps
121	Grandview Ave at Sears Ave	The SW corner of the intersection lacks a curb ramp	City of Daytona Beach	Install curb ramp
122	Grandview Ave at Sears Ave	The SW, NW, and NE corners of the intersection lacks curb ramps	City of Daytona Beach	Install curb ramps

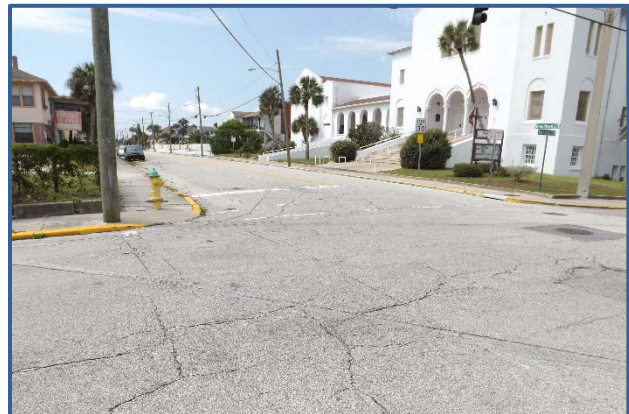
115. The intersection of Grandview Avenue and Harvey Avenue lacks ADA accessible sidewalk ramps and faded crosswalk paint. In addition, there is a fire hydrant obstruction at the southeast corner of the intersection.

A faded crosswalk at the intersection of Grandview Ave and Harvey Ave.

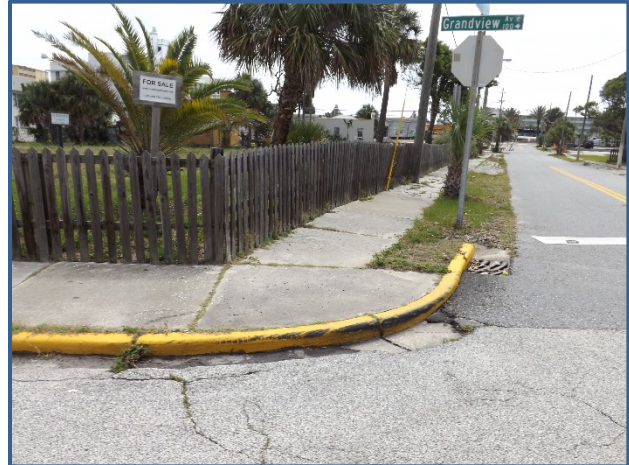
116. The intersection of Grandview Avenue and 5th Avenue lacks ADA accessible sidewalk ramps.

There are no ADA accessible sidewalk ramps at the intersection of Grandview Ave and 5th Ave.

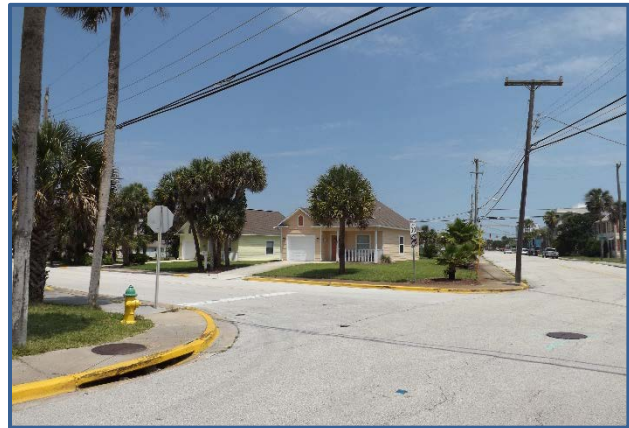
There are no ADA accessible sidewalk ramps on the west side of the intersection of Grandview Ave and Vermont Ave.

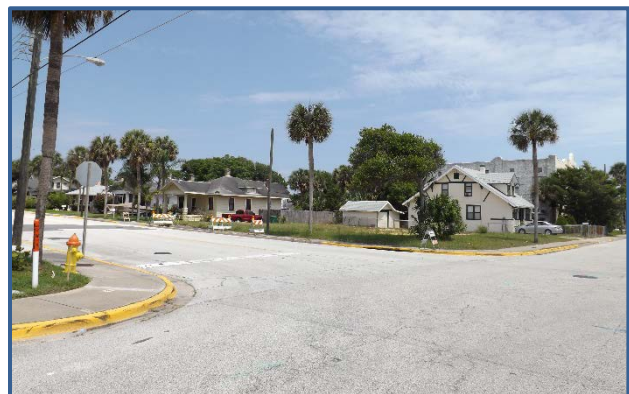
118. The curb ramps at the intersection of Grandview Avenue and Goodall Avenue lack ADA accessible sidewalk ramps.

There are no ADA accessible sidewalk ramps at the intersection of Grandview Ave and Goodall Ave.

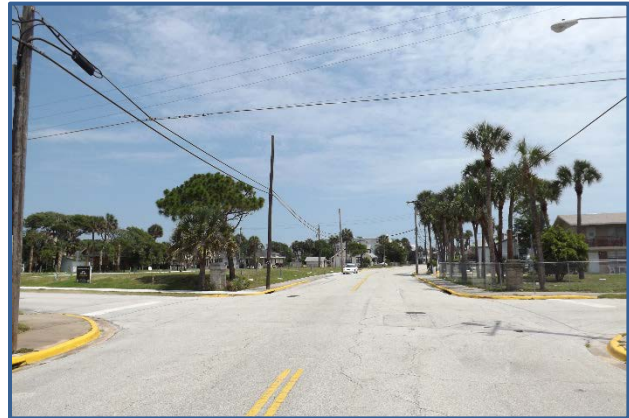
119. The intersection of Grandview Avenue and Braddock Avenue lacks ADA accessible sidewalk ramps.

The intersection of Grandview Ave and Braddock Ave lacks ADA accessible sidewalk ramps.

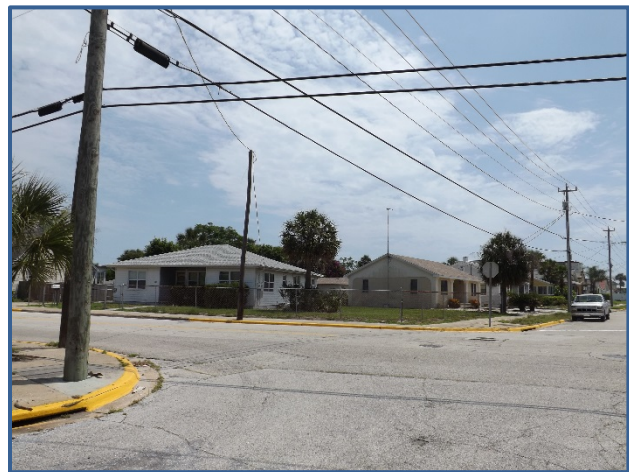
Three of four corners at the intersection of Grandview Ave and Lenox Ave lack ADA accessible sidewalk ramps.

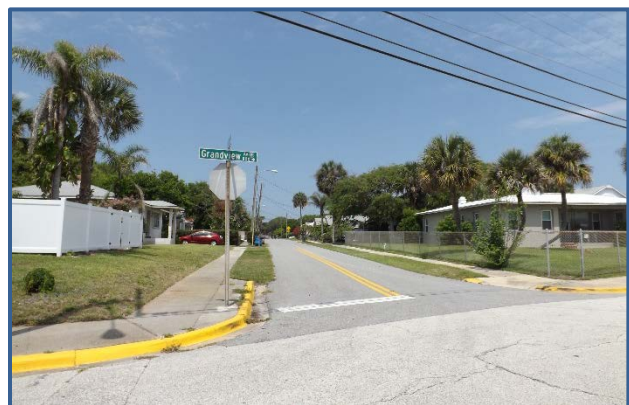
121. The southwest curb at the intersection of Grandview Avenue and Sears Avenue lacks an ADA accessible sidewalk ramp.

The southwest corner of Grandview Ave and Sears Ave lacks an ADA accessible sidewalk ramps.

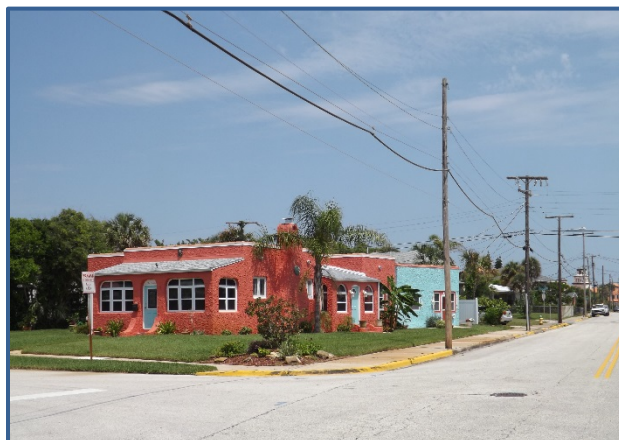
A corner lacking ADA accessible sidewalk ramps at the intersection of Grandview Ave and Ribault Ave.

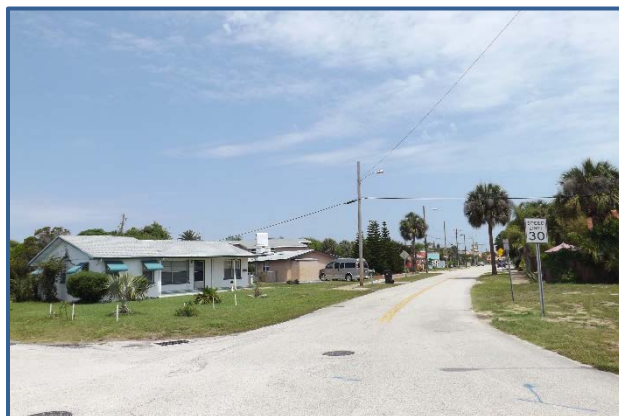
123. The sidewalks on Grandview Avenue abruptly end 75' north of Frances Terrace.

Sidewalks on Grandview Ave end just north of Frances Terr.

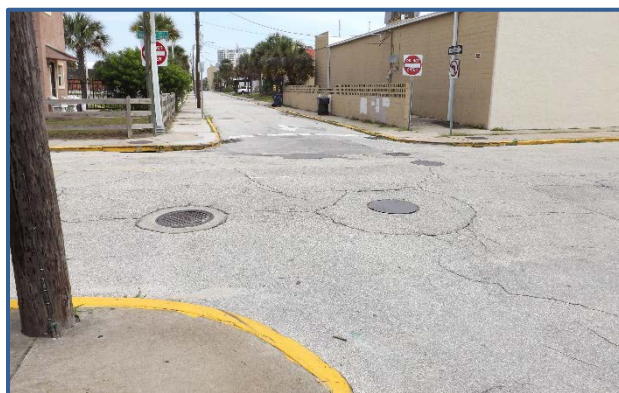
124. The intersection of Coates Street and Harvey Avenue lacks ADA accessible sidewalk ramps.

There are no ADA accessible sidewalk ramps at the intersection of Coates St and Harvey Ave.

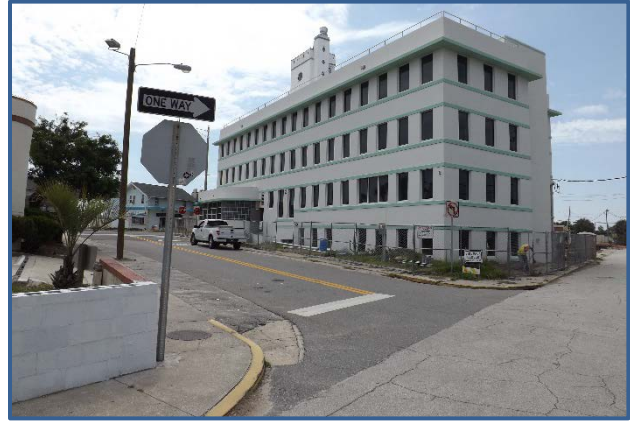
125. The east sidewalk at the intersection of Coates Street and Kemp Street lacks ADA accessible sidewalk ramps.

Sidewalk curbs lacking ADA accessible ramps at Coates St and Kemp Streets.

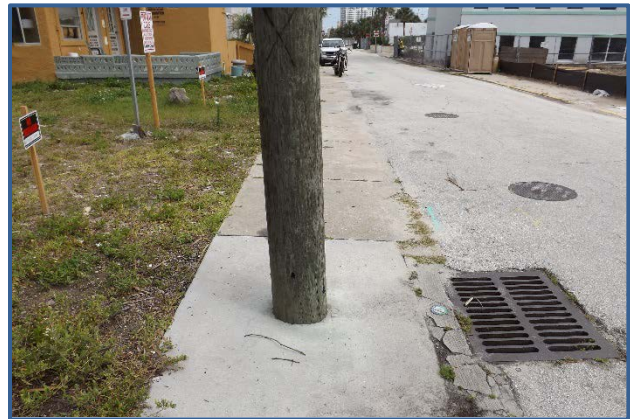
126. The location of a utility pole on the west sidewalk of Coates Street, just north of 5th Avenue obstructs the sidewalk's width and ADA accessibility.

A utility pole obstructs the sidewalk on Coates Street.

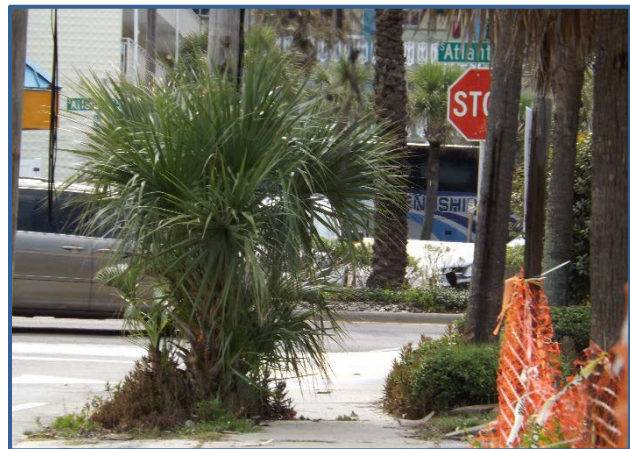
128. Overgrown vegetation and deteriorating sidewalk conditions obstruct and create tripping hazards on the south side of 5th Avenue between Coates Street and SR A1A/Atlantic Avenue.

Vegetation obstructs the sidewalk on 5th Avenue.

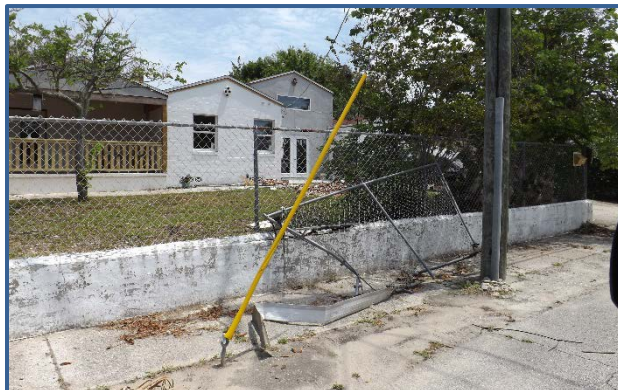
129. A structurally failing fence obstructs the north sidewalk on Goodall Avenue near Sunset Drive.

A broken fence obstructs the sidewalk on Goodall Ave.

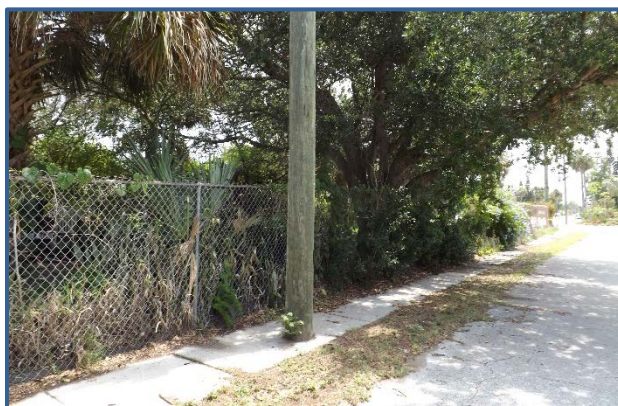
A utility pole obstructs the sidewalk on Goodall Ave.

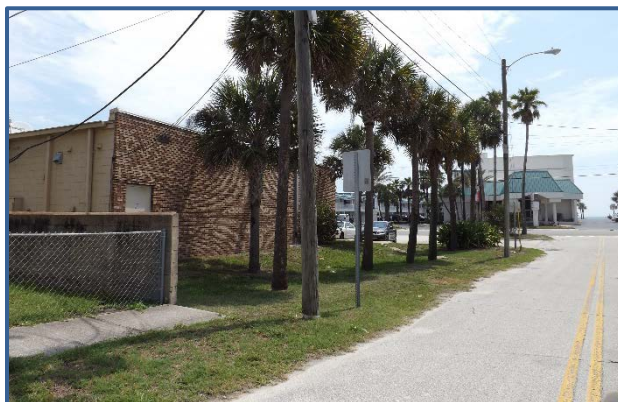
131. There is a gap in the sidewalk network on the north side of Phoenix Avenue between SR 441/Peninsula Drive and SR A1A/Atlantic Avenue.

A gap in the sidewalk network on Phoenix Ave.

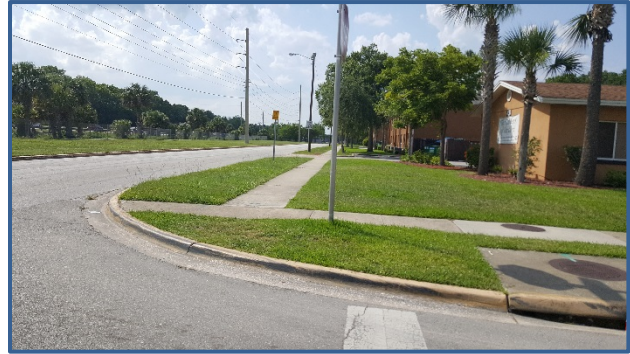
132. There are no ADA accessible sidewalk ramps at the intersection of Jean Street and Loomis Avenue.

There are no ADA accessible sidewalk ramps at the intersection of Jean St and Loomis Ave.

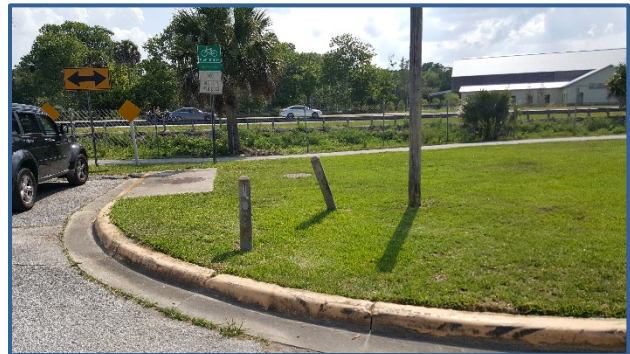
133. There is a 40' gap within the sidewalk network between the intersection of Jean Street and Loomis Avenue and the existing 12' multi-use path on the west side of Jean Street.

There is a gap in the sidewalk network between the SR 5A/Nova Rd multi-use path and Jean St.

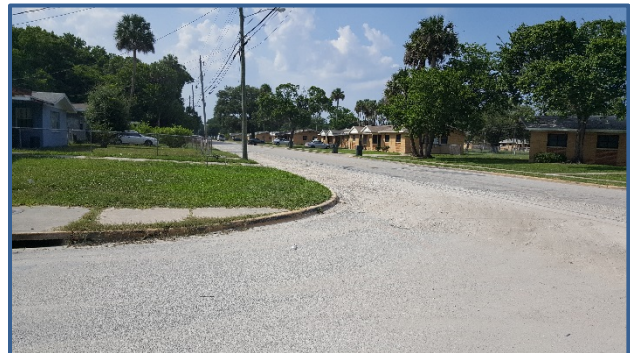
134. There are no ADA accessible sidewalk ramps at the intersection of Loomis Avenue and Caroline Street.

There are no ADA accessible sidewalk ramps at the intersection of Loomis Ave and Caroline St.

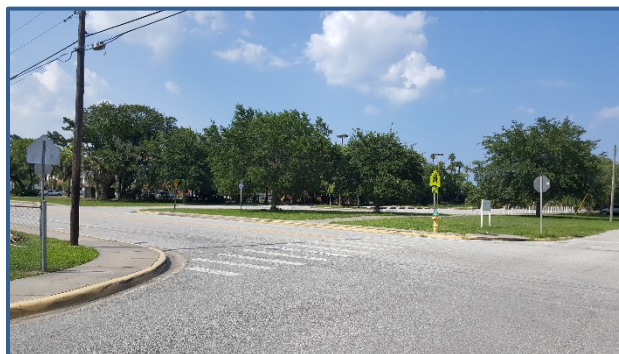
135. There are no ADA accessible sidewalk ramps at the intersection of Loomis Avenue and Keech Street.

There are no ADA accessible sidewalk ramps at Loomis Ave and Keech St.

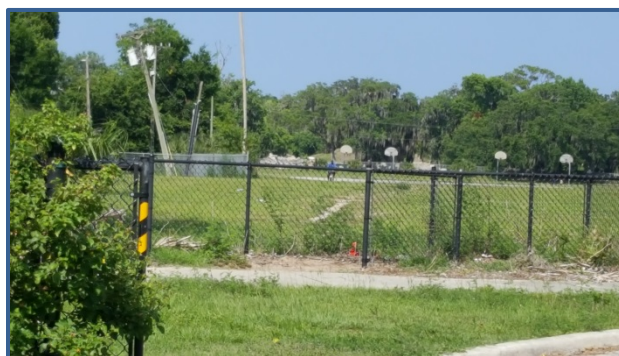
136. A three block long “cattle trail” through the property of Campbell Middle School connects the intersections of Loomis Avenue with Cedar Street and Lockhart Street.

A three block long “cattle trail” exists between Cedar St and Lockhart St.

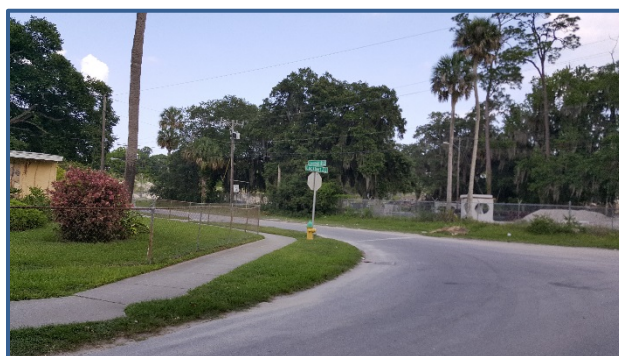
137. There are no ADA accessible sidewalk ramps at the intersection of Loomis Avenue and Lockhart Street.

There are no ADA accessible sidewalk ramps at the intersection of Loomis Ave and Lockhart St.

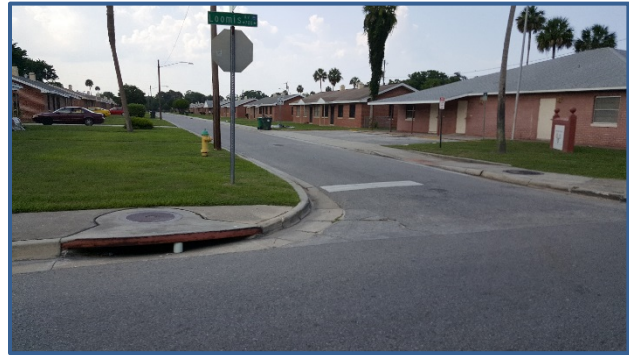
138. There are no ADA accessible sidewalk ramps at the intersection of Loomis Avenue and Whitney Street.

There are no ADA accessible sidewalk ramps at the Loomis Ave and Whitney St intersection.

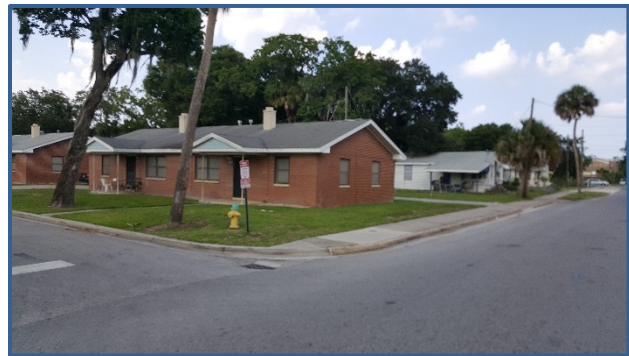
139. The sidewalk curb at the northeast corner of Loomis Avenue and Hudson Street does not have an ADA accessible sidewalk ramp.

The northeast corner of Loomis Ave and Hudson St is lacking an ADA accessible sidewalk ramp.

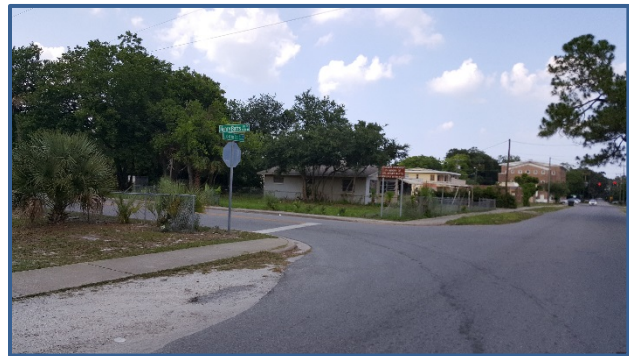
140. There are no ADA accessible sidewalk ramps at the northwest, northeast and southeast corners at the intersection of Loomis Avenue and Henry Butts Drive.

The intersection of Loomis Ave and Henry Butts Dr is lacking ADA accessible sidewalk ramps.

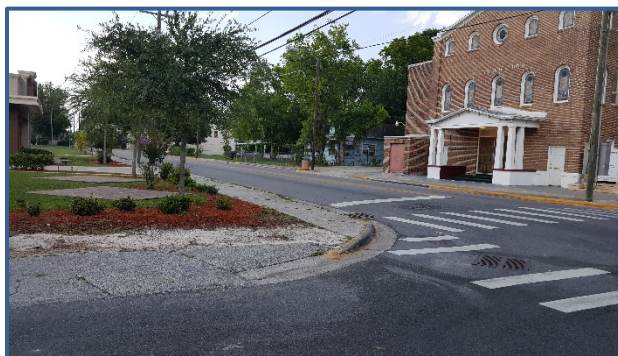
141. The sidewalk on the west side of Loomis Street and Dr. MLK, Jr. Boulevard does not have ADA accessible sidewalk ramps.

The west side of Loomis Street and Dr. MLK Boulevard lacks ADA accessible sidewalk ramps.

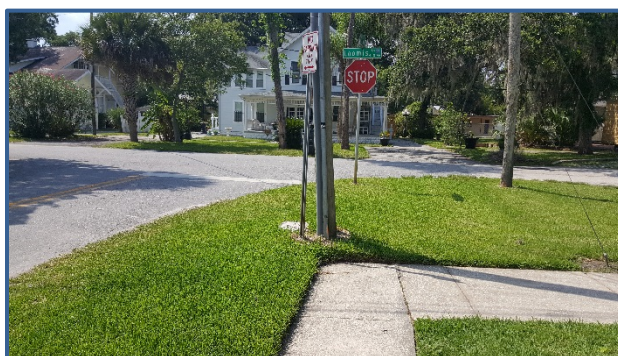
142. There is a gap in the sidewalk network at the intersection Loomis Avenue and Gardiner Court.

The sidewalk does not extend to the curb at the intersection of Loomis Avenue and Gardiner Court.

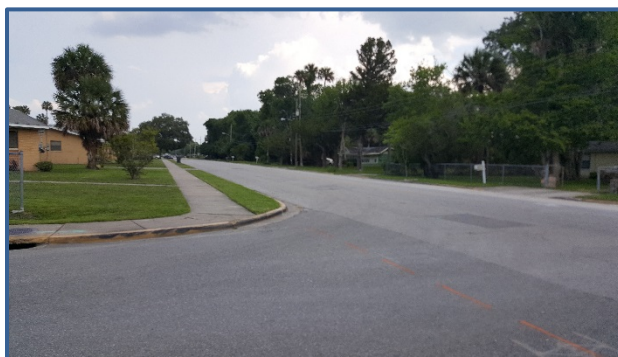
143. The intersection of Maley Street and Caroline Street lacks ADA accessible sidewalk ramps.

There are no ADA accessible sidewalk ramps at Maley and Caroline Streets.

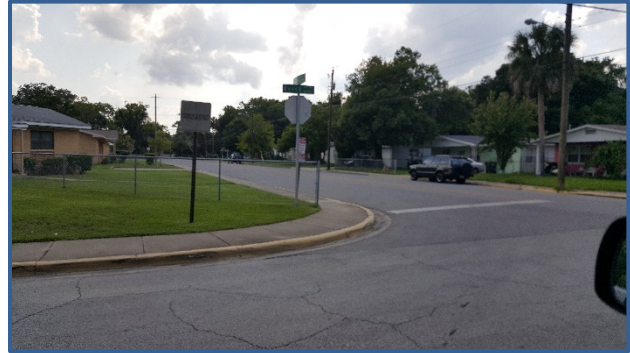
There are no ADA accessible sidewalk ramps at Maley St and Keech St.

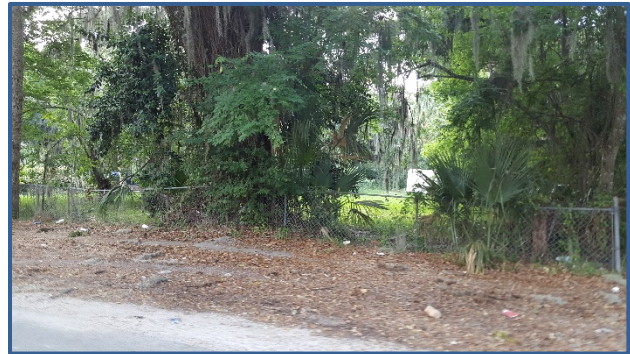
145. Sections of the sidewalk on the north side of Maley Street are broken just west of Franklin Street. As this may cause a tripping hazard, they should be repaired as soon as possible.

A stretch of broken sidewalk on Maley St.

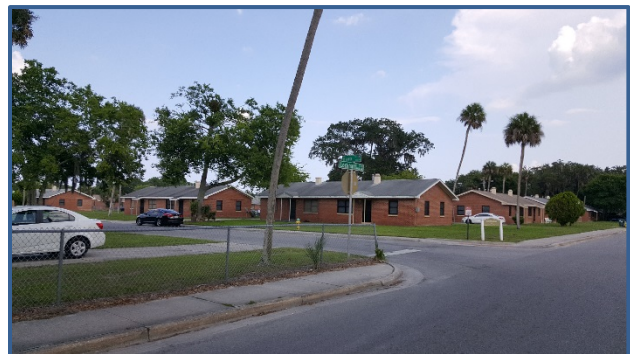
146. The sidewalk at the northeast corner of Lockhart and Hawk Streets lacks an ADA accessible sidewalk ramp.

There is no ADA accessible sidewalk ramp at the northeast corner of Lockhart St and Hawk St.

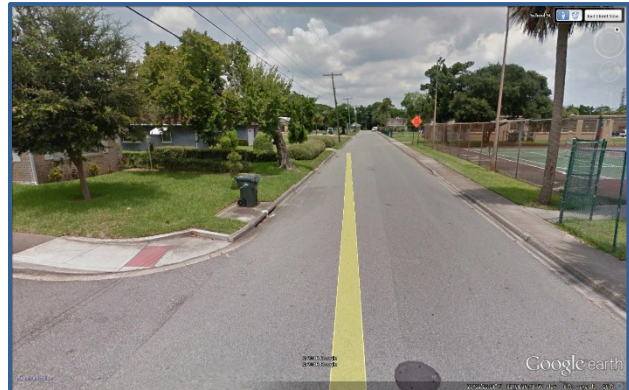
147. The intersection of Henry Butts Drive and Heron Street lacks an ADA accessible ramp along the east sidewalk.

There is no ADA accessible sidewalk ramp on the east side of Henry Butts Dr at Heron St.

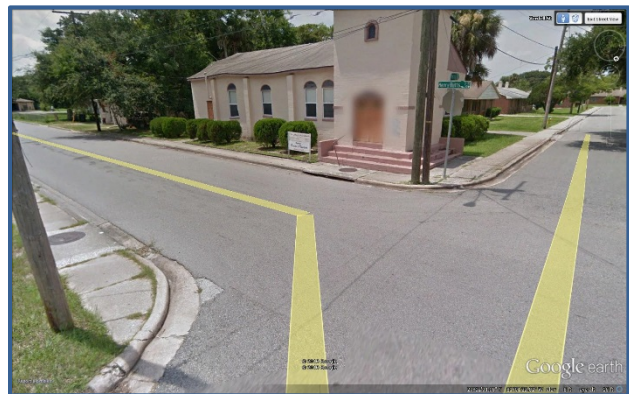
148. The intersection of Henry Butts Drive and Verdell Street lacks ADA accessible sidewalk ramps.

There are no ADA accessible sidewalk ramps at Henry Butts Dr and Verdell St.

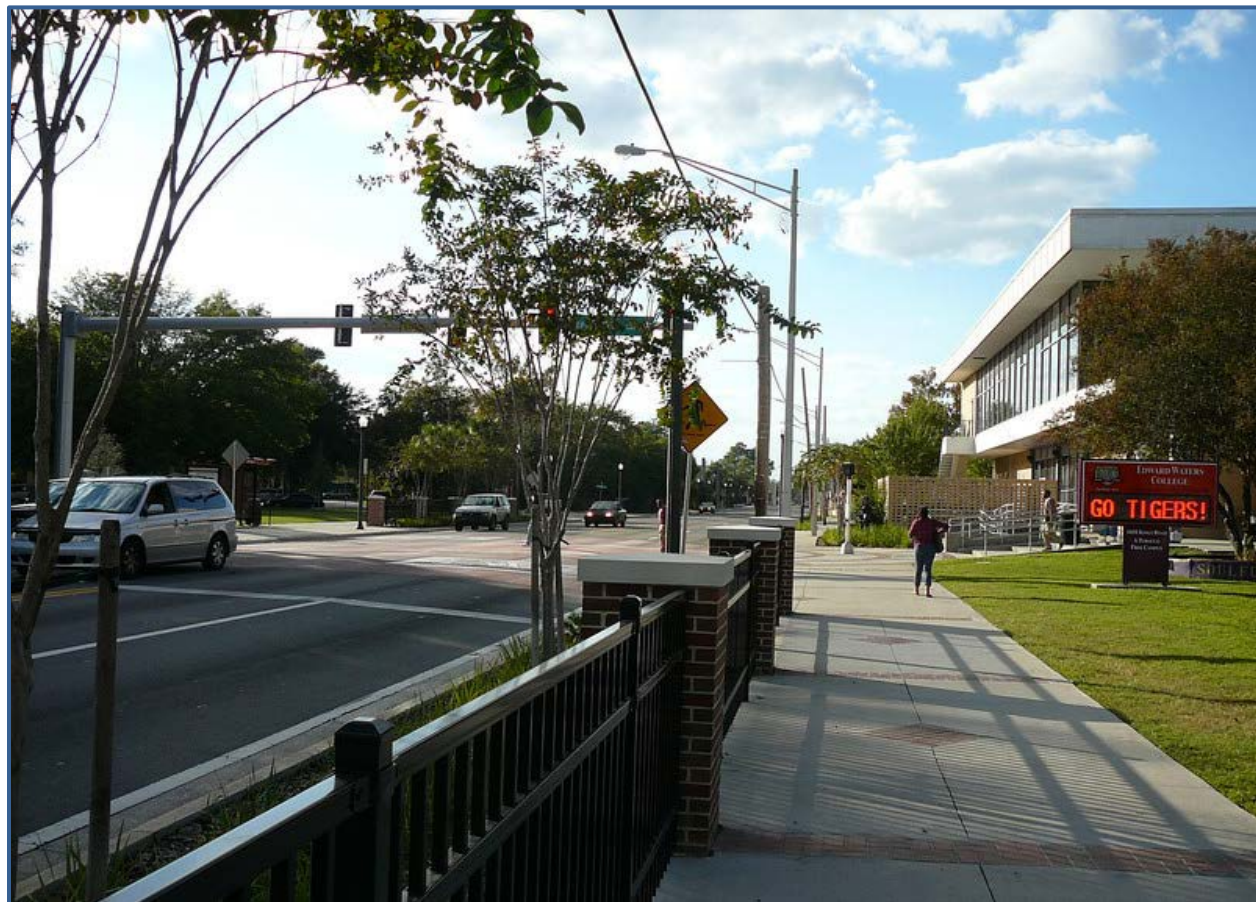
US 23/Kings Rd, which passes through the campus of Edward Waters College in Jacksonville, FL is a good example of a walkable street. Photograph courtesy of Moderncities.com.

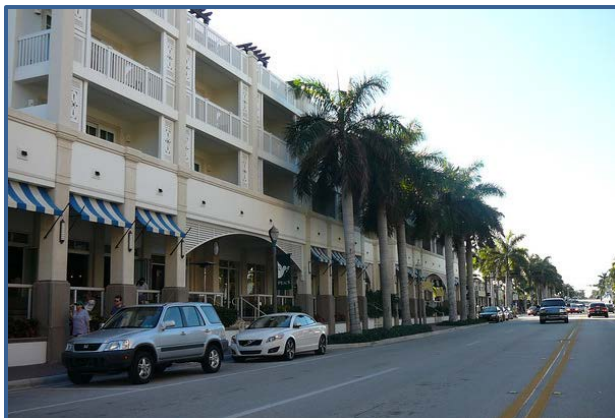
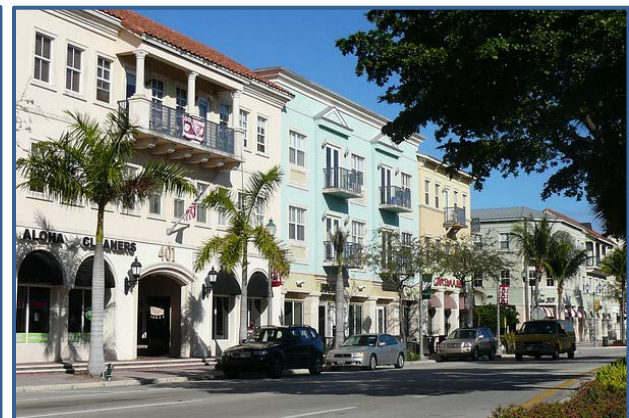
Enhanced landscaping, pedestrian treatments and infill development along SR 806/Atlantic Ave. Photographs courtesy of Moderncities.com and dated December 2012.
