US 92/International Speedway Blvd (ISB) Pedestrian Connectivity & Safety Assessment Study - Phase II

Field Evaluation Report

Prepared for:
Florida Department of Transportation District 5, DeLand, FL
Contract No. C9F27 TWO 74

September 2016

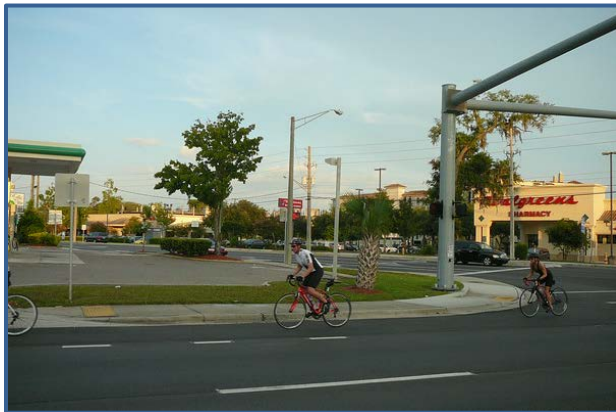
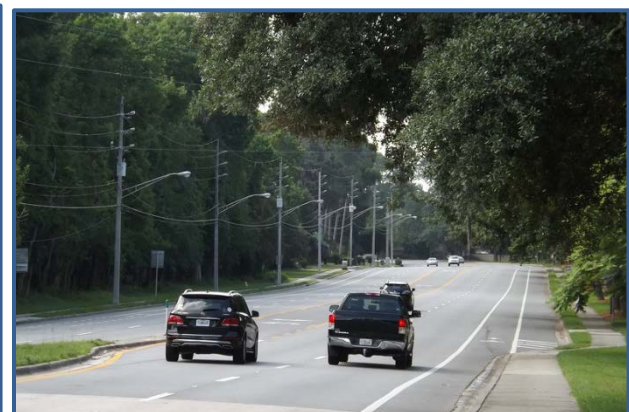
A view of SR 13/San Jose Blvd, shortly after the completion of a FDOT milling and resurfacing project. As a part of the project, existing roadway lane widths were "right-sized" to create space for new bicycle lanes. Photographs courtesy of Moderncities.com and dated August 2014.

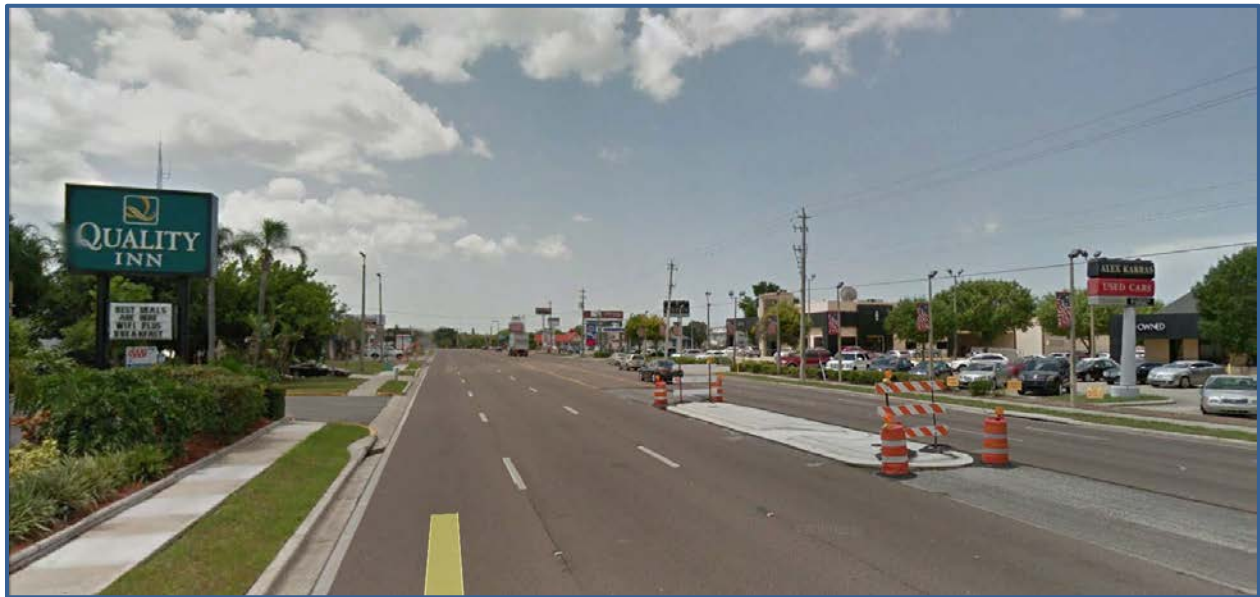
A mid-block crossing under construction on US 41/Tamiami Trail between Florida Blvd and 68th Ave West in Manatee County. Photograph, courtesy of Google Streetview and dated July 2015.

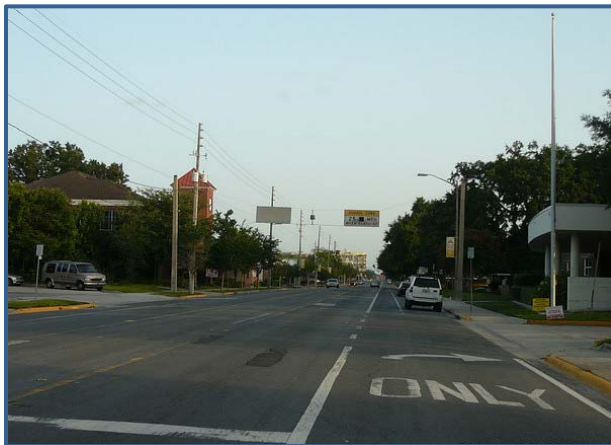
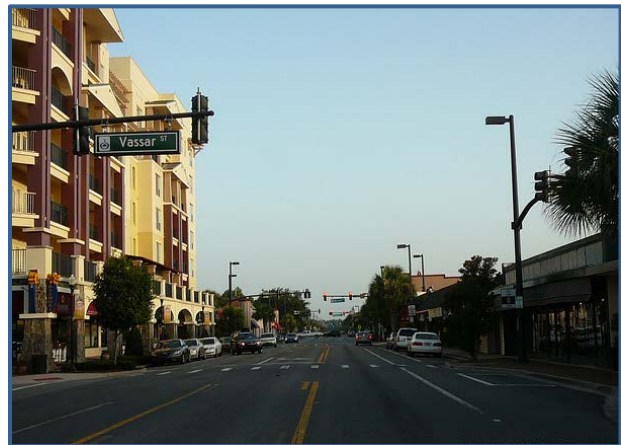
Edgewater Dr (formerly SR 424) road diet concept in Orlando's College Park neighborhood may be applicable to collector streets within the PCSA study area such as White St, Bill France Blvd, and Dr. Mary McLeod Bethune Blvd. Photographs courtesy of Moderncities.com and dated August 2010.

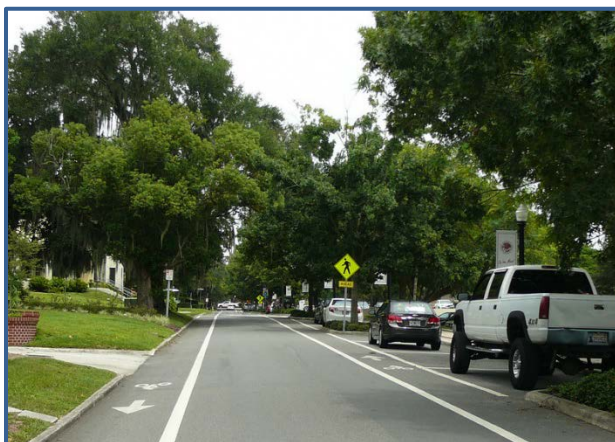
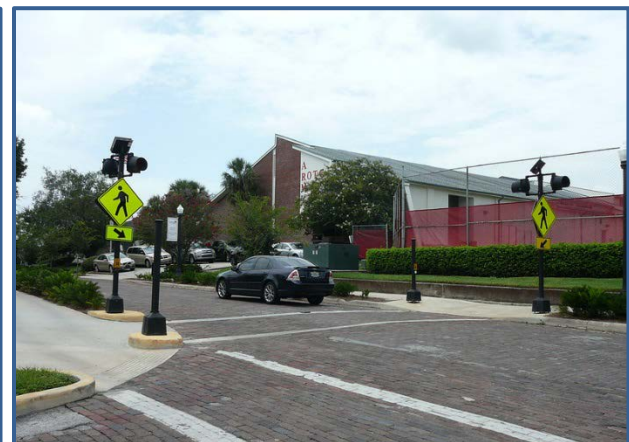
The City of Lakeland's Pathways and Road Diet Program includes the "right sizing" of roadways to provide on-street bicycle facilities and enhanced pedestrian crossings in select locations. Photographs courtesy of Moderncities.com and dated July 2014.
