EDR Radius Map Report with GeoCheck

I-75 From Floridas Turnpike To SR 200

Inquiry Number: 7474752.5s

October 19, 2023

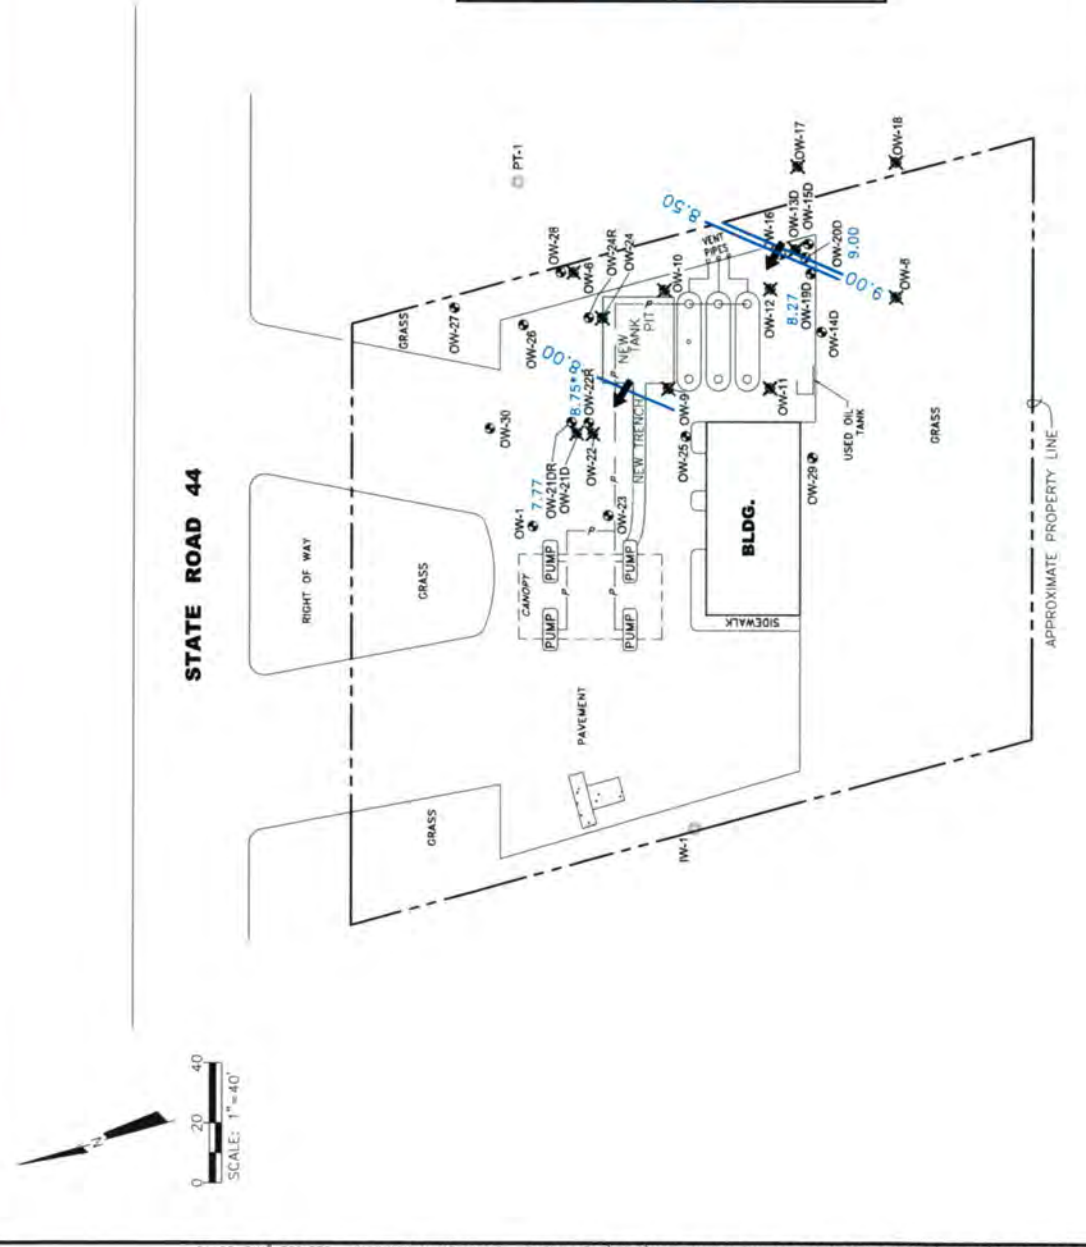
FIGURE NO.	5
FIGURE TITLE	GROUNDWATER BENZENE CONCENTRATION ISOCONTOUR MAP (DEEP ZONE) APRIL 6, 2022

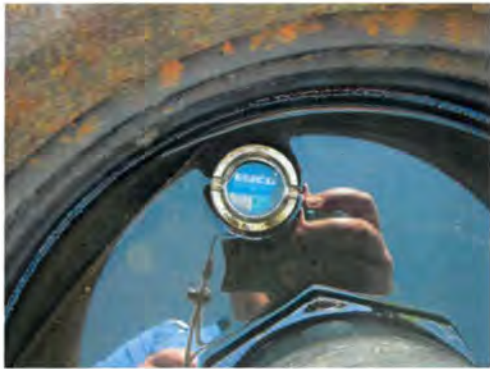
RUL spill bucket secondary gauge showing liquid

Type: Violation
Significance: Minor
Rule: 62-761.100(3)
Violation Text: No reasonable access provided.
Explanation: The PUL primary spill bucket was filled with PCW at time of inspection and could not be properly inspected.
Corrective Action: Remove all liquid the PUL spill bucket primary so it can be inspected. Submit pictures of the primary spill bucket, the flow shutoff valve, and the secondary gauge to Citrus County Environmental Health.

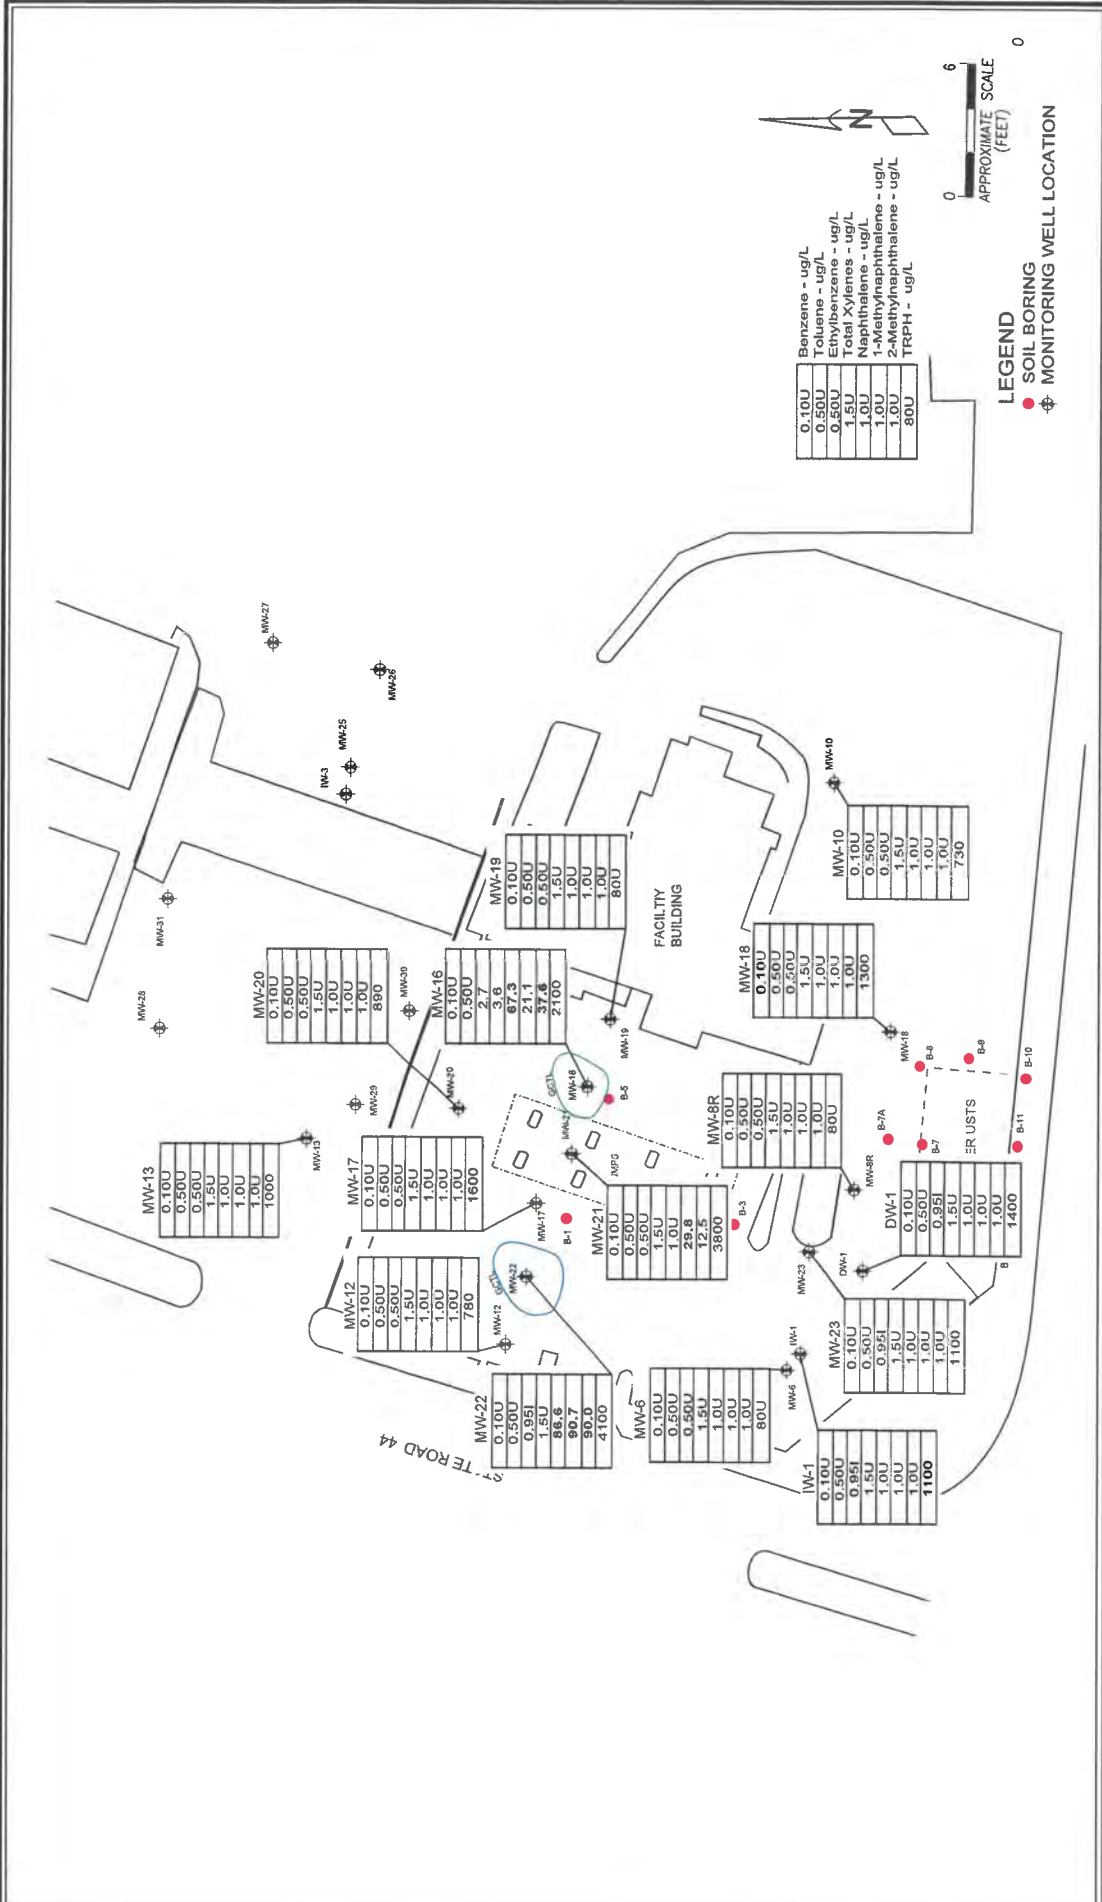
FIGURE 4A
GROUNDWATER ANALYTICAL LABORATORY CONCENTRATIONS (NAPHTHALENE)
 WILDWOOD TRAVEL CENTER
 WILDWOOD, FLORIDA
 Source: PANGEAN-CMD ASSOCIATES & GOOGLE EARTH (2016)

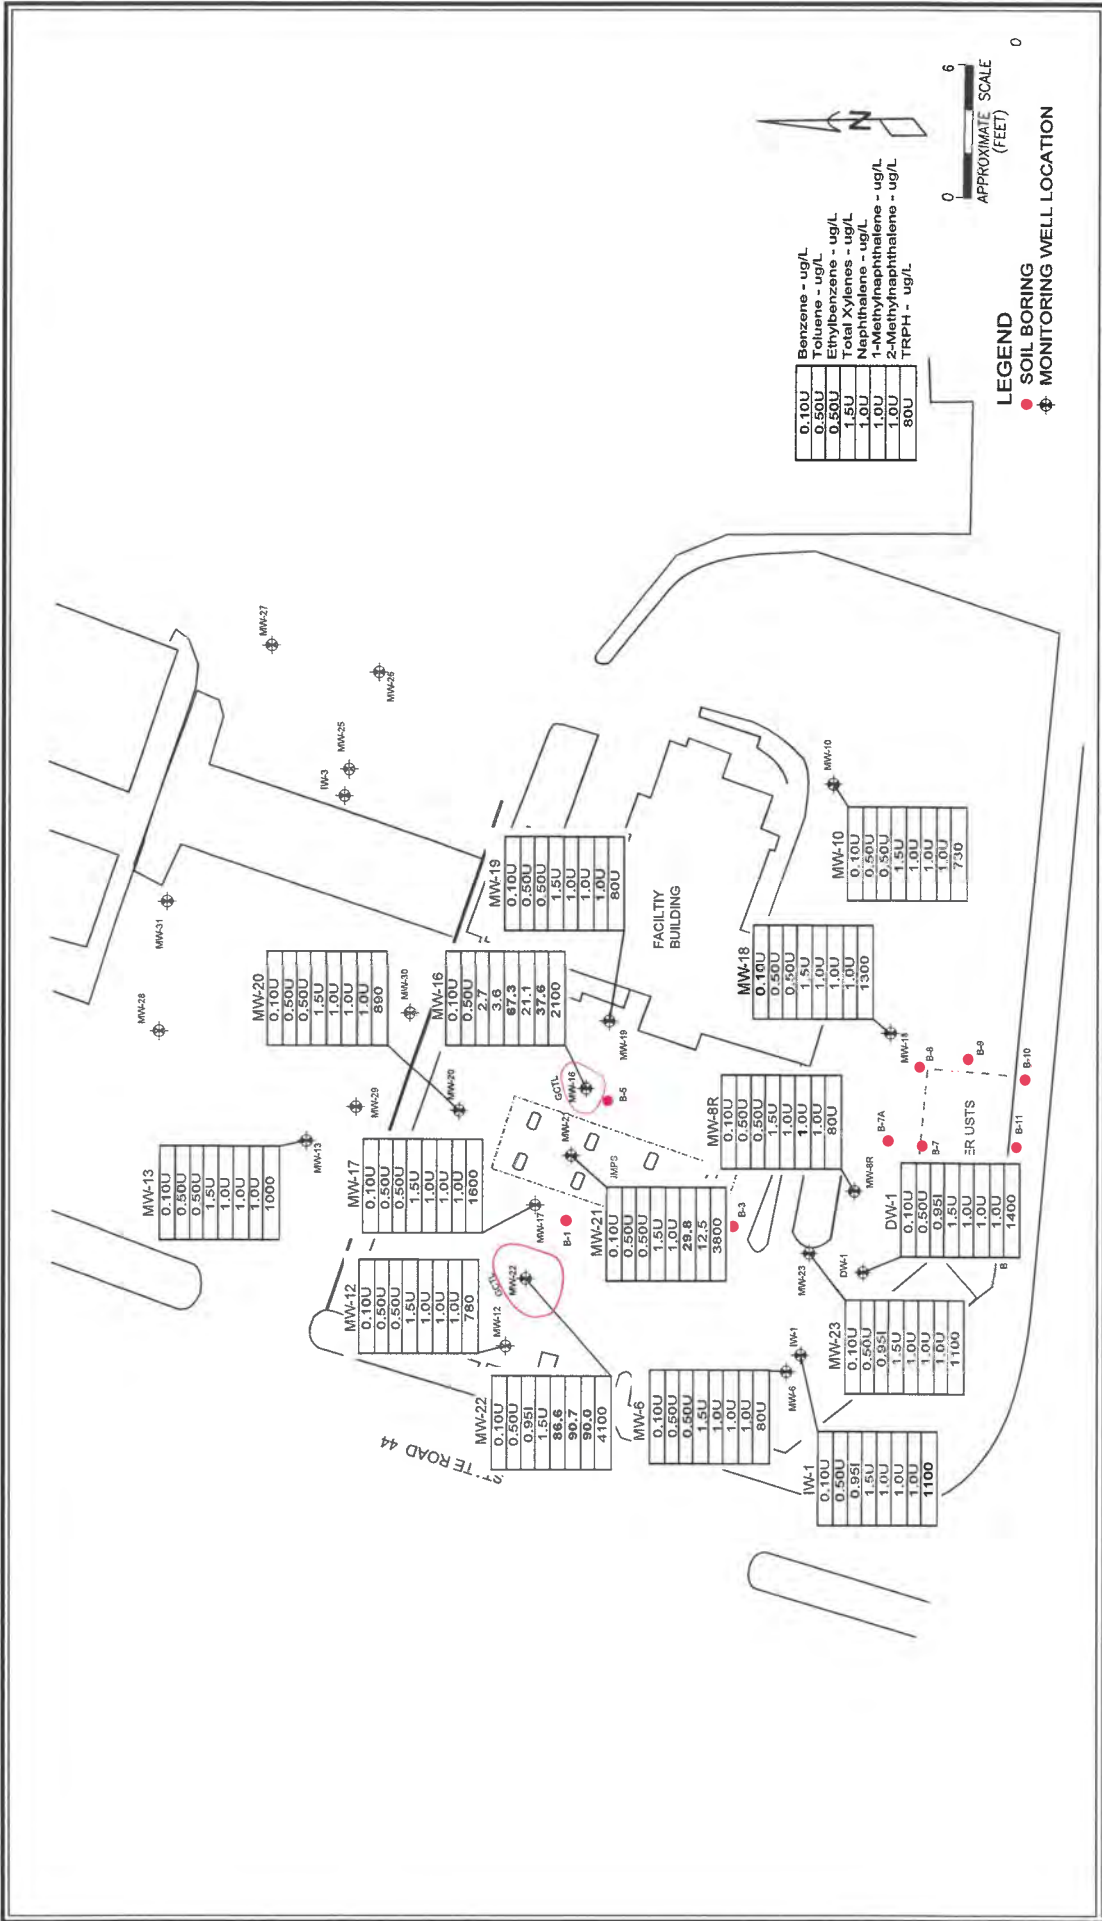
FIGURE 4C
 GROUNDWATER ANALYTICAL LABORATORY CONCENTRATIONS (2-METHYLNAPHTHALENE)
 WILDWOOD TRAVEL CENTER FAC ID# 60/8516878
 556 E STATE ROAD 44, WILDWOOD, SUMNER COUNTY, FLORIDA
 Source: Pangean-CMD Associates, Inc. 2012 / Google Earth 2016

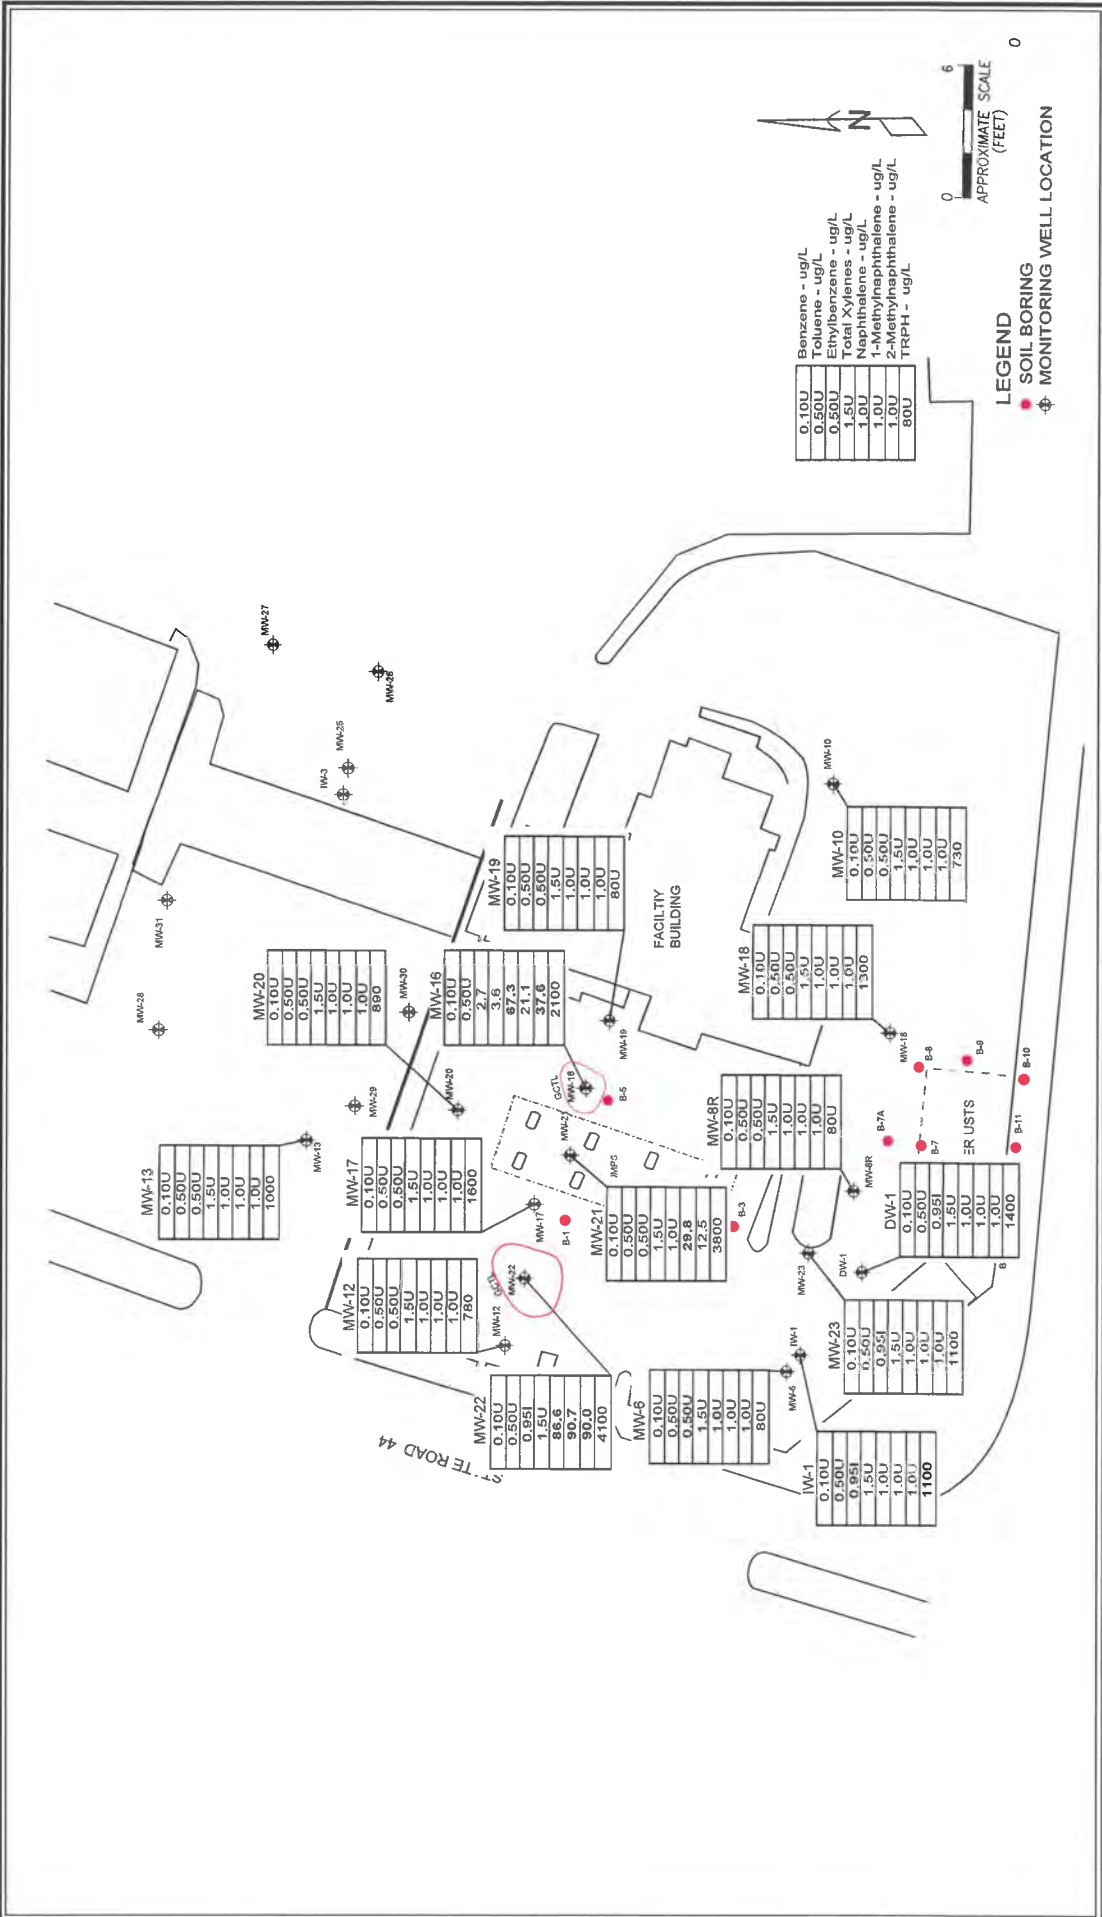
FIGURE 4C
 GROUNDWATER ANALYTICAL LABORATORY CONCENTRATIONS (2-METHYLNAPHTHALENE)
 WILDWOOD TRAVEL CENTER FAC ID# 60/8516878
 556 E STATE ROAD 44, WILDWOOD, SUMTER COUNTY, FLORIDA
 Source: Pangean-CMD Associates, Inc. 2012 / Google Earth 2016

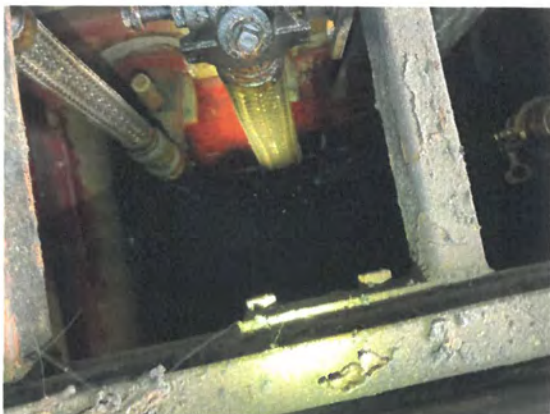
Dispenser 7/8satellite product in base

Type: Violation
Significance: SNC-B
Rule: 62-761.700(1), 62-761.700(1)(a), 62-761.700(1)(a)1, 62-761.700(1)(a)2
Violation Text: Not repaired or isolated component or piping which has not caused a discharge or release.
Explanation: Integrity testing of the automotive dispenser liners was due on 7/24/2022 and was performed on 7/29/2022. At that time dispenser 5/6 failed, all others passed. Integrity testing of the truckstop side diesel dispensers/satellite dispensers was due on 8/2/2022 and

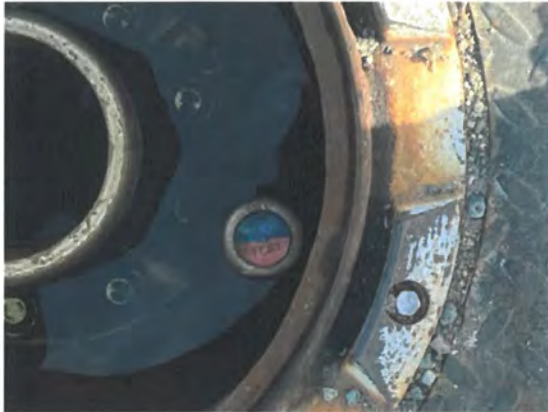
PUL doublewalled spill bucket liquid in secondary

Type: Violation
Significance: Minor
Rule: 62-762.501(2)(e)3, 62-762.501(2)(e)3.a, 62-762.501(2)(e)3.b, 62-762.501(2)(e)4, 62-762.502(2)(e)4, 62-762.502(2)(e)4.a, 62-762.502(2)(e)4.b, 62-762.502(2)(e)5
Violation Text: Failure to designate, register, or annually test primary overfill protection device,
Explanation: Annual testing of the primary overfill device on the new oil aboveground tank (Morrison Bros 918 clock gauge with high level alarm) was due on 1/18/2023 and testing was not available at time of inspection.
Corrective Action: Annual testing of the primary overfill device on the new oil aboveground tank (Morrison Bros 918 clock gauge with high level alarm) shall be performed at least once per year, no more than 12 months apart. Submit previous test results if available. If testing was performed or documentation is not available perform operability testing and submit results to Citrus County Environmental Health.

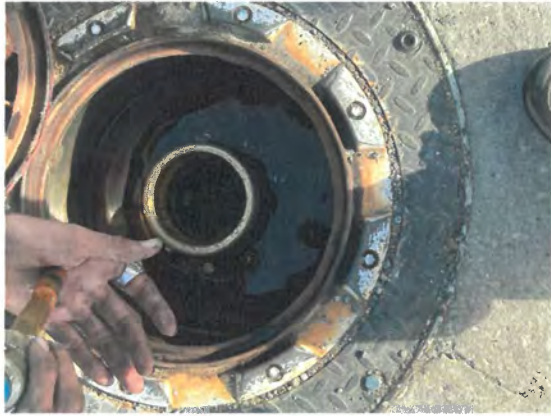
PUL doublewalled spill bucket EMCO gauge damaged

Type: Violation
Significance: SNC-B
Rule: 62-761.700(1), 62-761.700(1)(a), 62-761.700(1)(a)1, 62-761.700(1)(a)2
Violation Text: Not repaired or isolated component or piping which has not caused a discharge or release.
Explanation: The underground waste oil tank interstice sensor was in alarm at time of inspection.
Corrective Action: Remove the waste oil tank interstice sensor, if the interstice is found dry repair/replace /retest the sensor. If liquid is found in the tank interstice further testing may be required. Submit all documentation to Citrus County Environmental Health.
