**CULTURAL RESOURCE ASSESSMENT SURVEY
OF INTERSTATE 75 FROM SOUTH OF STATE ROAD 44
TO STATE ROAD 200 PONDS ADDENDUM
SUMTER AND MARION COUNTIES, FLORIDA**

**FINANCIAL MANAGEMENT NO. 452074-2
SEARCH PROJECT NO. 230271**

**FLORIDA DEPARTMENT OF TRANSPORTATION, DISTRICT 5
DELAND, FLORIDA**

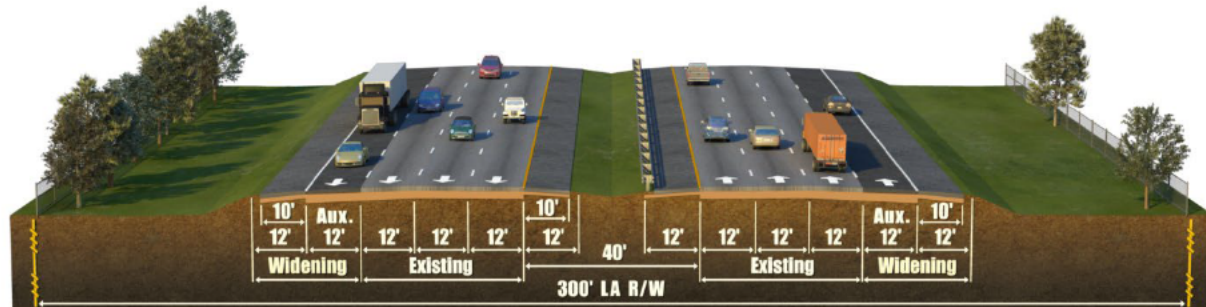
Figure 4. I-75 Typical Section.

The Auxiliary Lanes Alternative is the sole build alternative evaluated in this PD&E study and is based on recommendations from previous master planning activities. The Auxiliary Lanes Alternative proposes to add one 12-foot auxiliary lane (additional lane between interchanges) to the outside of the general-purpose lanes in each direction. The auxiliary lanes would not impact the interchange bridges. The typical section is shown in Figure 4.

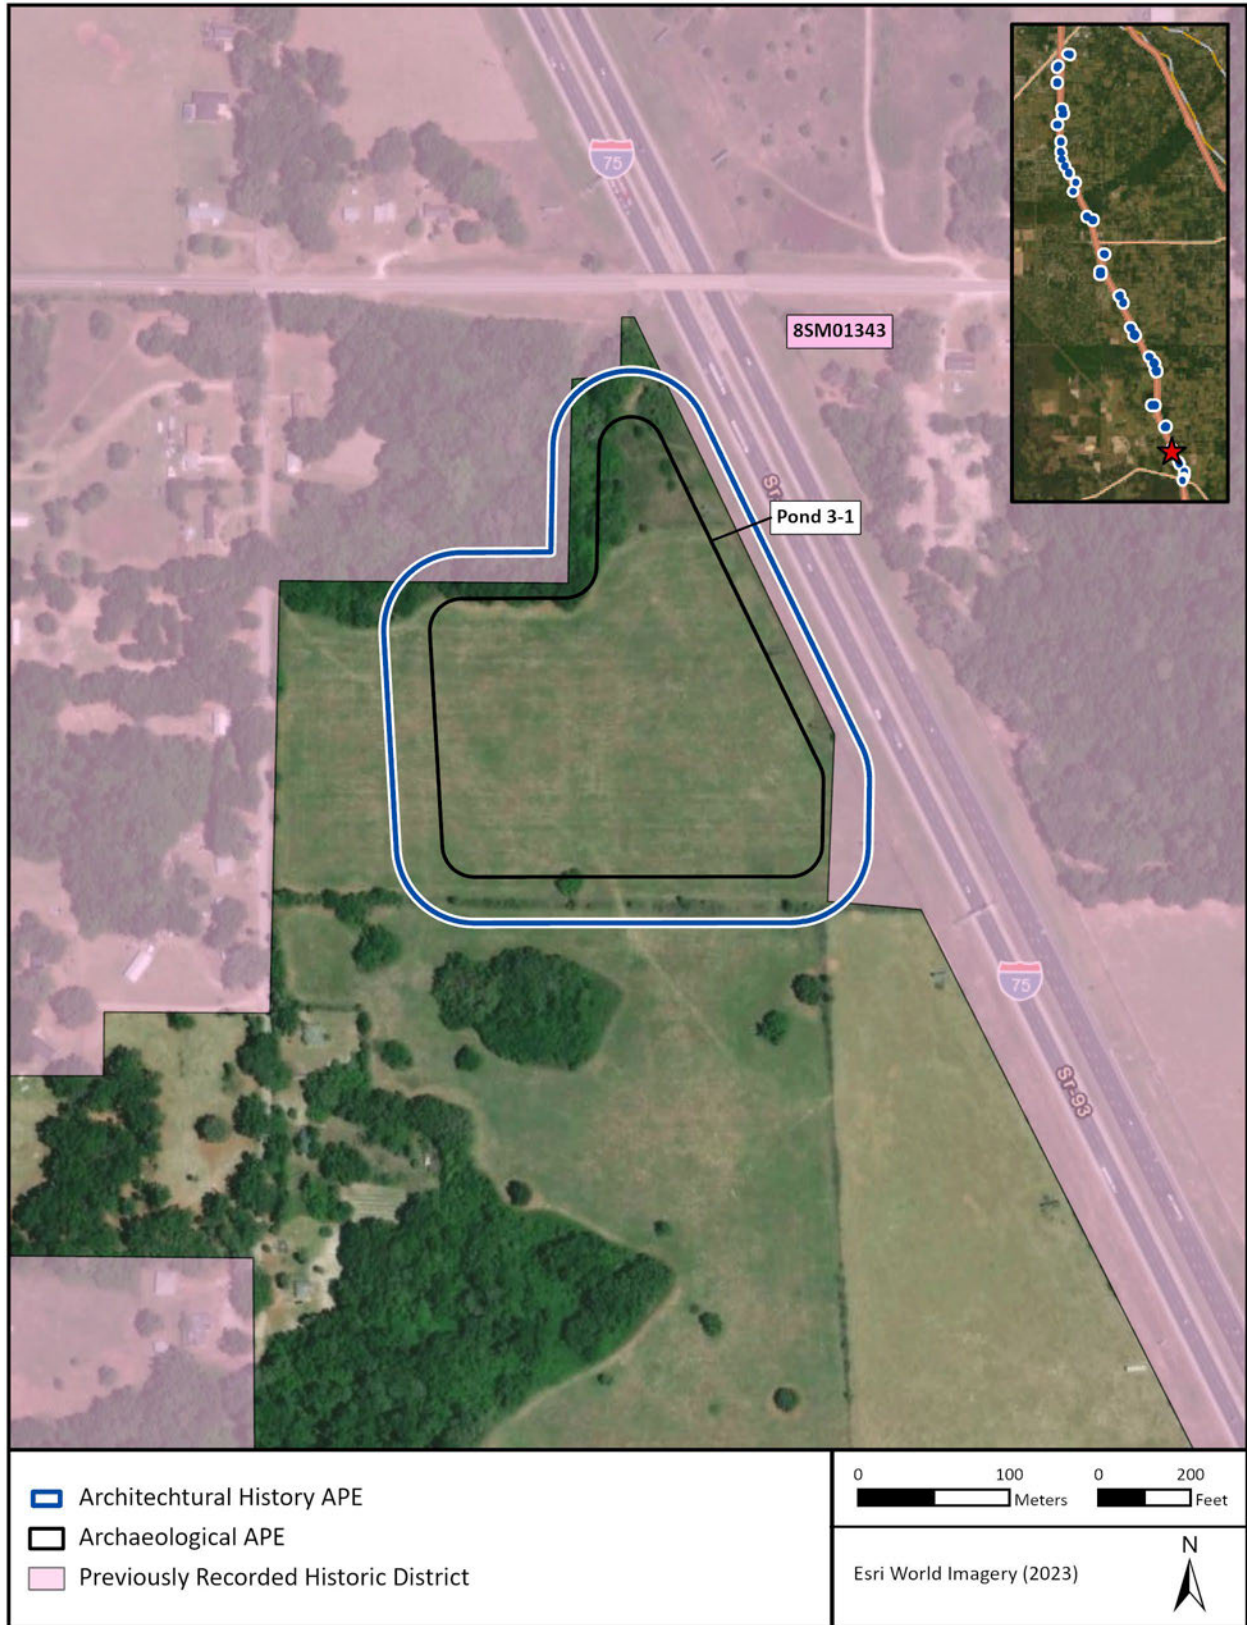
Figure 72. Overview of the current limits of 8SM01343 in relation to Pond 3-1.

FMSF Resource No. 8SM01343 (Community of Royal) is a previously recorded rural historic landscape located in north-central Sumter County. The current limits of the resource begin just south of Pond 4-1 and continues to just north, west, and east of Pond 3-1 (see **Figures 72 and 73**). Resource 8SM01343 was recommended as eligible for listing in the NRHP by the SHPO in 2022 under Criterion A for its significance in Ethnic Heritage (Black), Agricultural, Exploration and Settlement, and Community Planning and Development. Although there is no significant overlap, an assessment of effects was completed to assess impacts to the eligible resource.

SEARCH recommends 8SM01343 retains sufficient integrity necessary to convey its significance under Criterion A and recommends it eligible for NRHP inclusion. Under Criterion A, the resource's integrity of location, feeling, and association is important to its significance. The proposed project plans to build an irregularly shaped pond along the southern border of the resource. No existing historic fabric associated with 8SM01343 will be altered by the proposed project. As such, it is the opinion of SEARCH that the proposed project poses no adverse effects to 8SM01343.

The proposed project is to construct an irregularly shaped pond just south of the Community of Royal (8SM01343), west of I-75. The pond will be located in an existing field with no effect to historic buildings. Because the Community of Royal is a rural historic landscape, a pond would not constitute an adverse visual effect because it is a feature that would be found in a rural landscape. As such, it is the opinion of SEARCH that the proposed project will have no adverse effect on the viewshed of the Community of Royal (8SM01343).
