NATURAL RESOURCES EVALUATION REPORT

Interstate 75

PD&E STUDY

Limits of Project: South of S.R. 44 to S.R.200

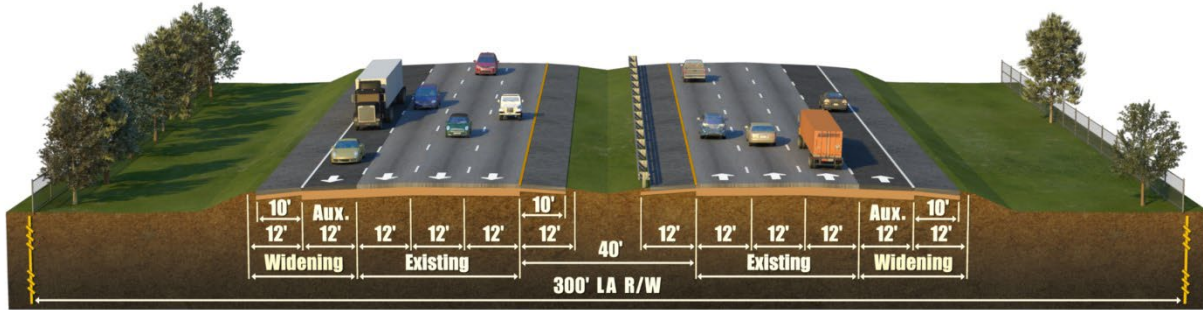
Figure 1-2: I-75 Typical Section

The Auxiliary Lanes Alternative is the sole build alternative evaluated in this PD&E study and is based on recommendations from previous master planning activities. The Auxiliary Lanes Alternative proposes to add one 12-foot auxiliary lane (additional lane between interchanges) to the outside of the general-purpose lanes in each direction. The auxiliary lanes would not impact the interchange bridges. The typical section is shown in **Figure 1-2**.

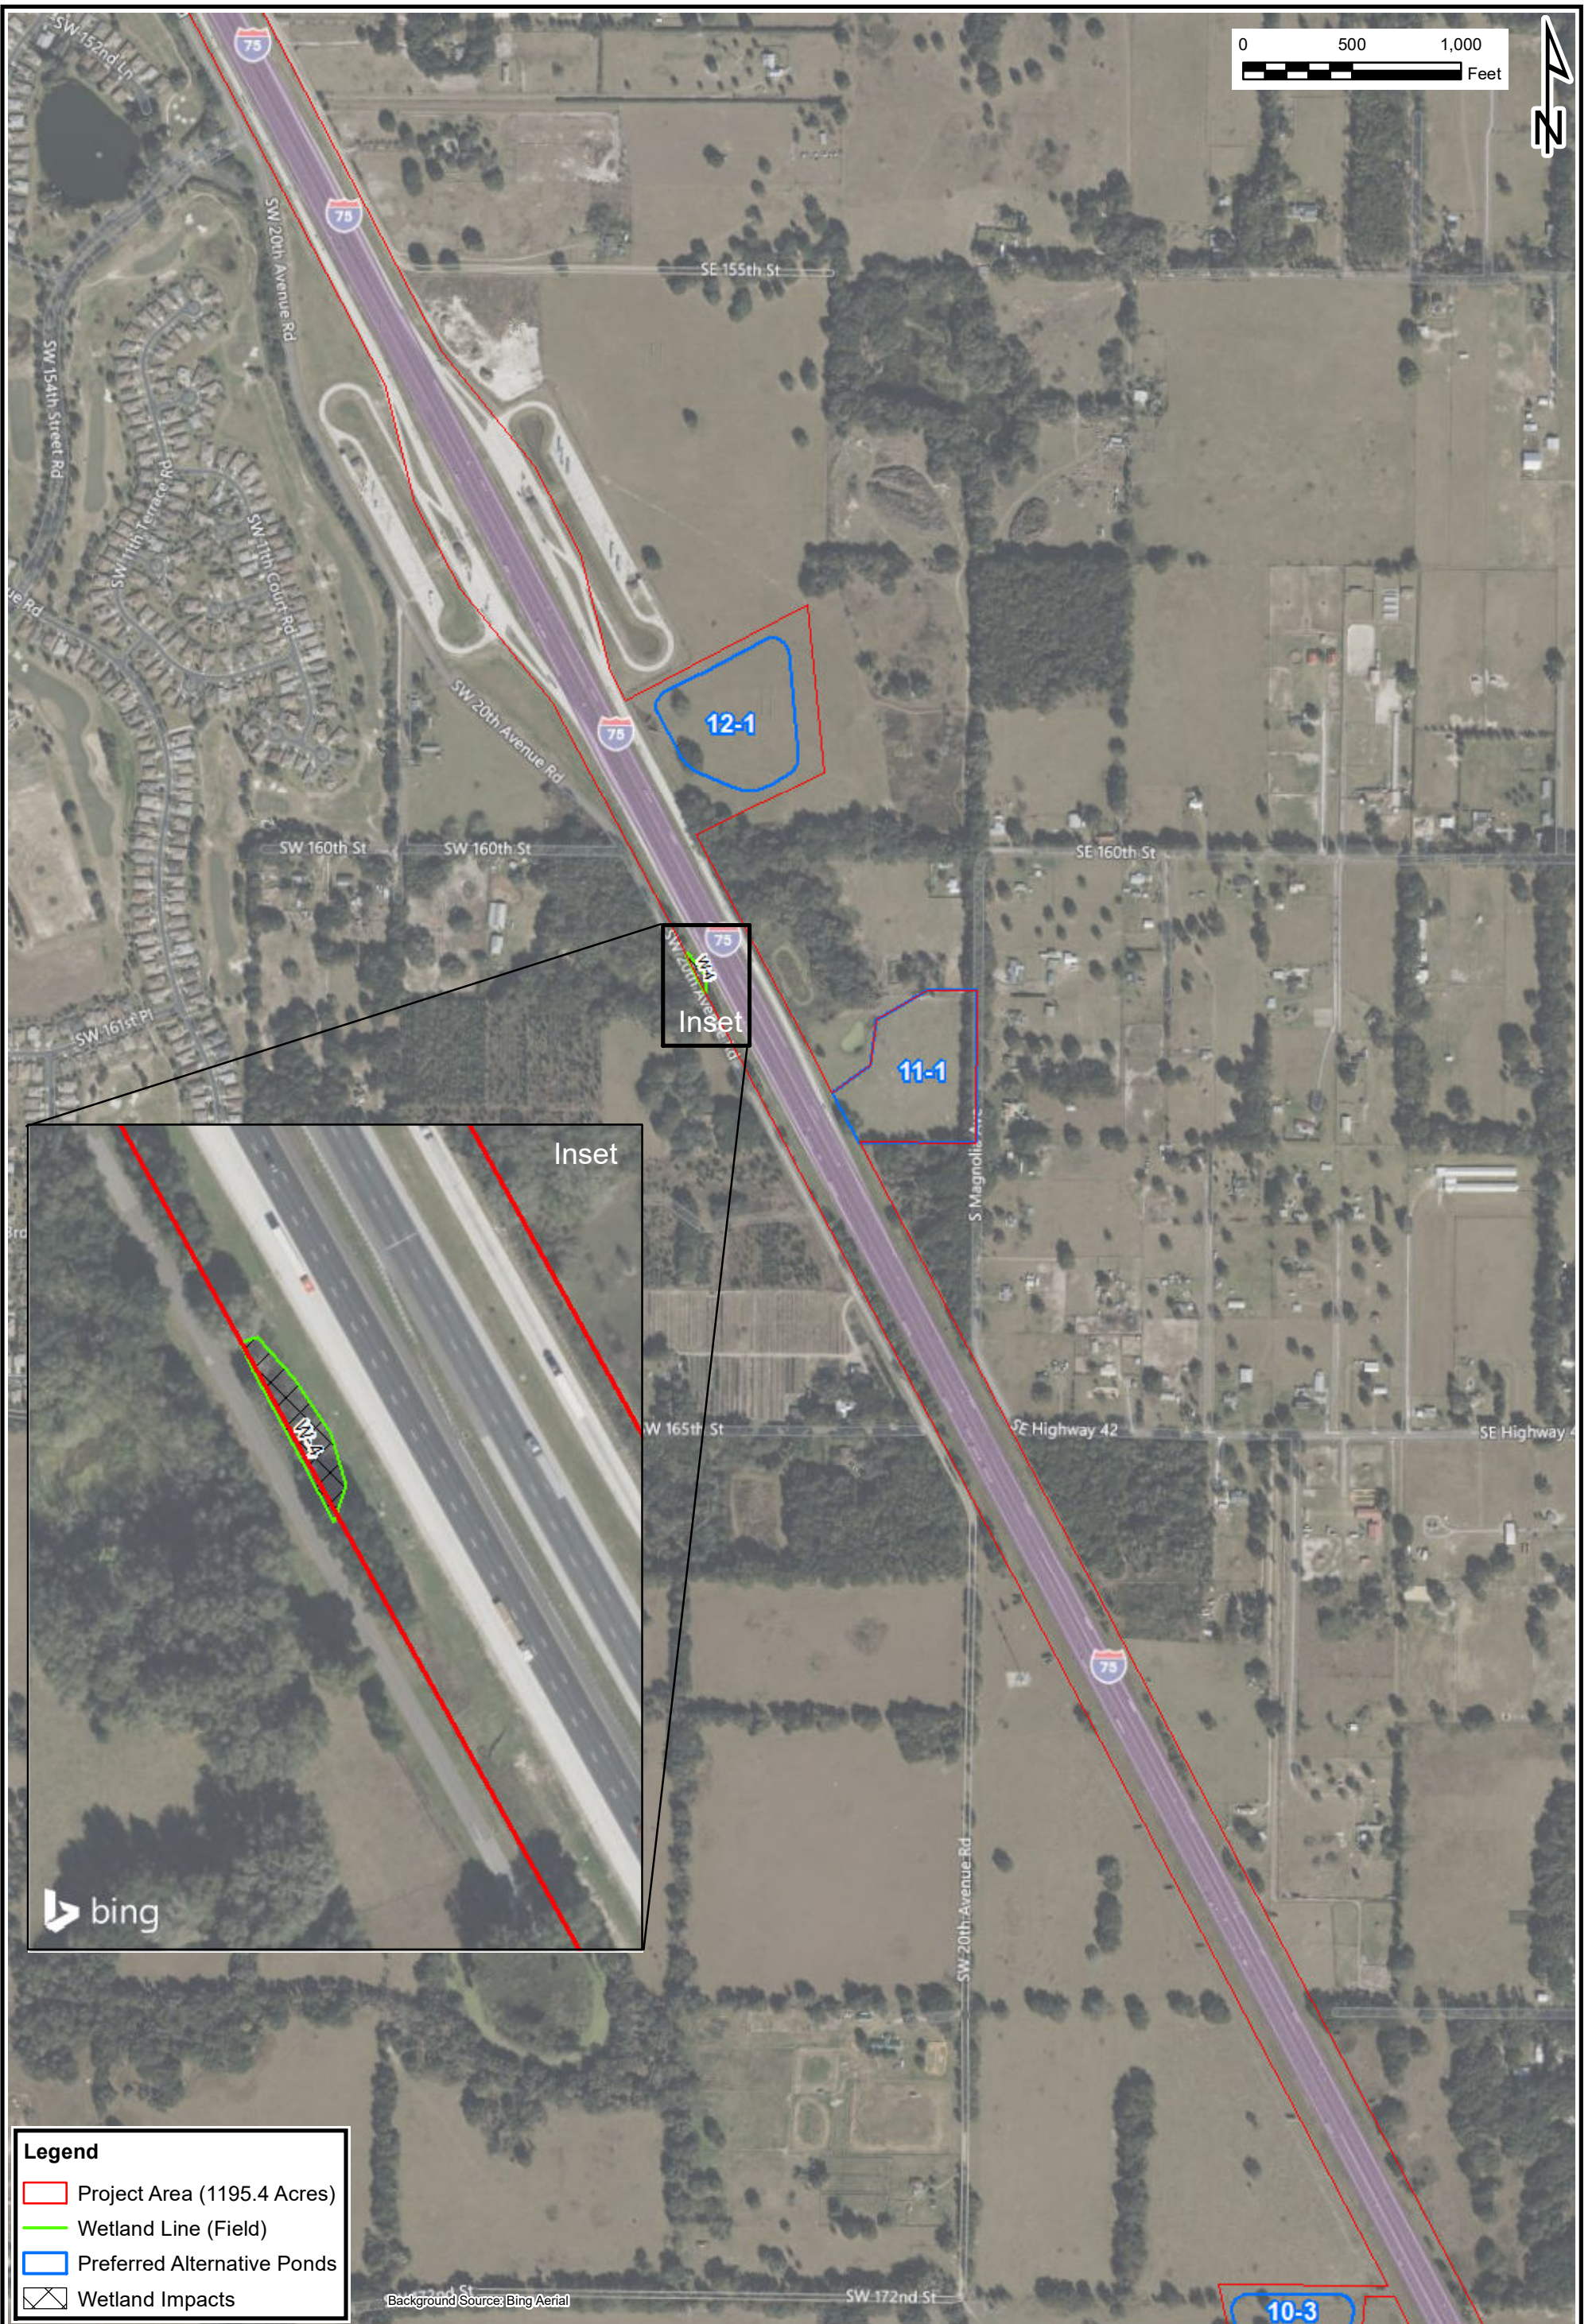
FIGURE
6E

Legend	
	Project Area (1195.4 Acres)
	Wetland Line (Field)
	Preferred Alternative Ponds
	Wetland Impacts

Approximate wetland and OSW locations were identified along the project corridor (**Figures 6A to 6J**). Fifteen (15) wetland areas and five (5) OSWs were identified in proximity to the project. Wetland communities anticipated to be impacted primarily consist of mixed wetland hardwood communities (FLUCCS 615). Dominant vegetation within these areas consists primarily of red maple, American elm, and sugar berry, with scattered swamp bay and box elder. The understory is comprised of box elder, beggarticks, royal fern, button bush, elderberry, cinnamon fern, and climbing fern. Signs of hydrology included stained leaves, water lines, lichen lines, and drainage patterns. Several small freshwater marsh areas occur scattered along the project corridor. Dominant vegetation within these areas consists of maidencane, duck potato, saw grass, Virginia chain fern, and swamp fern, with Carolina willow, primrose willow, and wax myrtle along the margins. Signs of hydrology included standing water, saturated soils, and drainage patterns.
