## **CONTAMINATION SCREENING EVALUATION REPORT**

**I-75 FROM SOUTH OF SR 44 TO SR 200**  
Marion County and Sumter County, Florida  
Financial Project ID No. 443623-1-22-01  
GEC Project No. 4477E1

I-75 Improvements Project Development and Environment (PD&E) Study  
(Southern Section)

Limits of Project: I-75 from South of S.R. 44 to S.R. 200

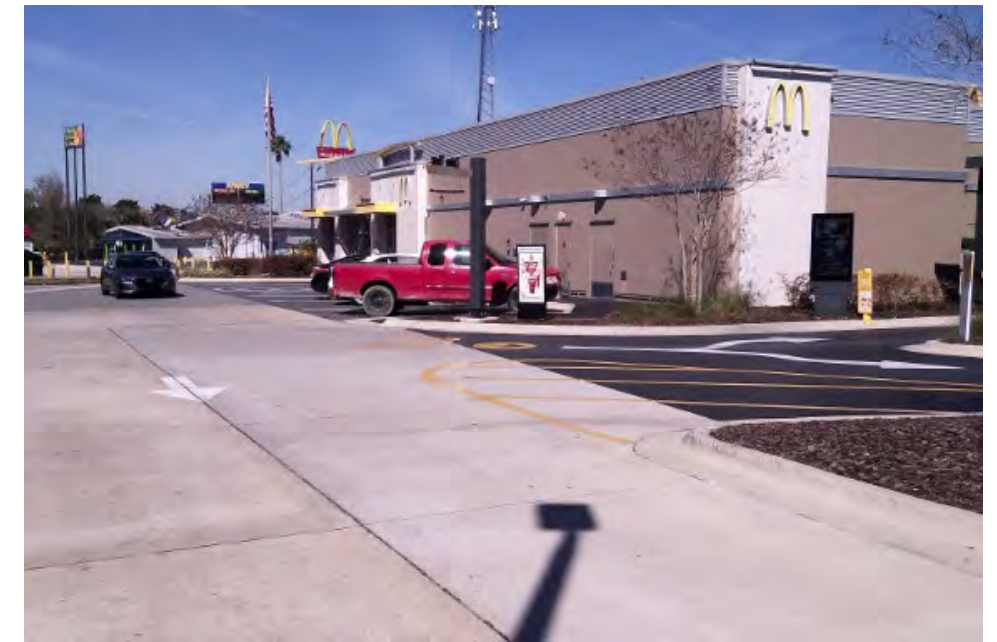
**SITE OBSERVATIONS:** The site has been redeveloped with a fast-food restaurant.

**CONCLUSIONS:** Due to the Site Rehabilitation Completion Order, this site has been assigned a Contamination Risk Rating (CRR) of **Low**.

Looking north at the current fast food restaurant building.

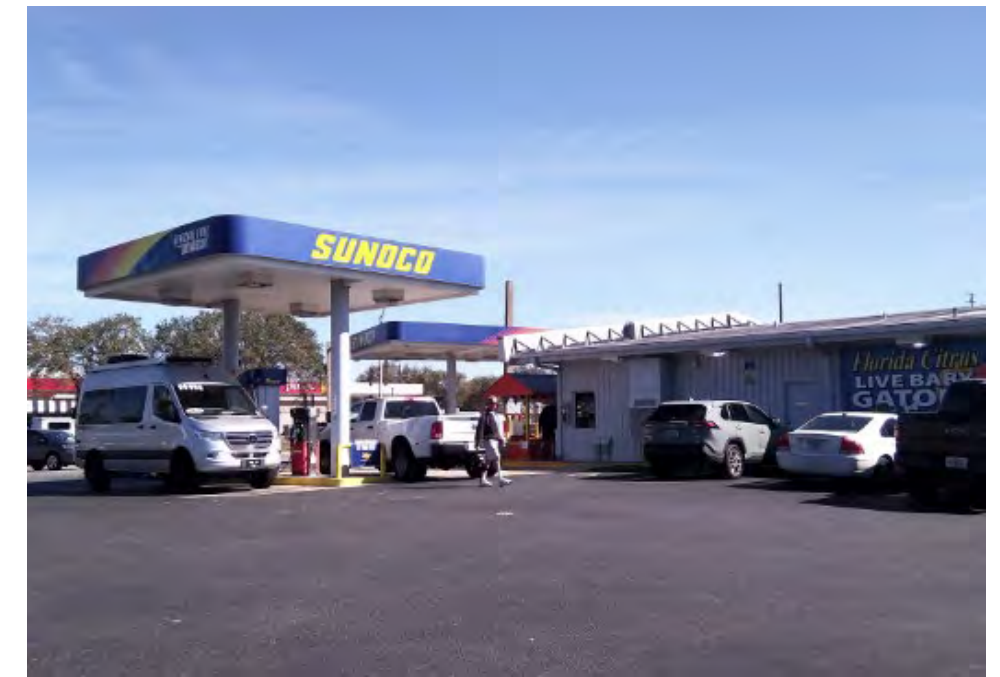
**SITE OBSERVATIONS:** The site is an operating gas station with two fueling canopies.

**CONCLUSIONS:** This site achieved regulatory closure. Due to being an active gas station, this site has been assigned a CRR of **Medium**.

*View of the gas station and fueling canopies on-site.*

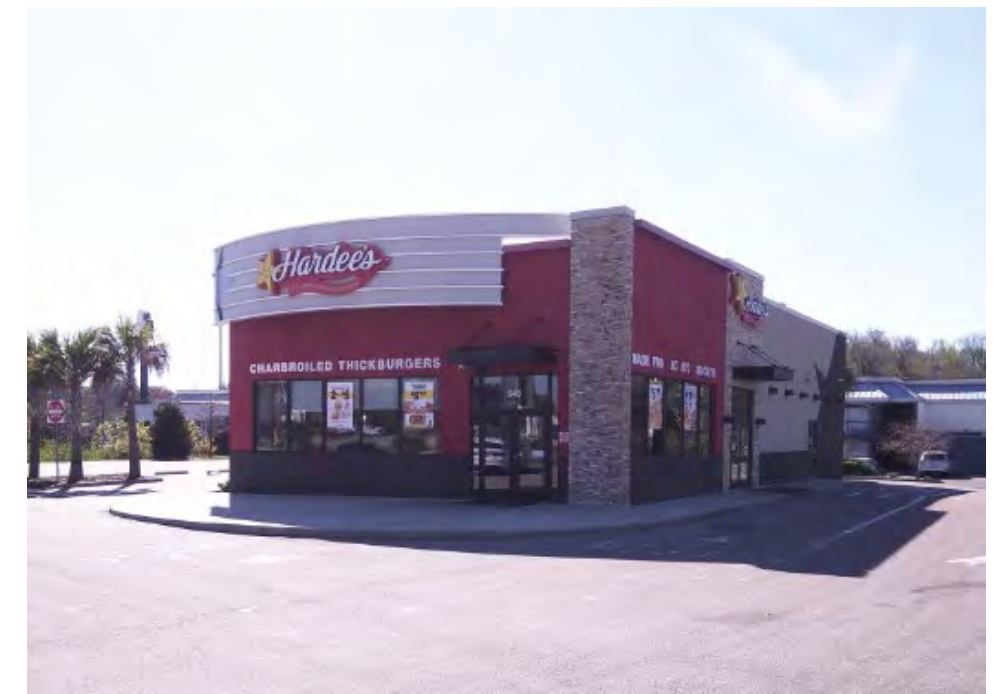
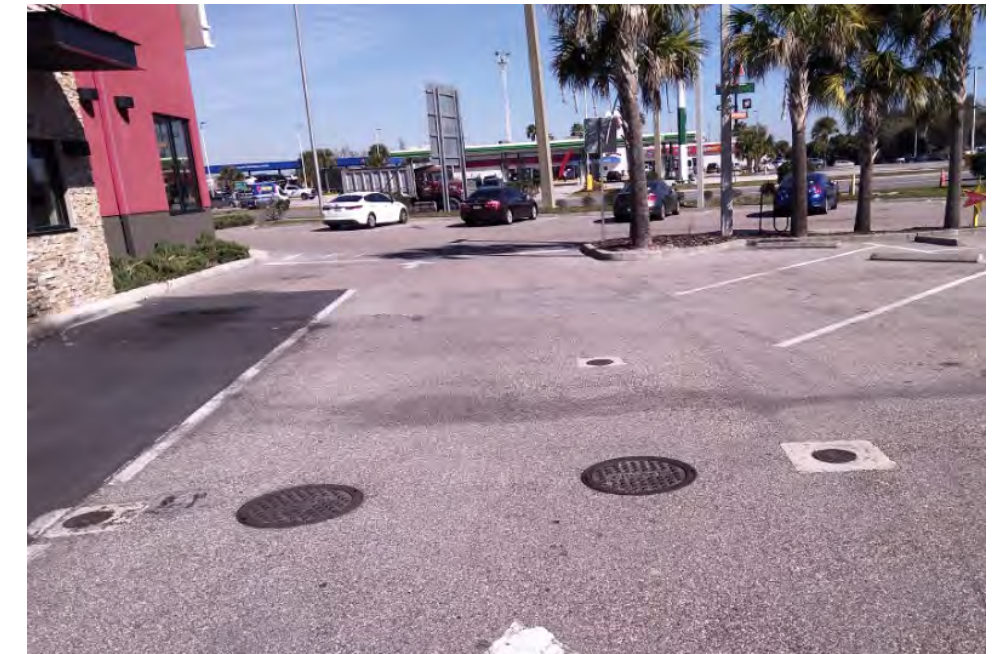
**SITE OBSERVATIONS:** The site has been redeveloped with a fast-food restaurant.

**CONCLUSIONS:** Due to existing impacts on-site, the distance of the site from I-75, and groundwater flow direction, this site has been assigned a CRR of **Medium**. This site could affect the southwest Pond 0-1 if dewatering is required.

Looking south at the area of the former gas station.

Looking north at an area of monitoring wells.

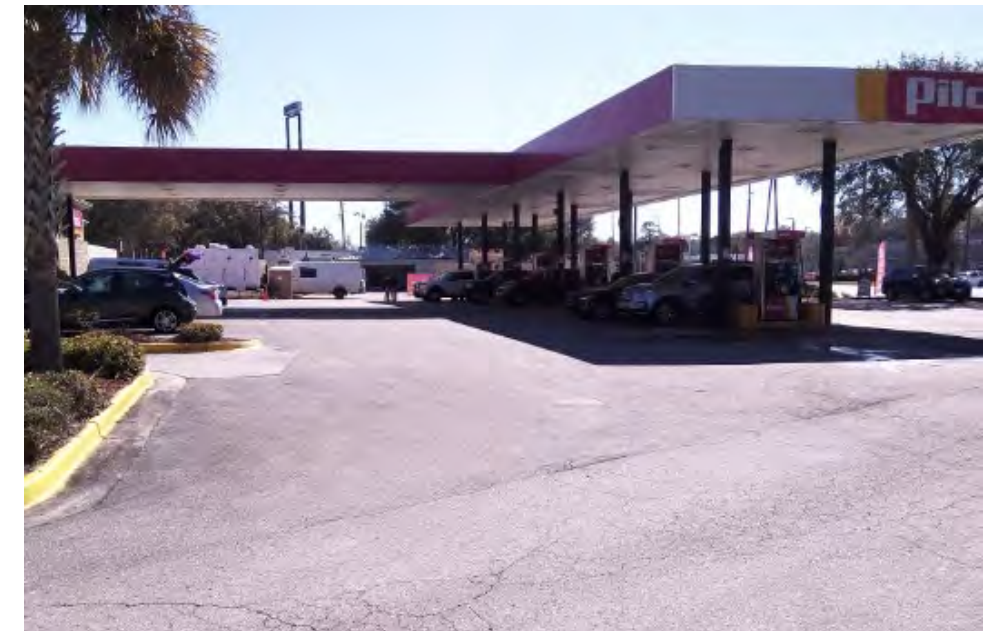
**SITE OBSERVATIONS:** The site is an operating gas station with two fueling canopies.

**CONCLUSIONS:** Due to existing groundwater impacts, this site has been assigned a CRR of **Medium**. This site could affect the northeast Pond 0-1 if dewatering is required.

View of the fueling canopy and gas pumps on-site.

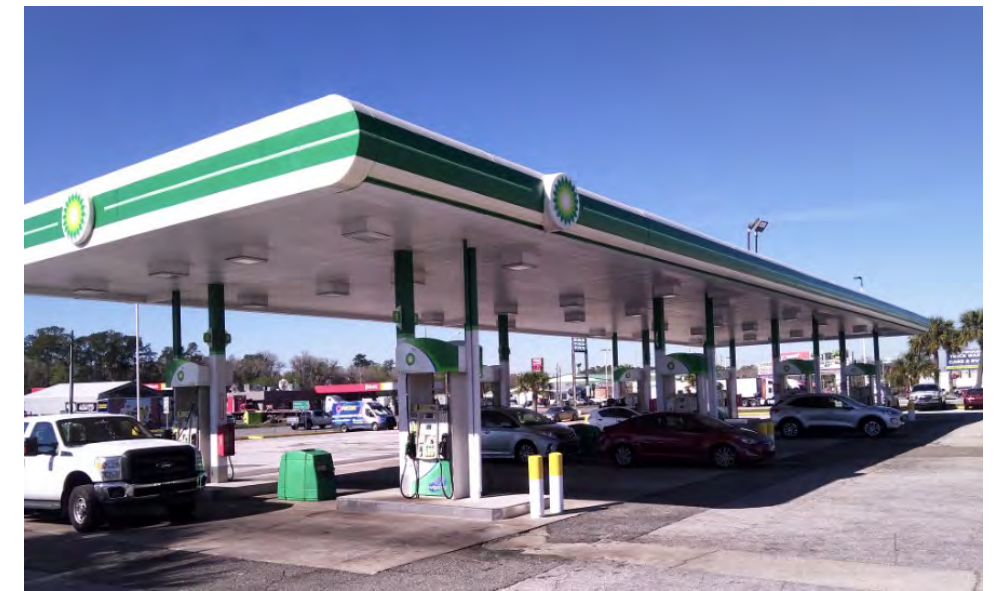
**SITE OBSERVATIONS:** The site is an operating gas station.

**CONCLUSIONS:** Due to existing impacts on-site, and the distance of the site from I-75, this site has been assigned a CRR of **Medium**.

View of the fueling canopy and gas pumps on-site.

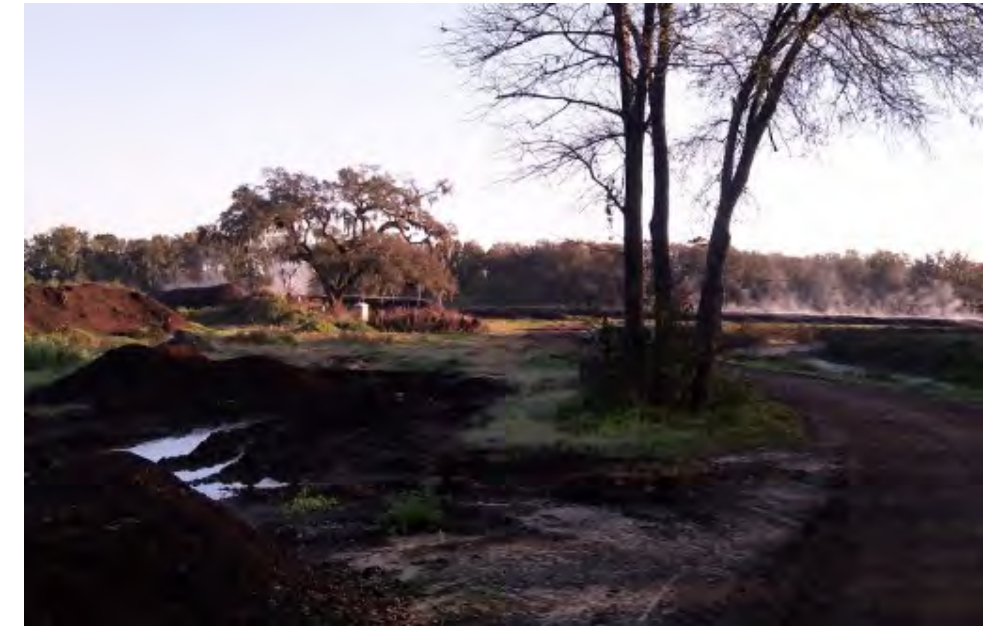
**SITE OBSERVATIONS:** The site contains mounds of compost.

**CONCLUSIONS:** Due to the lack of recorded contamination impacts, this site has been assigned a CRR of **Low**.

Compost mounds are visible on the left.

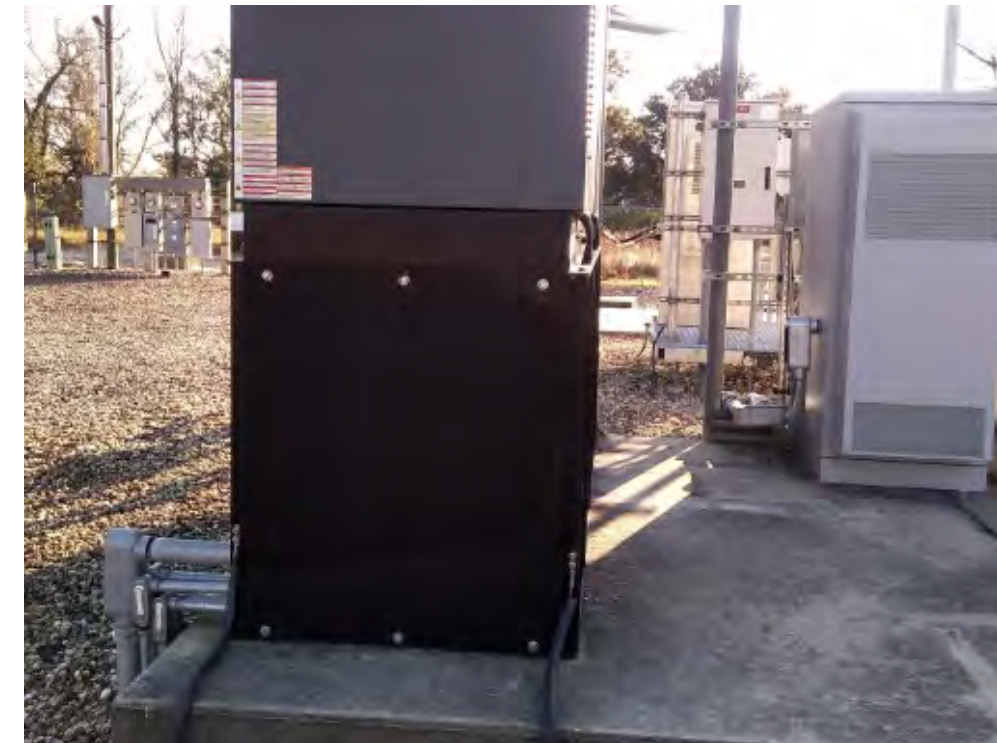
View of an emergency generator diesel tank.

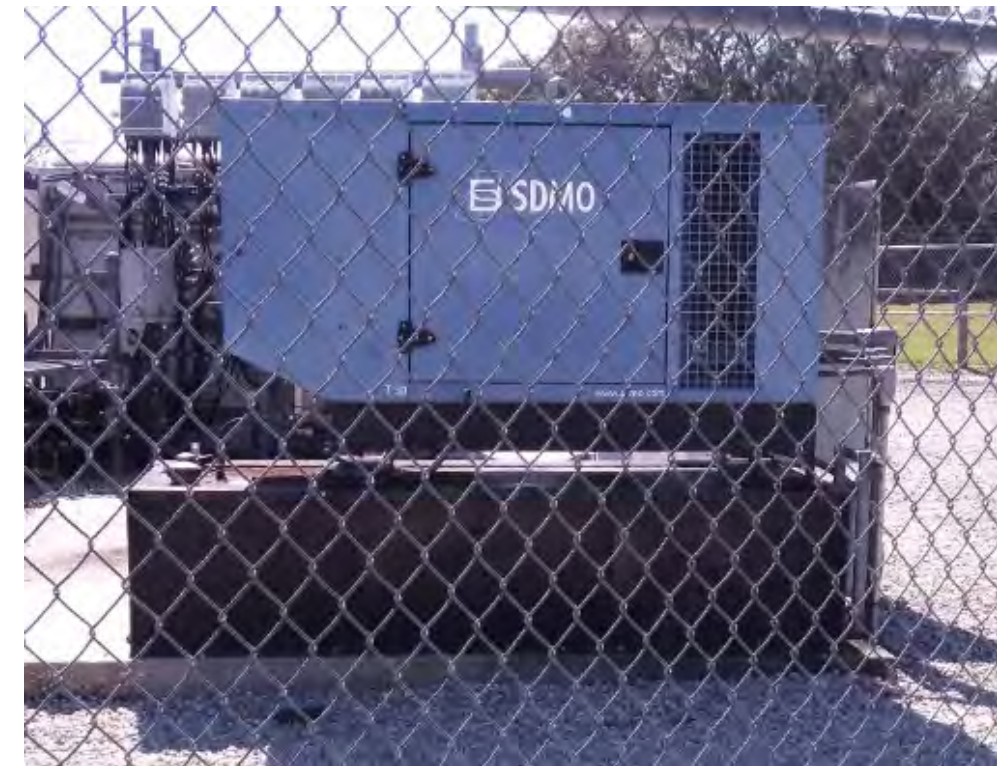
View of second emergency generator diesel tank.

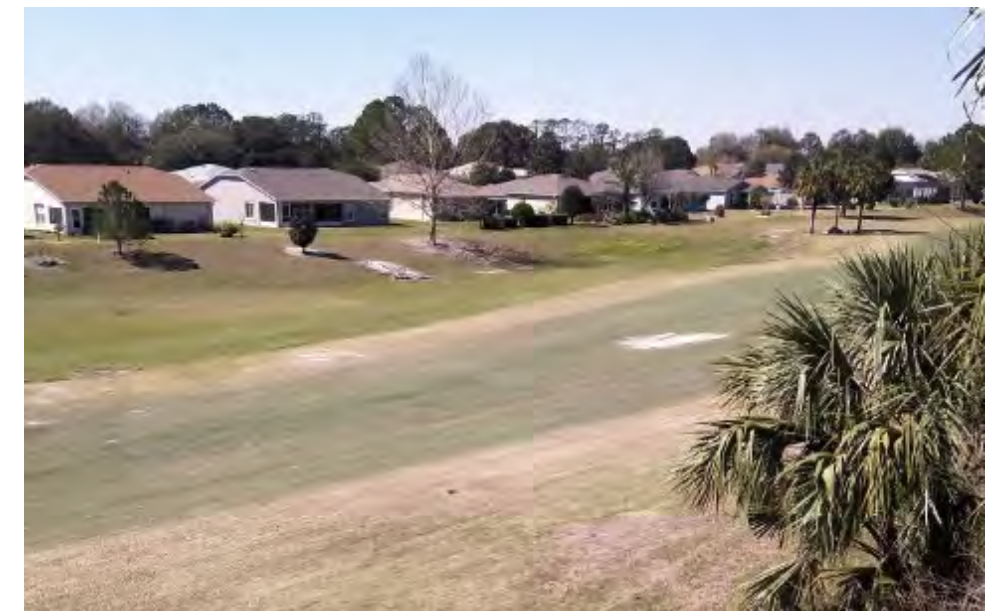
**SITE OBSERVATIONS:** The site is an 18-hole golf course surrounding a residential neighborhood.

**CONCLUSIONS:** Due to the golf course being outside the I-75 right-of-way, this site has been assigned a CRR of **Low**.

Looking northwest towards the golf course from the I-75 right-of-way.

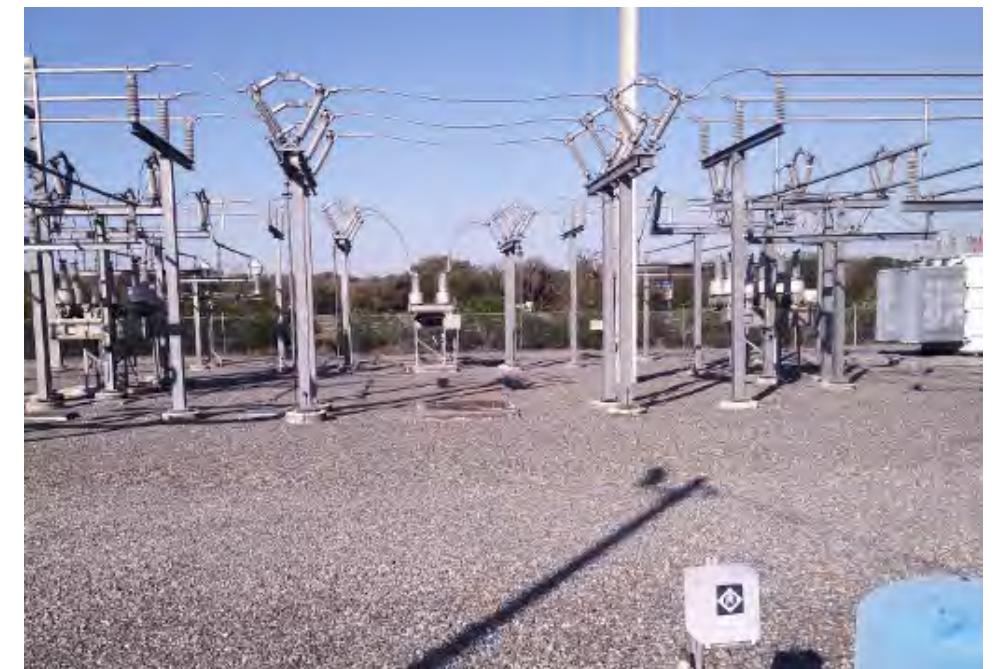
**SITE OBSERVATIONS:** The site is an electrical substation.

**CONCLUSIONS:** Due to the lack of recorded contamination impacts, this site has been assigned a CRR of **Low**.

View of the electrical substation.

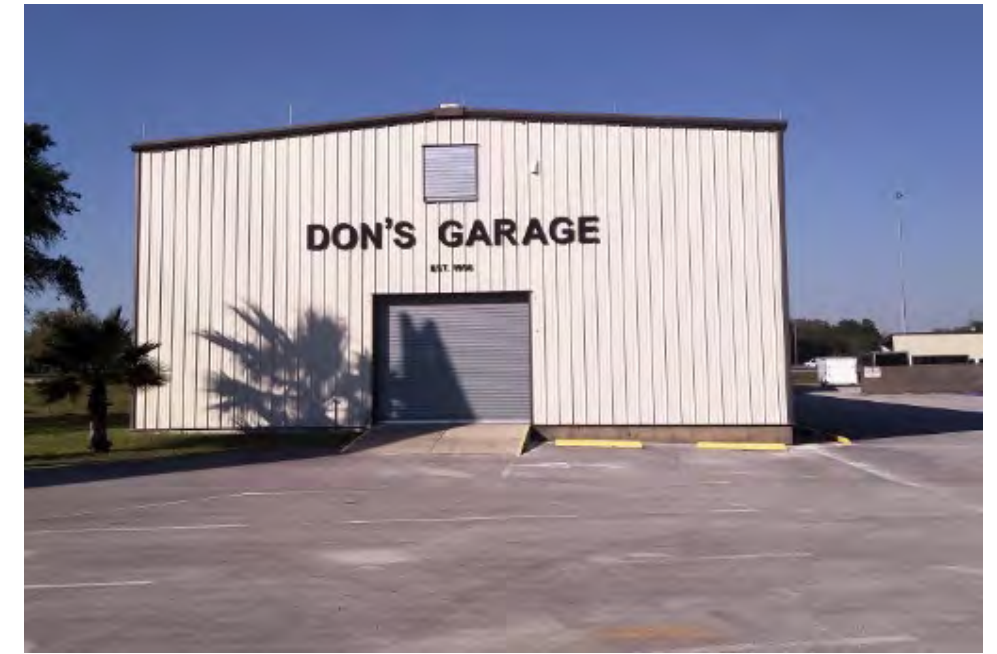
**SITE OBSERVATIONS:** The site is an auto museum consisting of two warehouse-type buildings.

**CONCLUSIONS:** Due to the lack of recorded contamination impacts, this site has been assigned a CRR of **Low**.

Looking north at the Don's Garage building.

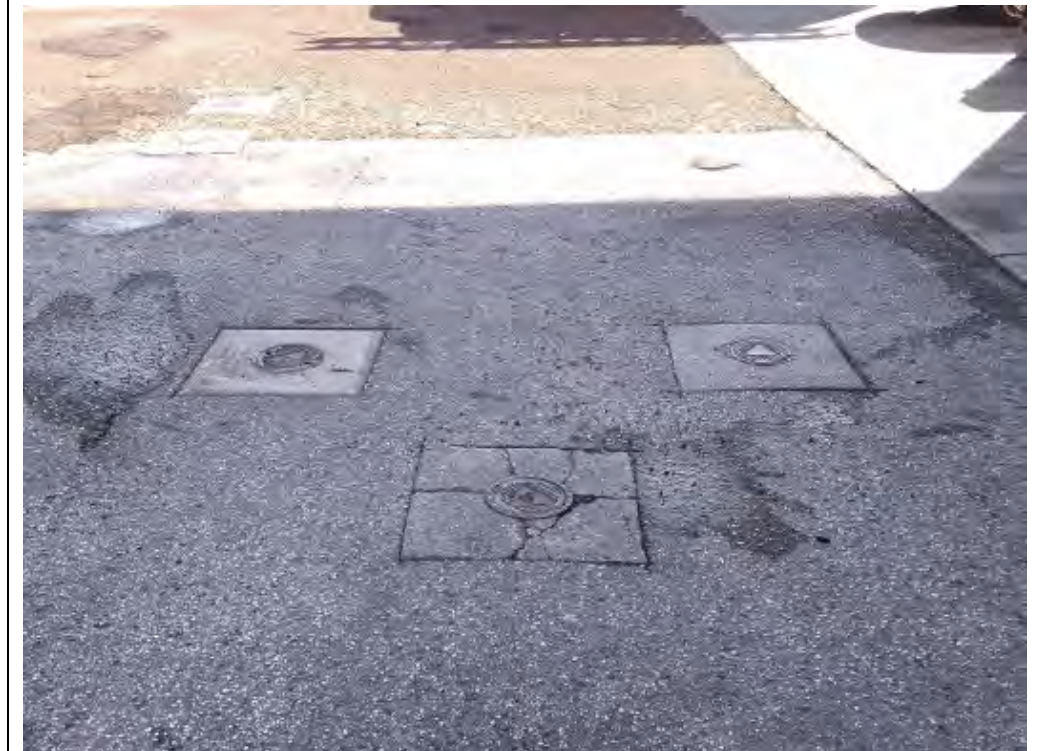
An area of monitoring wells on-site.

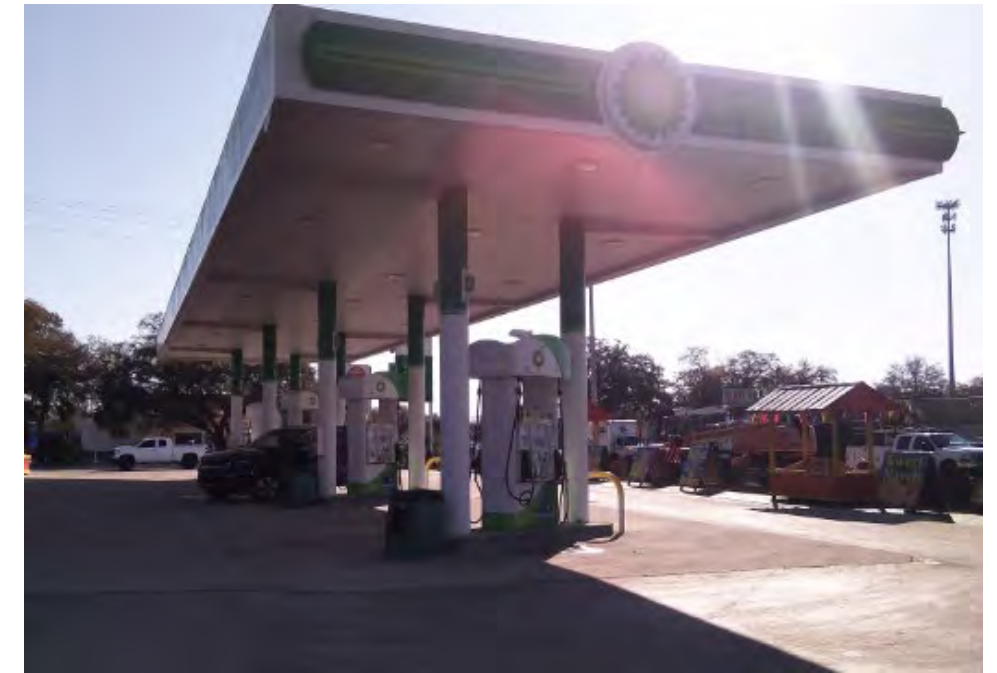
**SITE OBSERVATIONS:** The site is an operating gas station.

**CONCLUSIONS:** The site achieved regulatory closure. Due to being an active gas station, this site has been assigned a CRR of **Medium**.

View of the fueling canopy and gas pumps on-site.

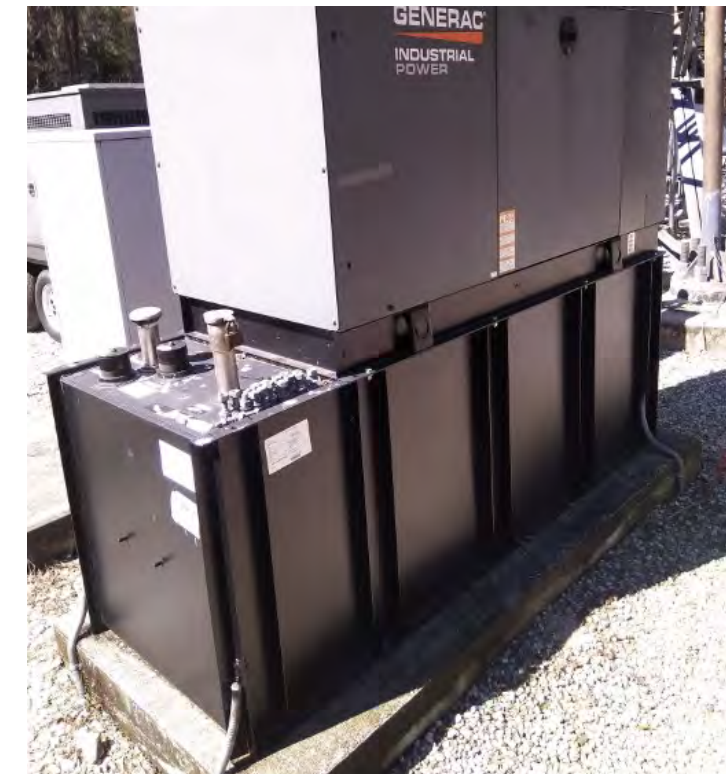
View of second emergency generator tank on-site.

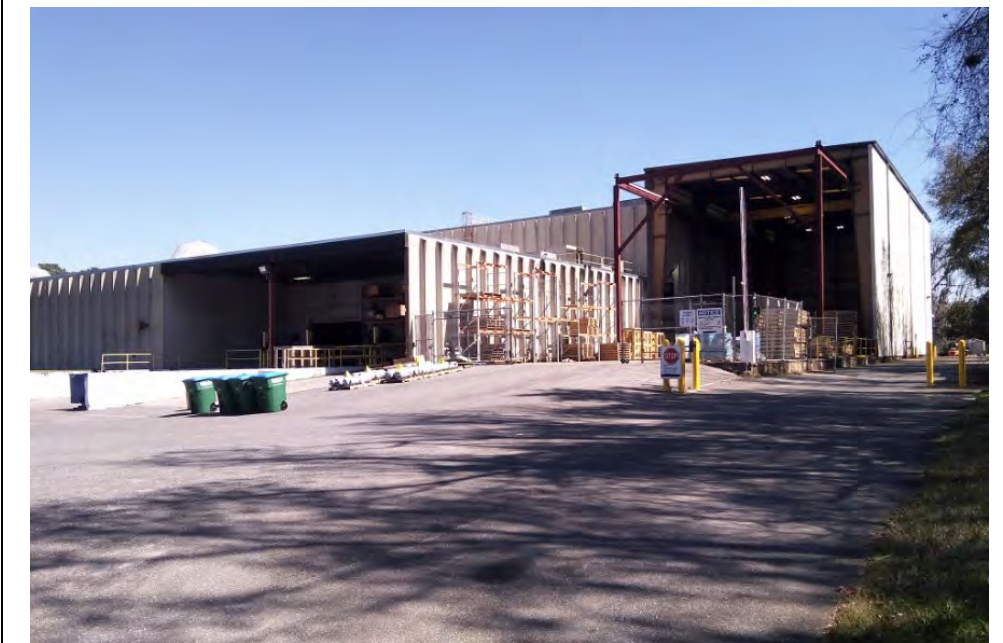
**SITE OBSERVATIONS:** The site is a large warehouse building.

**CONCLUSIONS:** Due to the lack of recorded contamination impacts this site has been assigned a CRR of **Low**.

View of the warehouse building on-site.

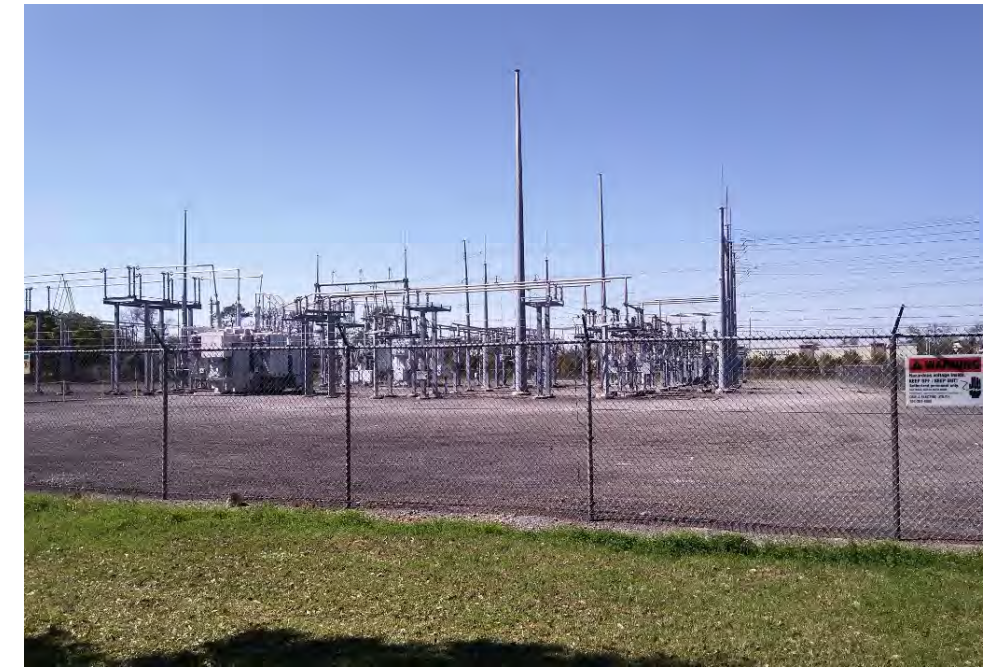
**SITE OBSERVATIONS:** The site is an electrical substation.

**CONCLUSIONS:** Due to the lack of recorded contamination impacts, this site has been assigned a CRR of **Low**.

*View of the electrical substation facility.*

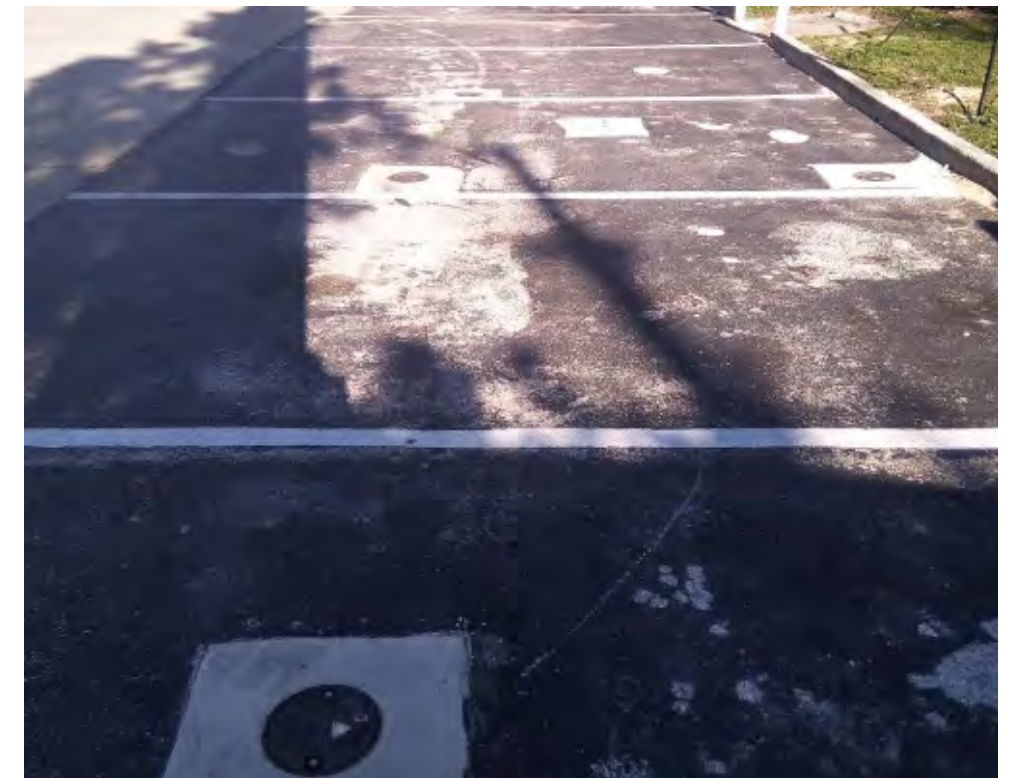
**SITE OBSERVATIONS:** The site is an operating gas station. Monitoring wells were observed throughout the site.

View of an area of monitoring wells on-site.

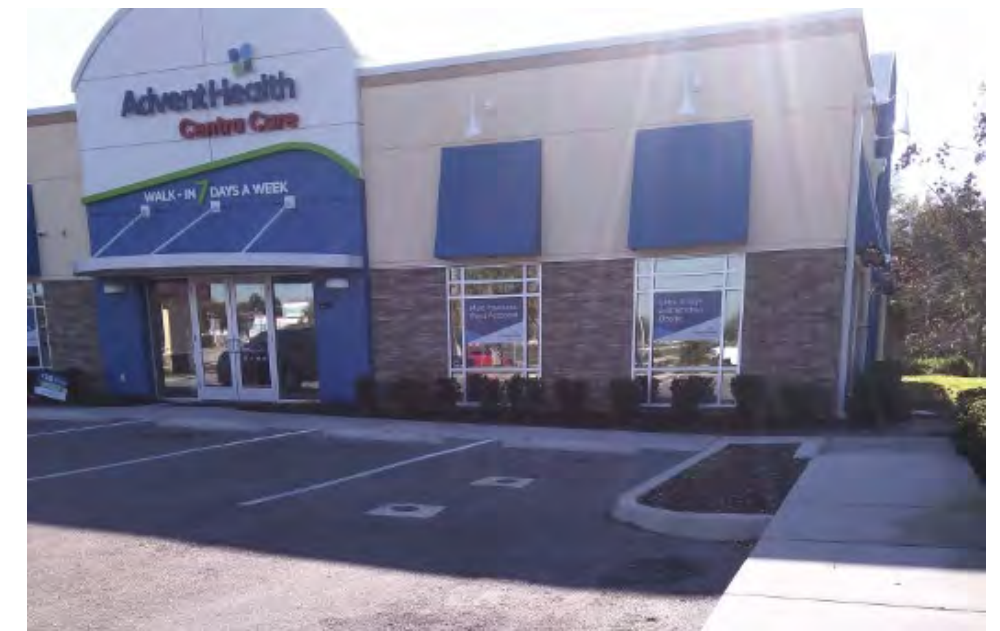
**SITE OBSERVATIONS:** The site has been redeveloped with a medical office building.

**CONCLUSIONS:** Due to remaining groundwater impacts being located within the footprints of **Site Nos. 31 and 32**, this site has been assigned a CRR of **Medium**. Based on the distance from I-75 and the depth of the groundwater on-site and in the site vicinity, this facility is unlikely to affect the project.

Looking south at the current building. Two monitoring wells are in the foreground.

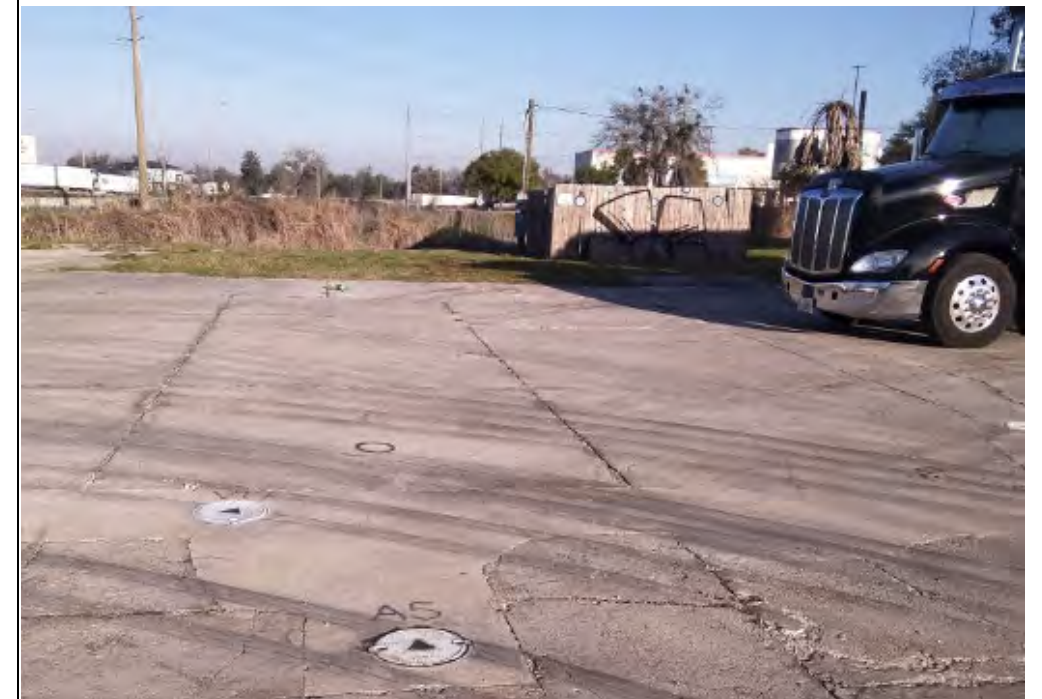
**PUBLIC RECORDS:** A discharge was reported at this site in December 1988, and about 916 tons of contaminated soil was removed in December 1989. A pump and treat/soil vapor extraction remediation system operated between December 1994 and May 1997. Assessment activities from August 1998 through May 2004 found remaining groundwater exceedances. An air sparge and soil vapor extraction remediation system was approved in July 2006 and Post Active Remediation Monitoring was performed in April and October 2007. A November 2016 Supplemental Site Assessment Report found remaining groundwater exceedances on-site and a second remediation system began operation in October 2021. A December 2023 Remedial Action Interim Report recommended a modified remedial action plan consisting of in situ chemical oxidation injection. The groundwater plume is located about 410 feet east of I-75. The depth to groundwater is reported at about 31 feet below the ground surface.

**SITE OBSERVATIONS:** The site is a vacant lot. A remediation system trailer was observed in the northern portion of the site.

Looking north at the area of the former gas station. The remediation system trailer is behind the fence in the background.

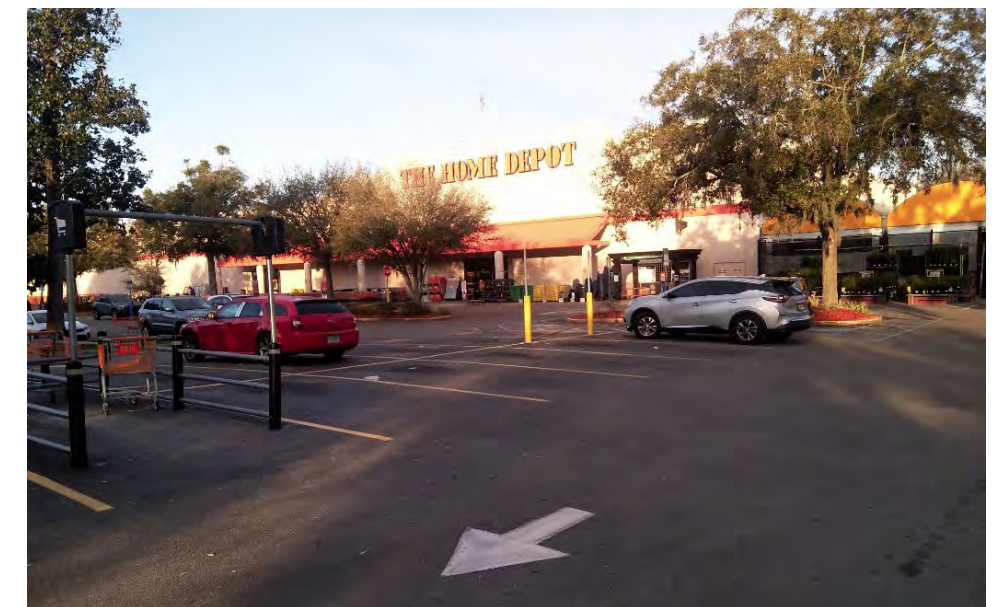
**SITE OBSERVATIONS:** The site is a retail store.

**CONCLUSIONS:** Due to the lack of recorded contamination impacts, this site has been assigned a CRR of **Low**.

Looking north at the Home Depot store.

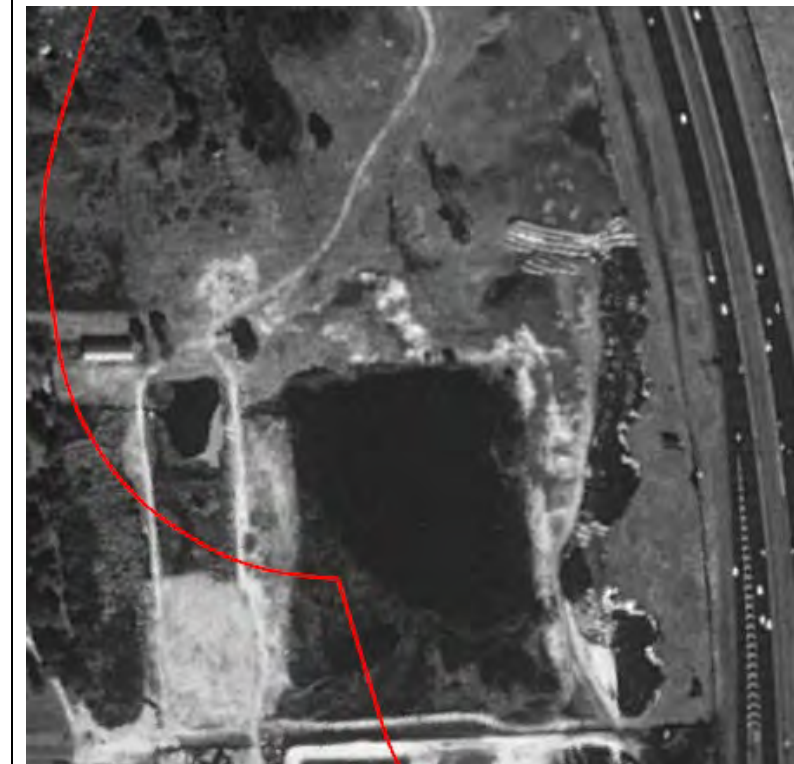
**SITE OBSERVATIONS:** No evidence of debris burial was observed in these areas.

**CONCLUSIONS:** Due to the possibility of encountering debris or hazardous materials while excavating several potential ponds, these areas have been assigned a CRR of **Medium**.

View of an area of excavation northwest of the I-75 and SR 44 interchange, on the 1995 aerial photograph.
