**CULTURAL RESOURCE ASSESSMENT SURVEY OF  
US 17/92 FROM COUNTY ROAD 54 TO WEST OF POINCIANA BOULEVARD,  
OSCEOLA AND POLK COUNTIES, FLORIDA**

**FINANCIAL MANAGEMENT No. 437200-1-22-01  
SEARCH PROJECT No. T21052**

**FLORIDA DEPARTMENT OF TRANSPORTATION, DISTRICT 5  
DELAND, FLORIDA**

**OCTOBER 2021**

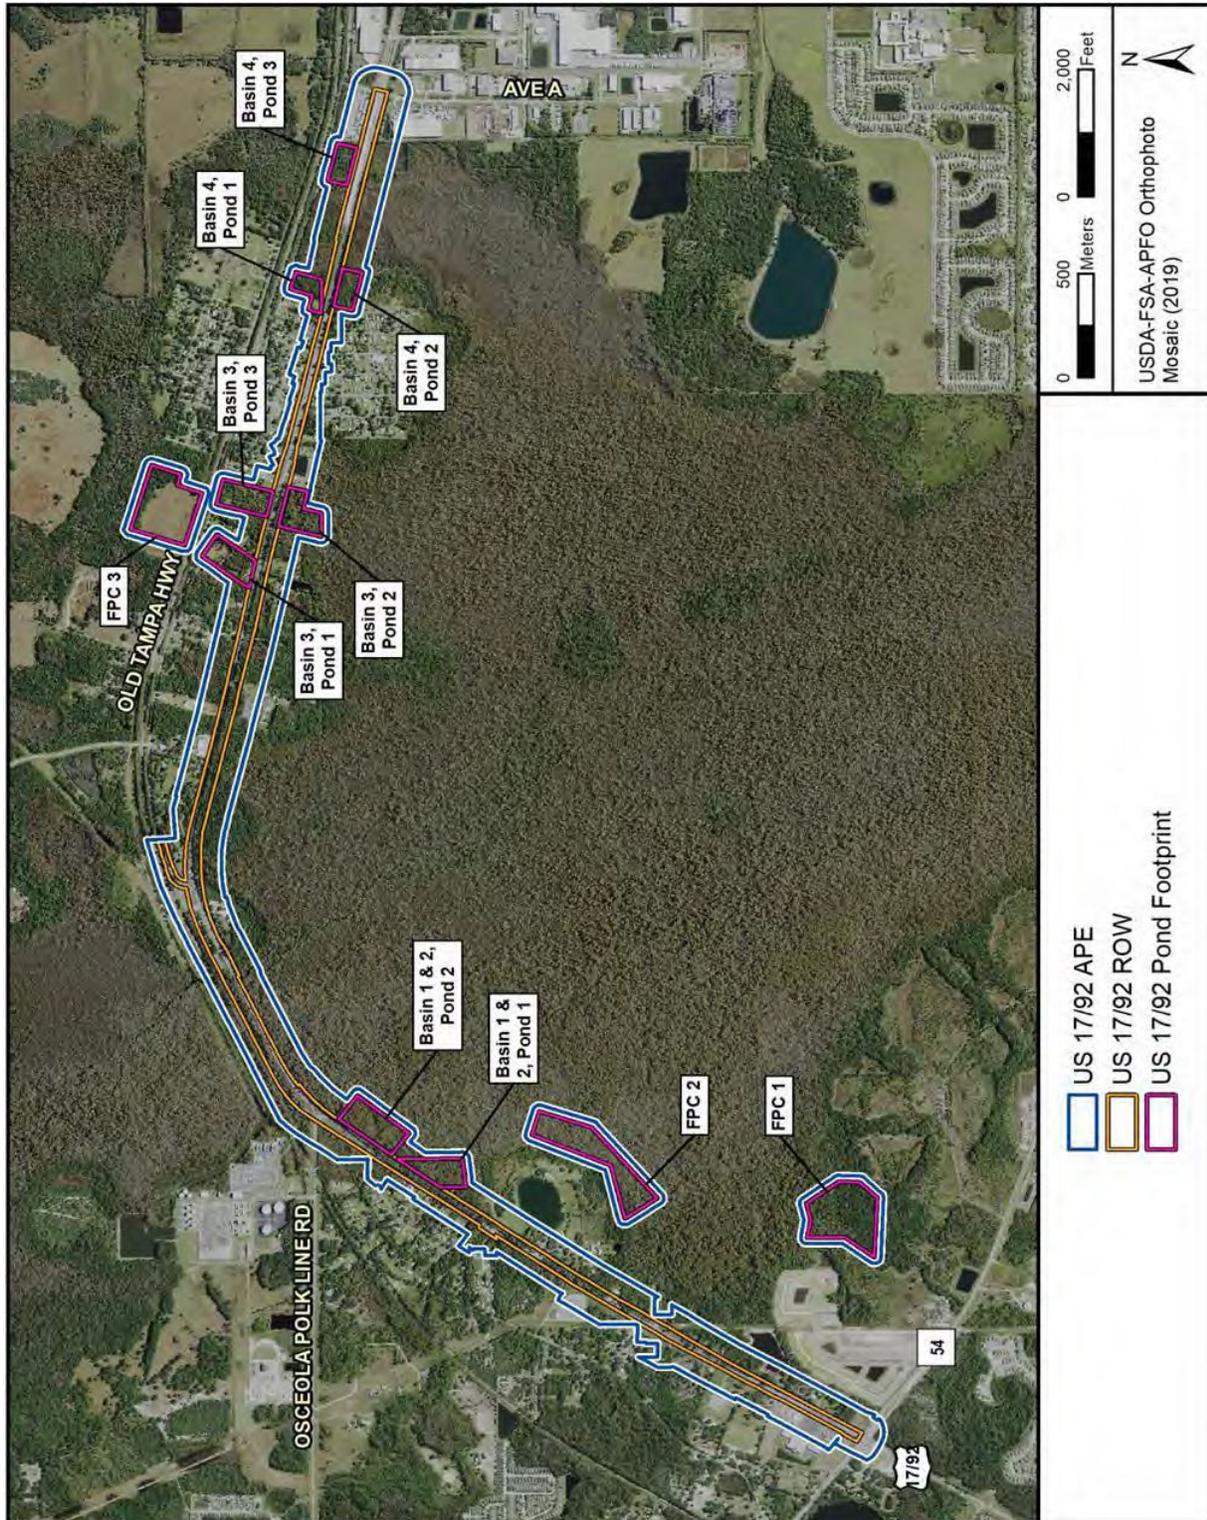
Figure 2. The US 17/92 APE and the US 17/92 Pond Footprint, Osceola and Polk Counties, Florida.

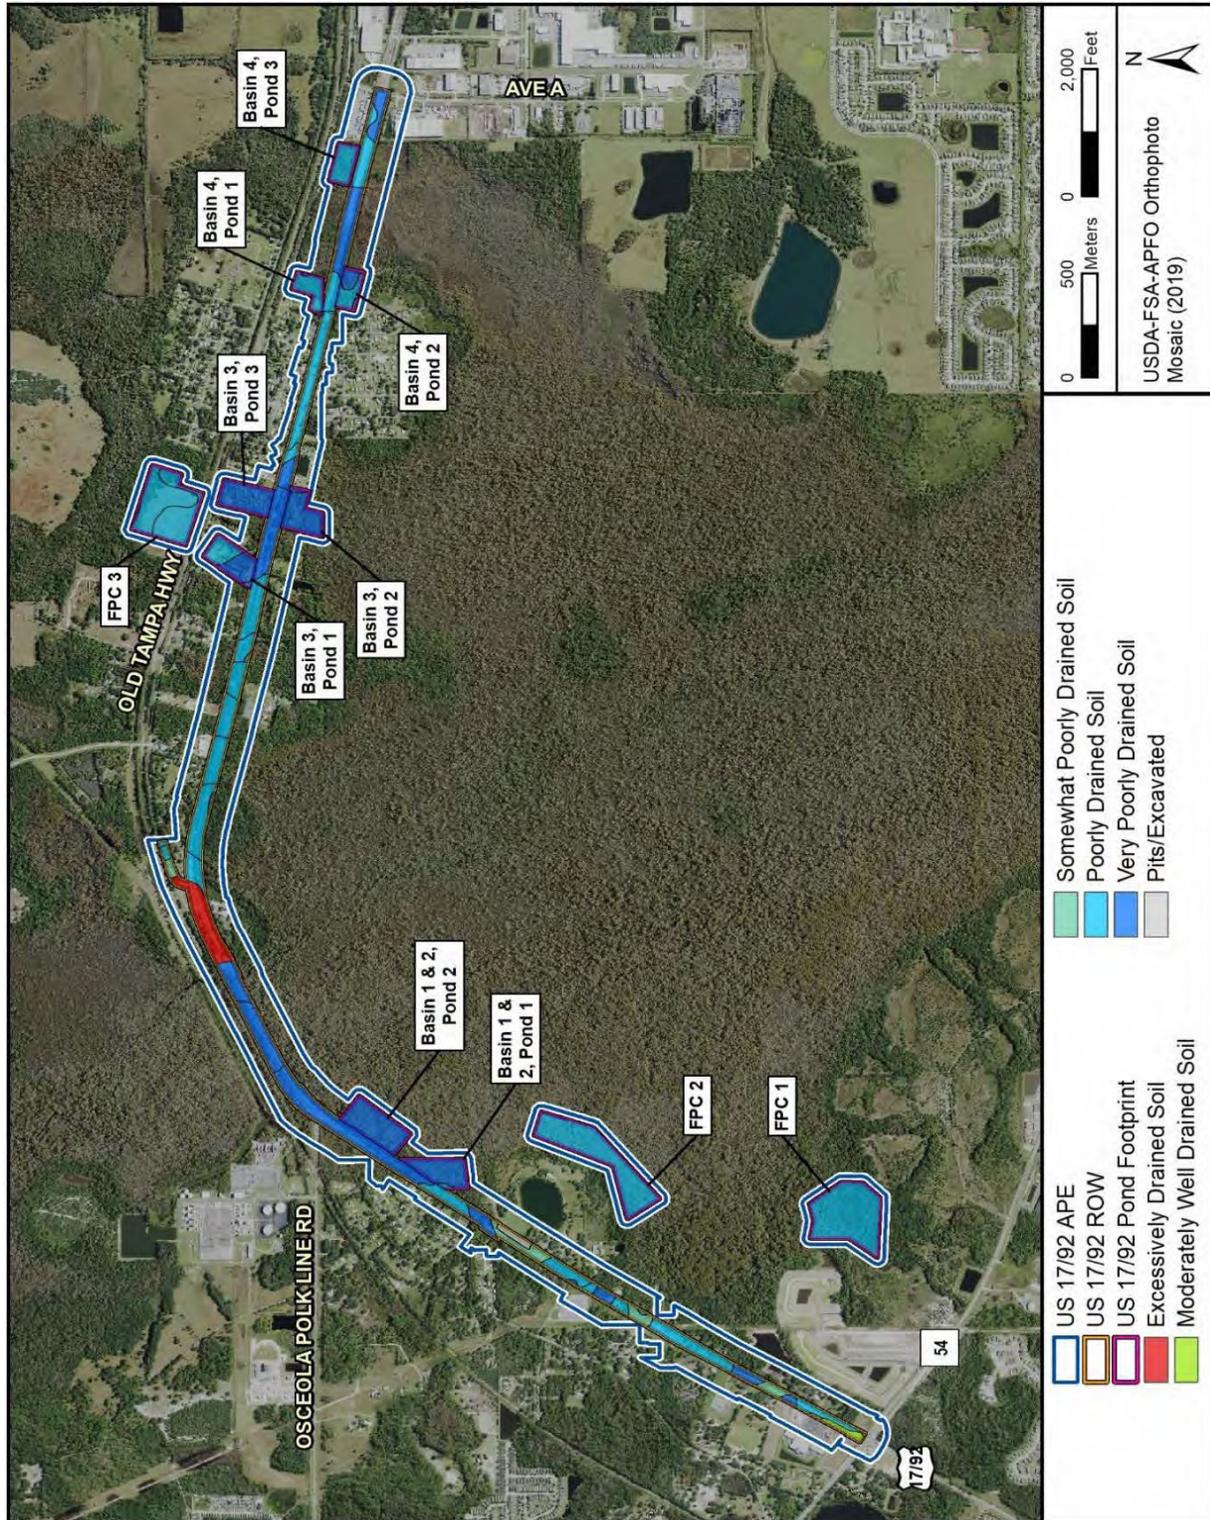
Figure 3. Soil drainage within the US 17/92 APE.

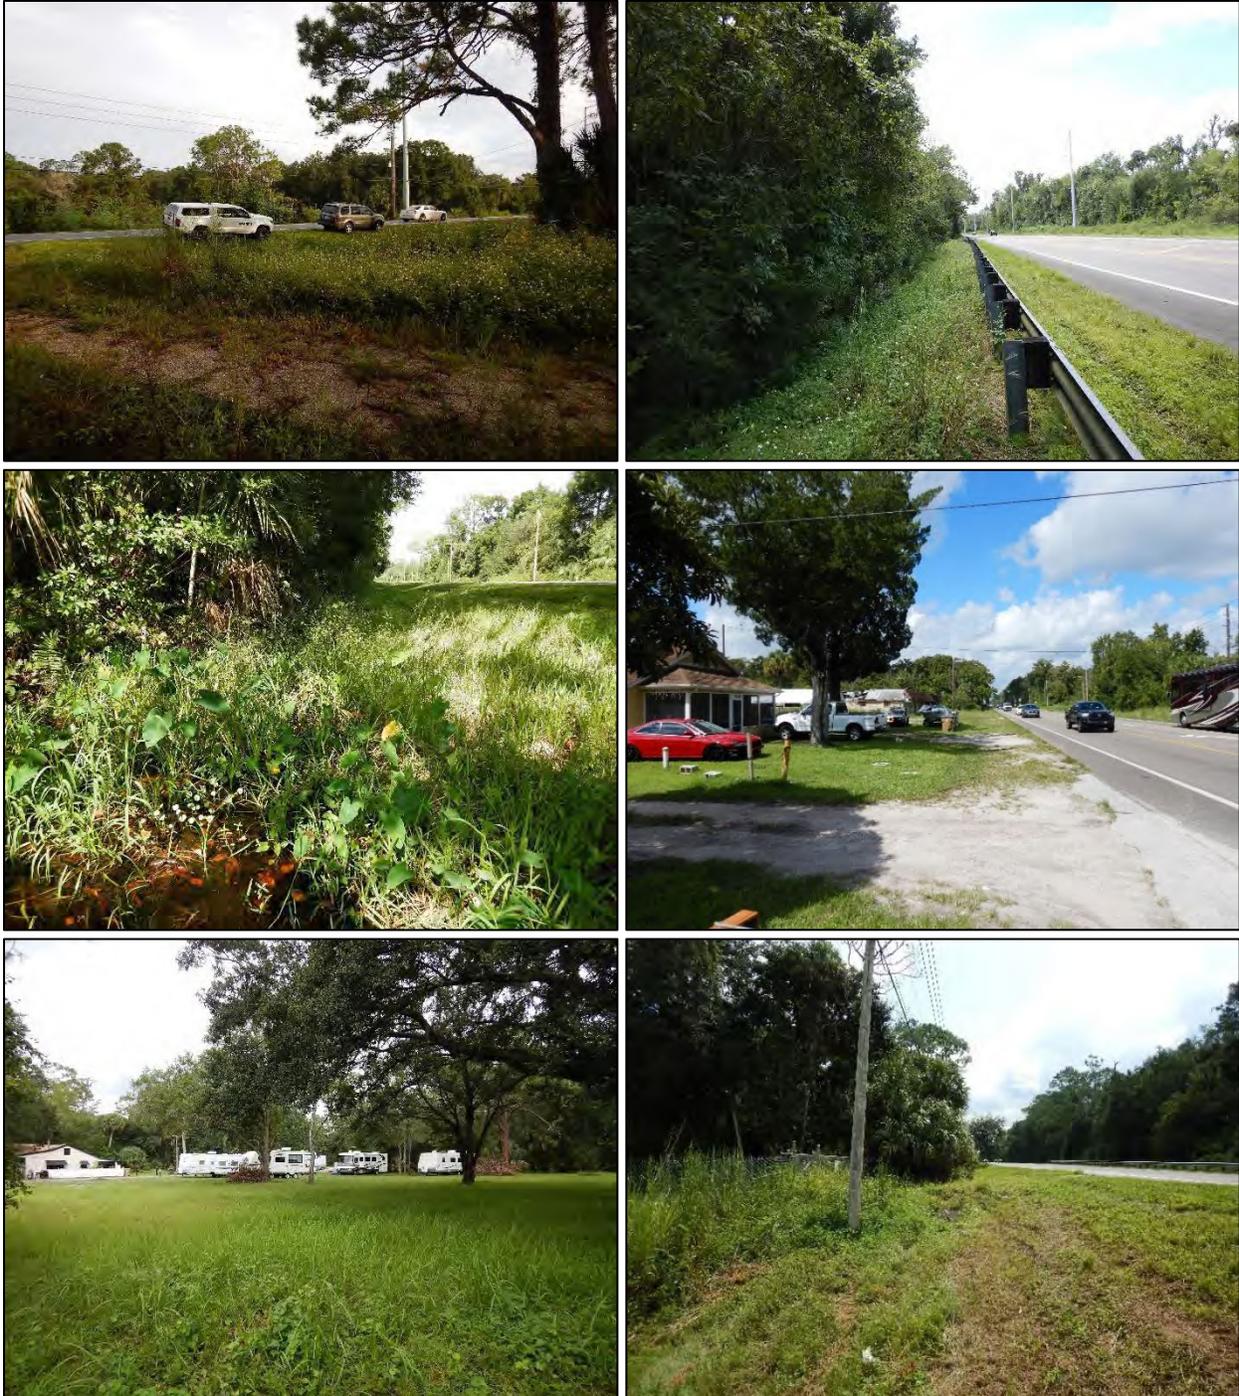
**Figure 16. Representative views of existing conditions within the US 17/92 Right-of-Way. Top left: Typical grassy wetland vegetation encountered within the US 17/92 right-of-way, facing north at Shovel Test 29. Top right: Raised roadbed and guardrail abut seasonal wetland, facing west at Shovel Test 43. Center left: Raised roadbed, inundated drainage ditch, and seasonal wetland, facing west at Shovel Test 58. Center right: Residential structures and associated development within Intercession City, facing west at Shovel Test 61. Bottom left: Cleared land and associated residential/commercial structures, facing north at Shovel Test 83. Bottom right: Raised roadbed, ditch, and overhead electric support poles adjacent to seasonal wetland, facing east at Shovel Test 87.**

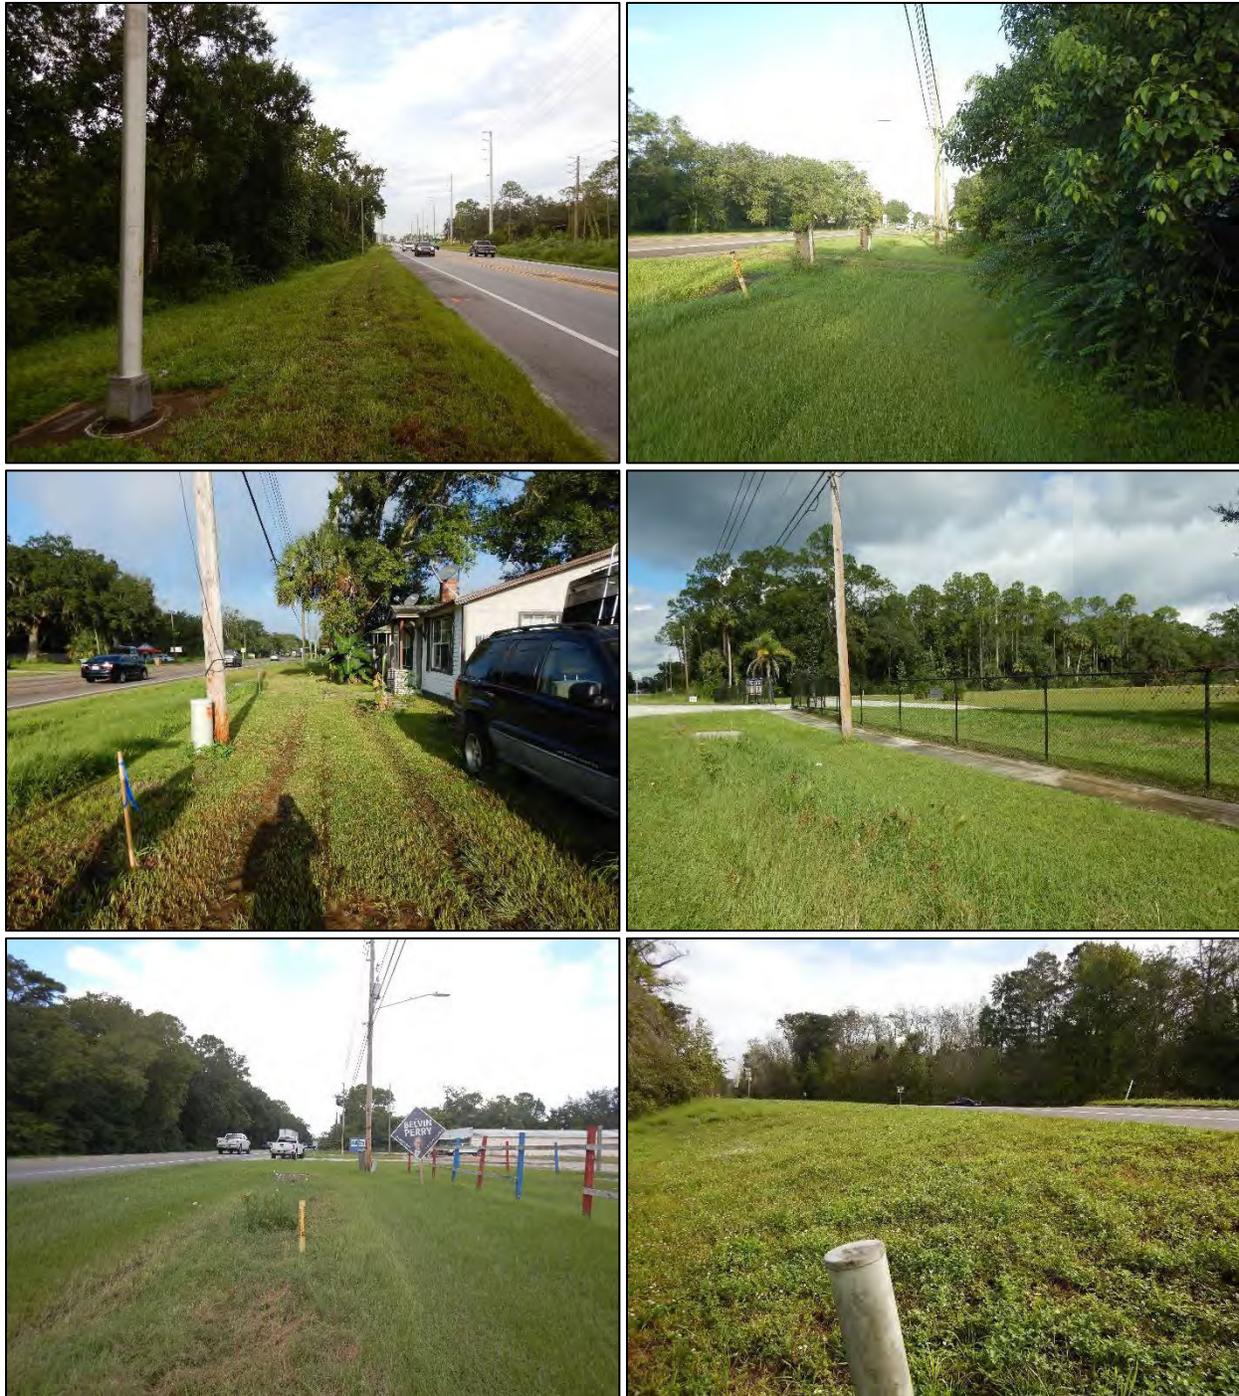
**Figure 17. Representative views of existing disturbances within the US 17/92 Right-of-Way. Top left: Lighting pole, fiber optic cable locate markings, and raised roadbed at Shovel Test 28, facing south. Top right: Gas line marker and drainage system at Shovel Test 76, facing west. Center left: Utility pedestal, overhead electric, and drainage ditch at Shovel Test 78, facing west. Center right: Overhead electric, drainage ditch, and existing sidewalk at Shovel Test 84, facing north. Bottom left: Gas line, overhead electric, and drainage ditch at Shovel Test 85, facing west. Bottom right: Utility pedestal and raised roadbed at Shovel Test 89, facing east.**

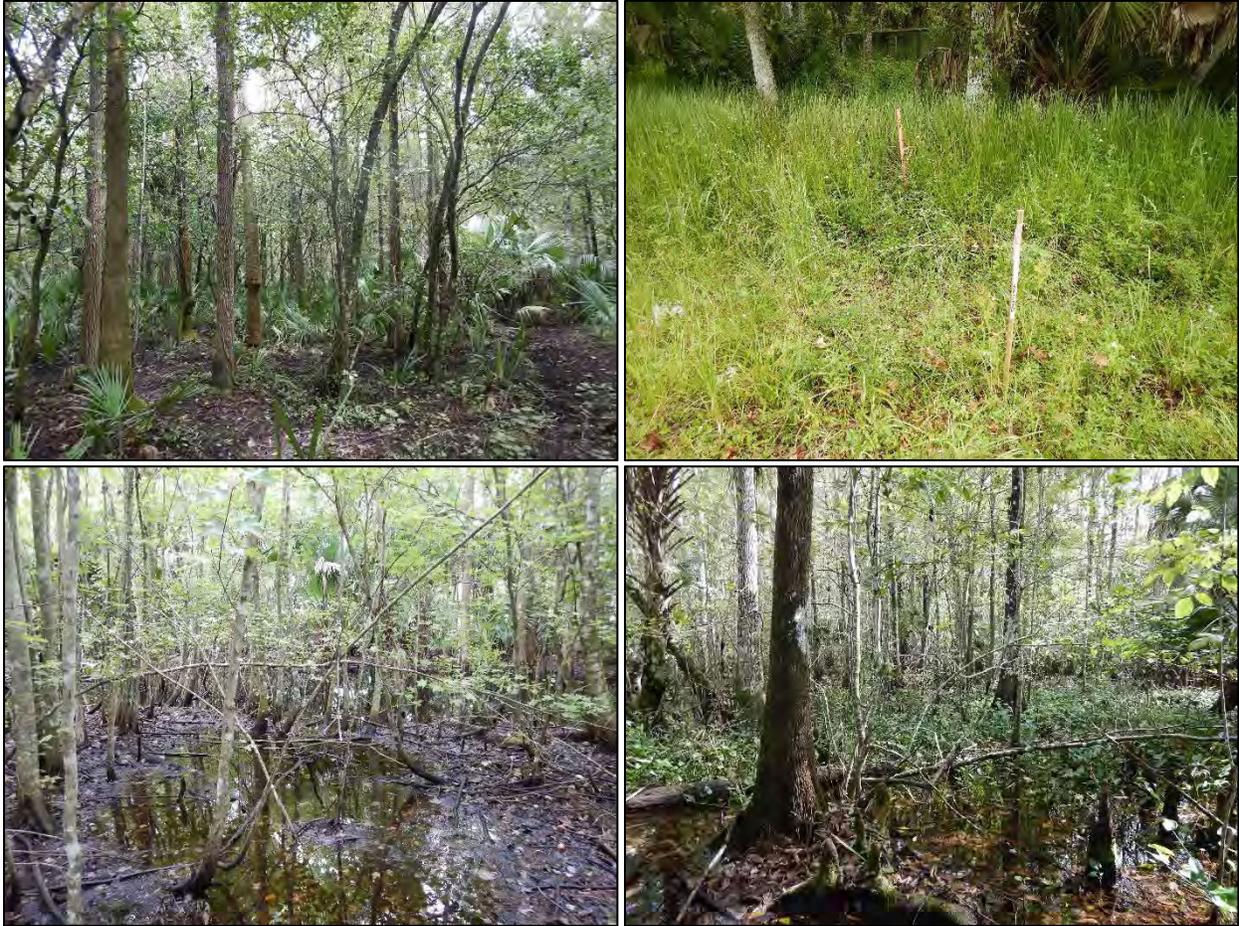
**Figure 18. Representative views of environmental conditions in proposed pond footprints. Top left: Wetland conditions in FPC 1, facing east. Top right: Wetland delineation flagging in Basin 1 and 2, Pond 1, facing southeast. Bottom left: Inundated wetland in Basin 3, Pond 1, facing east. Bottom right: Inundated wetland in Basin 3, Pond 2, facing east.**

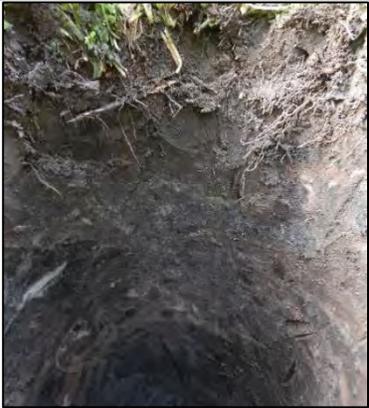
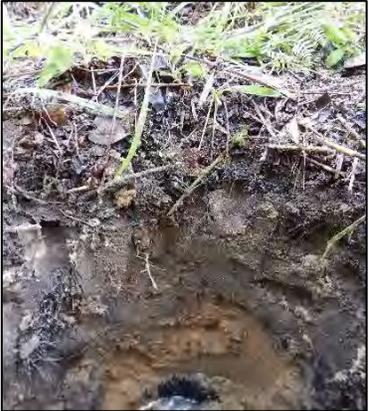
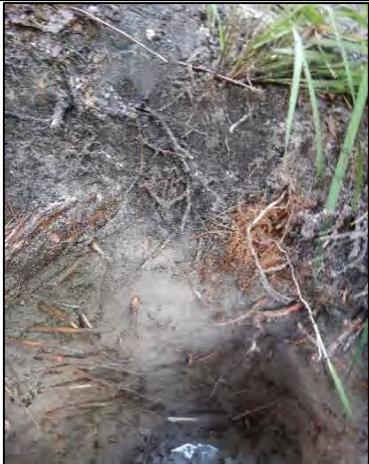
**Table 8. Representative Shovel Test Profiles that Contained Disturbed, Partially Disturbed, or Undisturbed Deposits within the US 17/92 Right-of-Way.**

Shovel Test	Soil Description			Profile
	Stratum	Soils Description	Depth (cmbs)	
76	I	Dark grayish-brown loamy sand mottled with brownish-yellow loamy sand, very dark grayish-brown loam, and light gray sand	0-100

<p>South profile</p>
	Target depth			
28	I	Dark grayish-brown coarse sandy loam (damp)	0-10

<p>West profile</p>
	II	Grayish-brown sand (damp)	10-30	
	III	Yellowish-brown sand (wet)	30-55	
	IV	Black sand (wet)	55-60	
	Water			
47	I	Black clayey loam (wet)	0-20

<p>Northwest profile</p>
	II	White coarse sand (wet)	20-45	
	Water

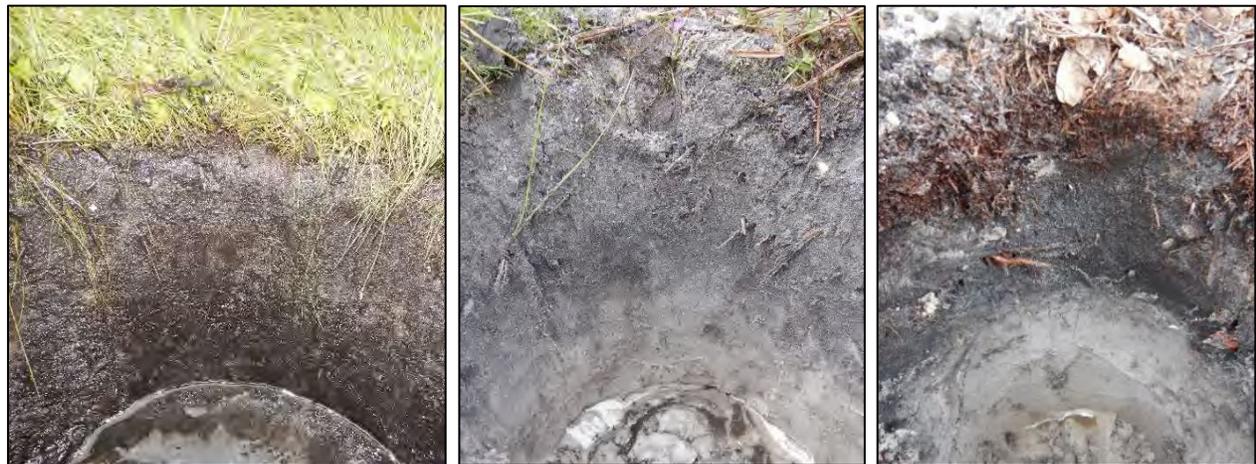
**Figure 20. Representative shovel test profiles in the US 17/92 Proposed Pond Footprint. Left: Shovel Test 12, east profile. Middle: Shovel Test 14, south profile. Right: Shovel Test 119, south profile.**

Shovel tests excavated within the proposed pond footprints generally contained consistent, undisturbed deposits (**Figure 20**). A typical profile within the pond footprints consisted of two strata: Stratum I, damp to wet dark grayish-brown to grayish-brown sand from approximately 0 to 20 cmbs (0 to 7.9 inches), and Stratum II, light gray sand from roughly 20 to 40 cmbs (7.9 to 15.7 inches). Inundation terminated testing prior to reaching the target depth. Shovel tests that contained partially or wholly undisturbed deposits within the US 17/92 Right-of-Way frequently revealed similar profiles to those encountered within the proposed pond footprints.

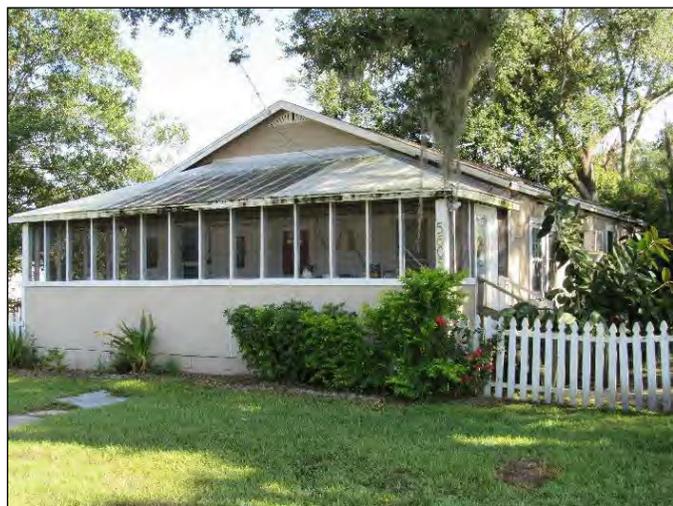
**Figure 35. Resource 8OS01744 provides an example of the Frame Vernacular style within the US 17/92 APE. Photograph facing northwest.**

There are 34 buildings within the US 17/92 APE that are considered to be Frame Vernacular in style (**Figure 35**). The Frame Vernacular style represents those “ordinary” wood frame buildings designed on a basis of local need, material availability, and tradition. The local environment and experience of the builder, often not architecturally trained, provide more influence over the end product than that of most other styles (City of Miami 2017; Glassie 1990).

- Balloon frame;
- Rectangular plan;
- One to two stories;
- Wood siding: weatherboard, drop siding, etc.; and
- Siding may have been replaced with vinyl, aluminum, asbestos shingle, etc. (City of Miami 2017).

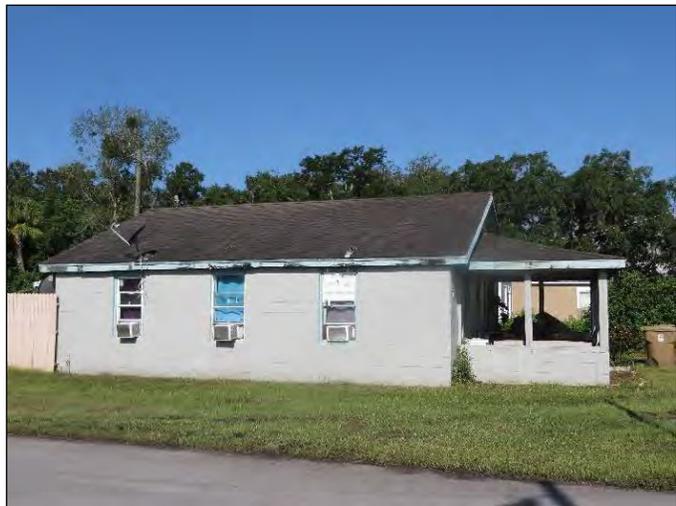
**Figure 36. Resource 8OS03166 provides an example of the Masonry Vernacular style within the US 17/92 APE. Photograph facing northwest.**

There are 30 Masonry Vernacular buildings within the US 17/92 APE (**Figure 36**). Masonry Vernacular buildings were designed on a basis of local need, material availability, and tradition. Materials of this style include brick, cement block, oolitic limestone, Ocala block, hollow clay tile, stucco, and stone, amongst others. Decoration is often sparse. However, examples of Masonry Vernacular may be influenced by a variety of high styles. Characteristics of the Masonry Vernacular style vary widely based on location, need, and experience. The style is further characterized by:

- Masonry construction;
- Simple, geometric forms;
- Relatively unadorned exterior;
- Some variation of stone, concrete, brick, or stucco as the exterior material; and
- Design meant to take advantage of the environment and site (McAlester 2013).

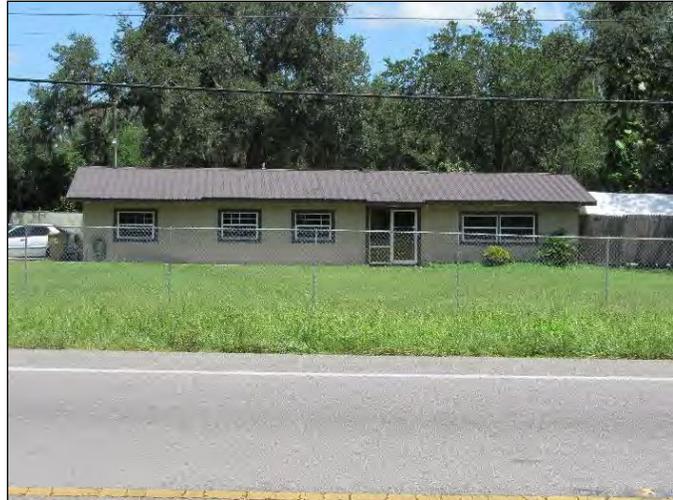
**Figure 37. Resource 8OS03120 provides an example of the Ranch style within the US 17/92 APE. Photograph facing north.**

Seven buildings within the US 17/92 APE are classified as the Ranch style (**Figure 37**). The evolution of the Ranch style had multiple centers: the Chicago area, inspired by the Prairie Houses of Frank Lloyd Wright; the American southwest, the vestiges of working ranches providing inspiration; and California, where rapid growth in the early part of the twentieth century called for a new vernacular architecture undertaking (Timberg 2005). California in the 1930s saw architects Cliff May, H. Roy Kelley, William Wurster, amongst others, adapting traditional houses

- Single story;
- Emphasis on horizontality;
- Low pitched roofs with deep set eaves;
- Set parallel to the street;
- Rectangular, L-, or U-shaped plan;
- Open plans;
- Attached garages;
- Modest stylistic details; and
- Picture windows (McAlester 2013).

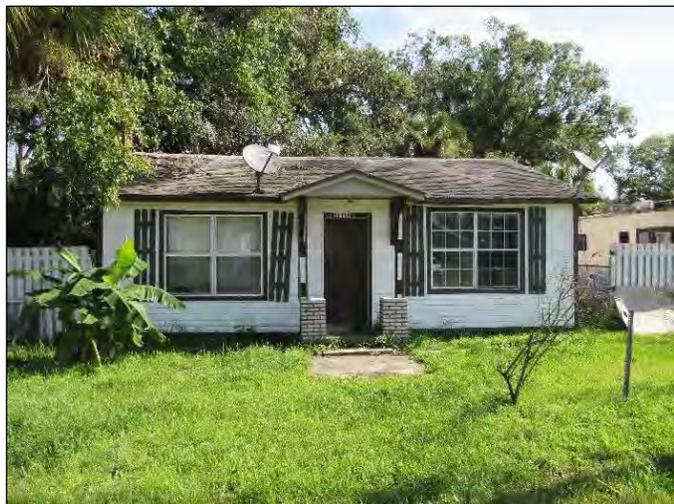
**Figure 38. Resource 8OS01743 provides an example of the Minimal Traditional style within the US 17/92 APE. Photograph facing north.**

There are six Minimal Traditional buildings within the US 17/92 APE (**Figure 38**). The Minimal Traditional style grew out of a need for small, simple, economical homes in the United States in the 1930s during the Great Depression. It was a product of the 1934 National Housing Act and the establishment of the Federal Housing Administration (FHA), which was formed to create jobs and improve housing by stimulating the construction industry.

Minimal traditional style houses were often built with the assistance of FHA-insured home loans. These houses later became a staple in housing veterans returning from World War II, due to the ease and speed of their construction. Minimal Traditional style houses were generally one-story high, took on a form based on traditional cottages and bungalows, and lacked ornamentation. Characteristics of the Minimal Traditional style include, but are not limited to:

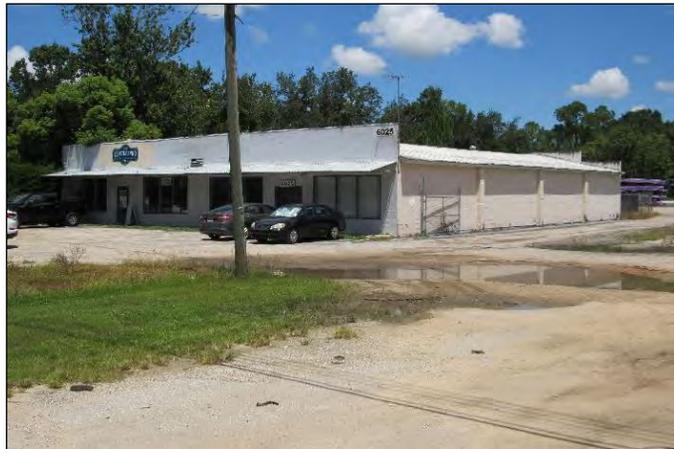
There are two Commercial style buildings within the US 17/92 APE (**Figure 39**). One type of Commercial style building is the kind found in smaller downtowns and along main streets. Well-kept commercial buildings signified economic prosperity, and they were often used by towns and small cities to project a more cosmopolitan or big city feel. This often led to a lack of regional differences in commercial districts. Because commercial districts often had abutting resources, the façade facing the main street was often the only façade that contained elaboration other than that needed for

**Figure 39. Resource 80S03123 provides an example of the Commercial style within the US 17/92 APE. Photograph facing northwest.**

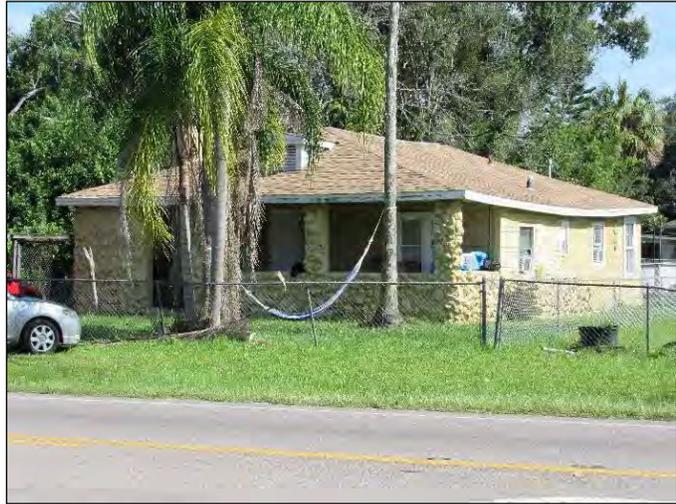
One building within the US 17/92 APE is classified as Craftsman in style (**Figure 40**). The Craftsman style, popular from roughly 1900 to 1930, is an elaborated type of Bungalow, distinguished by its detail, workmanship, and its particular leaning towards the Arts and Crafts Movement. The Arts and Crafts Movement was a rejection of the machine processes of the Industrial Age. Beginning in England, the ideas behind the movement were championed in the mid- to late 1800s by people such as Augustus Pugin, John Ruskin, and William Morris (Obniski 2008; Victoria and Albert Museum 2016). Emphasis was placed upon workmanship, materiality, and the custom, handmade product. Furthermore, a simplicity that went against the excess of the Victorian age was promoted (Gray n.d.; Obniski 2008).

**Figure 40. Resource 8OS01742 provides an example of the Craftsman style within the US 17/92 APE. Photograph facing northwest.**

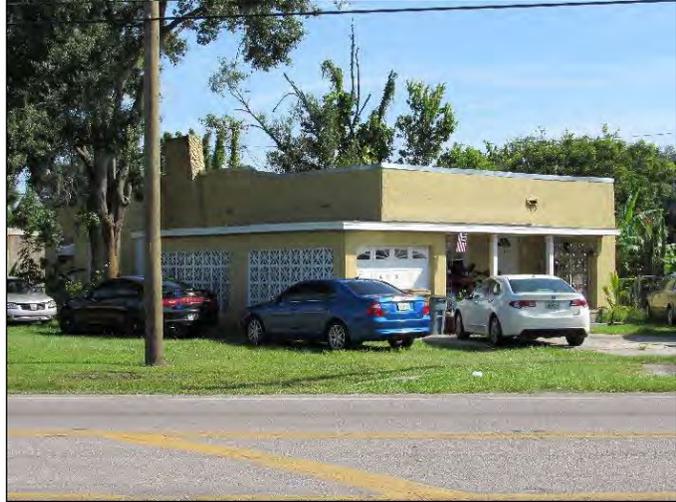
**Figure 41. Resource 8OS01741 provides an example of the Mediterranean Revival style within the US 17/92 APE. Photograph facing north.**

One building within the US 17/92 APE is classified as Mediterranean Revival in style (**Figure 41**). Florida was one of the first states where the Mediterranean Revival style gained popularity, and

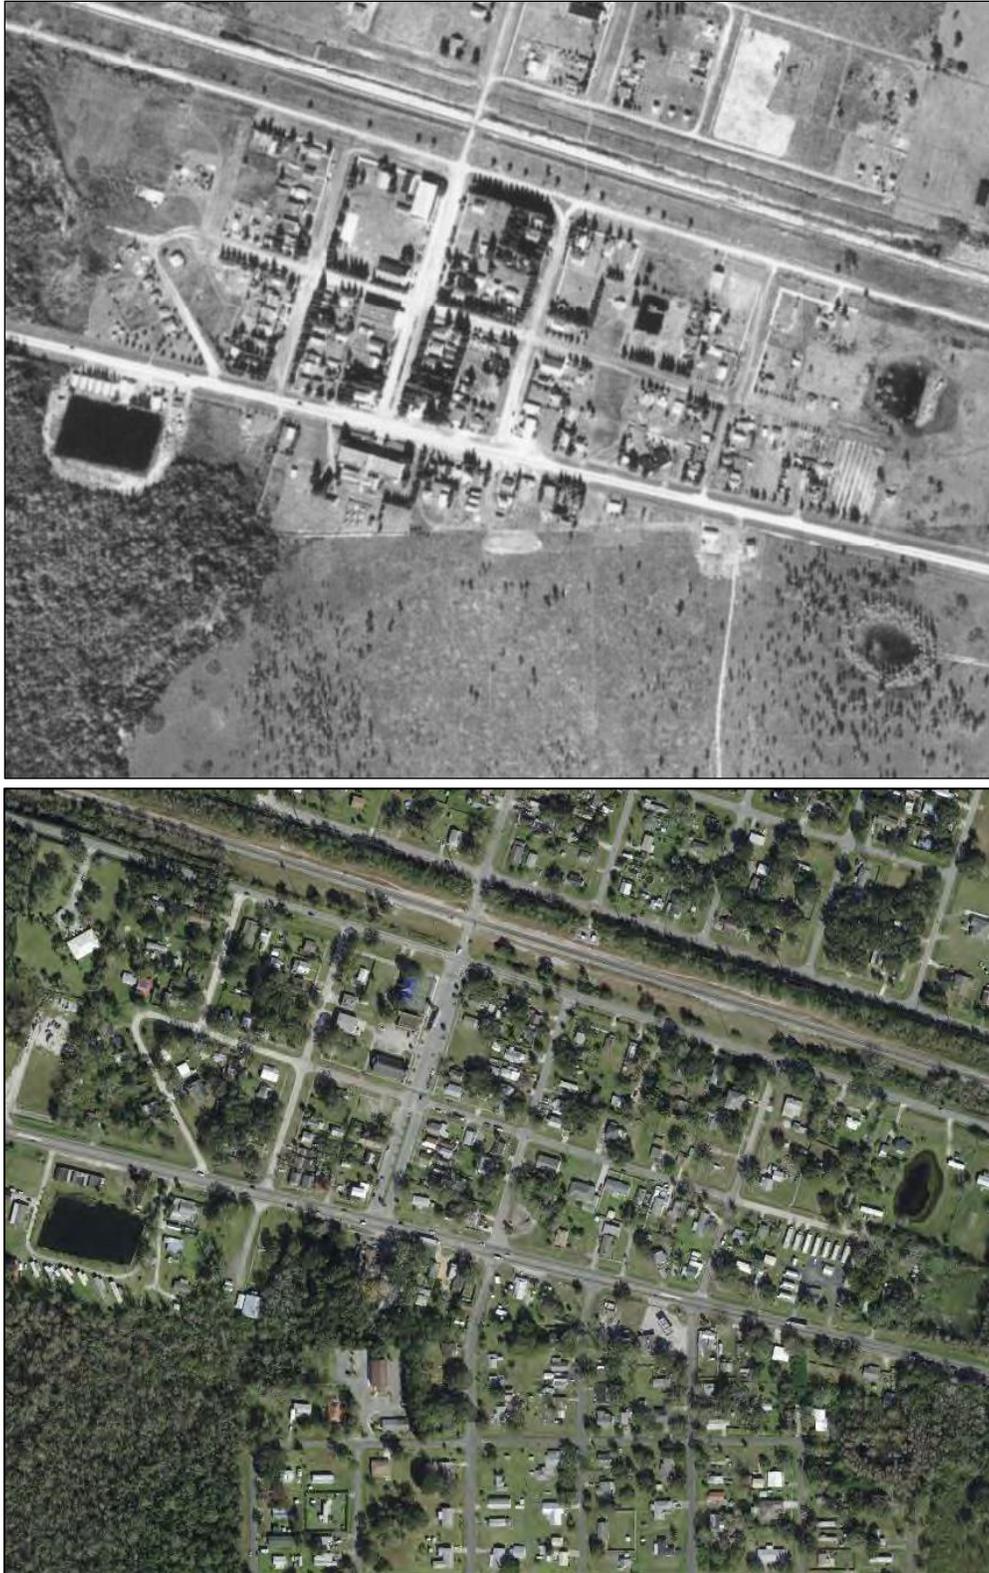
**Figure 42. Comparison of 1951 and 2020 USDA aerial photographs, illustrating both the significant number of early Intercession City structures that have since been demolished, as well as substantial later period growth.**

A comparison of 1951 and 2020 US Department of Agriculture (USDA) aerial photographs (**Figure 42**) indicates that almost all of the notable structures built during the Interocean City period and the period of the religious community have since been demolished. These include the Interocean City/Intercession City Hotel (which was renamed England Hall as part of the Intercession City Bible College), the Interocean City/Intercession City Administration Building (which house the library and chapel), the Music Emporium and Prayer Chapel, the prayer cabins, and others. The church is one of the only substantial structures remaining from the community's earlier history, prior to the period of decline that began in the 1950s.

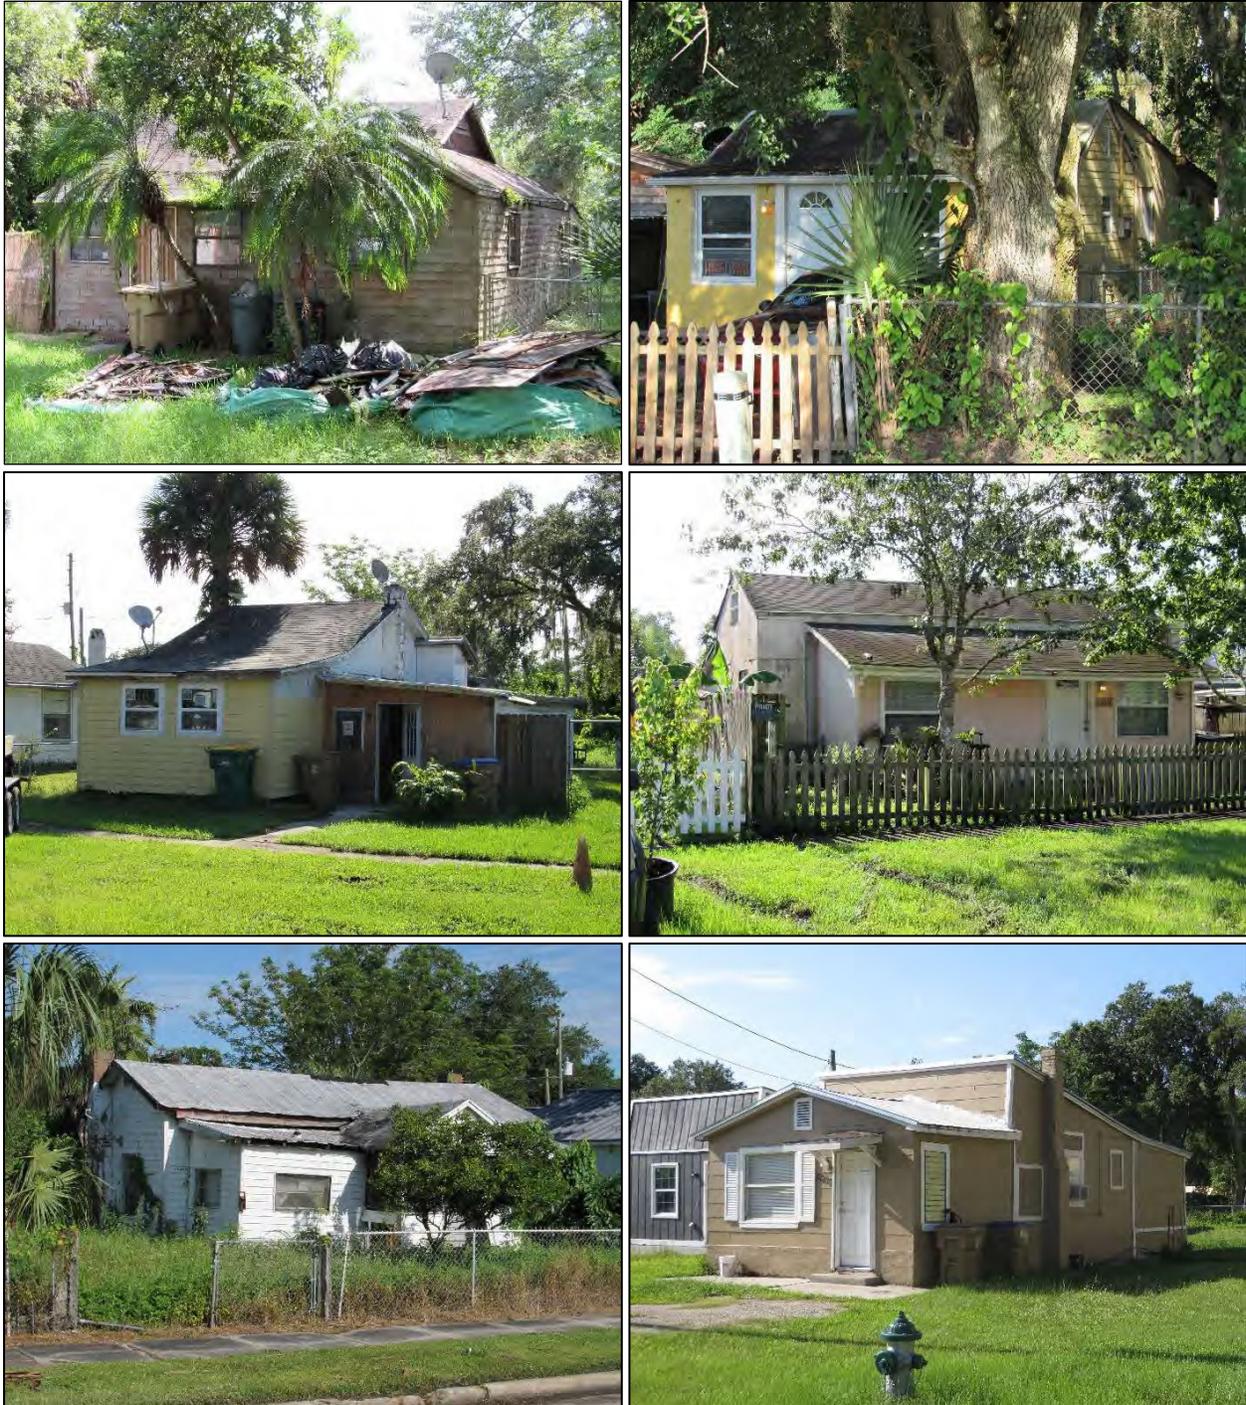
**Figure 43. Representative views of historic residences documented within Intercession City. Top left: Resource 8OS03138, ca. 1939. Top right: Resource 8OS03142, ca. 1940. Middle left: Resource 8OS03148, ca. 1944. Middle right: Resource 8OS03150, ca. 1944. Bottom left: Resource 8OS03151, ca. 1945. Bottom right: Resource 8OS03155, ca. 1945.**

left many of these small residences void of most of their historic materials and original appearance (**Figure 43**). Furthermore, there have been numerous demolitions throughout Intercession City, leaving abundant vacant parcels and parcels with non-historic structures or mobile homes intermixed among the altered historic residences (**Figure 44**). As a result, the community has lost its historic character and feeling, and the area no longer conveys a visual sense of its overall historic environment. For these reasons, it is the opinion of SEARCH that the community of Intercession City does not retain sufficient historic significance or historic integrity necessary to meet the requirements for NRHP eligibility as a historic resource group. As such, SEARCH did not record the community within the APE as a resource group as part of this project.

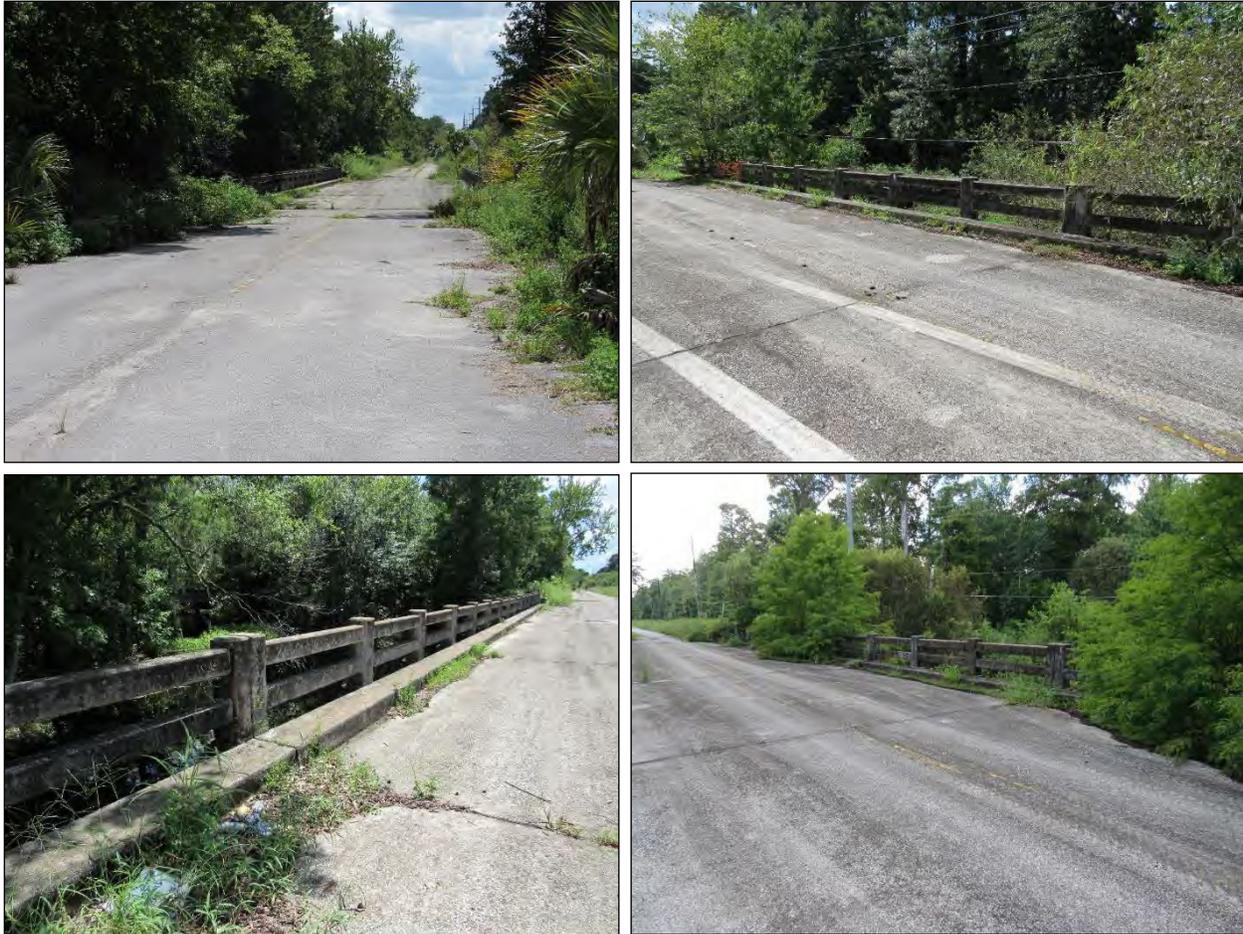
**Figure 45. Representative views of Resource Group 8OS03182 and contributing Resources 8OS01747–8OS01749. Top left: Resource 8OS01747, facing southwest. Top right: Resource 8OS01748, facing west. Bottom left: Resource 8OS01749, facing southwest. Bottom right: Resource 8OS1749, facing west.**

Resource 8OS03182 (South Orange Blossom Trail Bridges) is a collection of three previously recorded historic bridges (Resources 8OS01747-8OS01749) built in close proximity to each other along an abandoned section of US 17/92 (see **Figure 33**). These three bridges were originally recorded in 1994 and were determined not eligible for inclusion in the NRHP by the SHPO (FAS 1994). Resources 8OS01747, 8OS01748, and 8OS01749 (FDOT Bridge Nos. 920004, 920003, and 920002, respectively) are located west of the unincorporated community of Intercession City in Osceola County, Florida. They carry an abandoned section of US 17/92 east-west over the Reedy Creek in Section 32 of Township 25 South, Range 28 East, as shown on the 2021 *Intercession City, Fla.* USGS quadrangle map. This section of road was originally designated as SR 2 and was part of the original US 17/92 highway prior to the construction of the new 2002 alignment, and FDOT Bridge Nos. 920004, 920003, and 920002 have not been structurally inspected since construction of this new alignment. As these three bridges have not been inspected since approximately 2002, the FDOT cannot attest to their structural integrity (FDOT, personal communication 2021). This closed segment of US 17/92 has an overall length of 0.69 miles (1.1 kilometers). The length of roadway, including the three bridges, is approximately 1,470 feet (447.9 meters), which defines the boundary of Resource 8OS03182. As these bridges are similar in design and were constructed as an assemblage, they are discussed as a group here. Resources 8OS01747, 8OS01748, and 8OS01749 are respectively seven-span, five-span, and six-span bridges. The ca. 1938 bridges are constructed of cast-in-place concrete decks supported by steel girders resting atop capped pile wood piers (**Figure 45**). Resources 8OS01747, 8OS01748, and 8OS01749 are 175.6 feet (53.5 meters), 125.6 feet (38.2 meters), and 150.6 feet (45.9 meters) in length, respectively. The deck width edge-to-edge of the bridges are 26 feet (7.9 meters) wide, and the roadway carried by the bridges is 25 feet (7.6 meters) wide. There is a post and lintel concrete railing on either side of the bridges. Improvements to the bridges are apparent, including the addition of W-beam steel guardrails on either side of the roadway attached to the bridges. The bridges' date of construction is stamped on the end posts, and the FDOT bridge numbers are affixed to the railings or end posts. Beyond the stamped 1938 construction dates and bridge numbers, each bridge has no exceptional distinguishing architectural details or identifying signs.

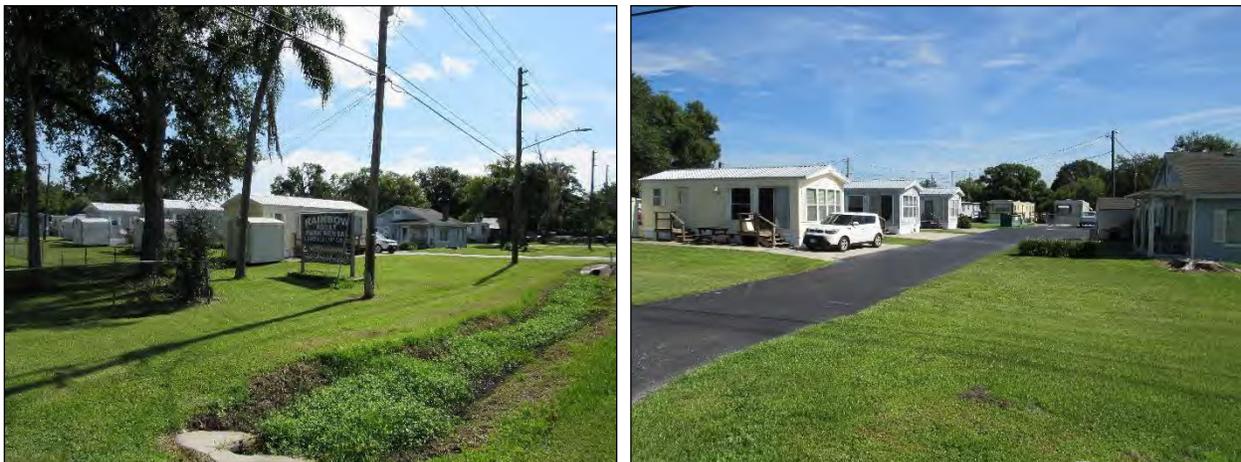
**Figure 46. Representative views of Resource 8OS03183. Left: Facing northeast. Right: Facing northwest.**

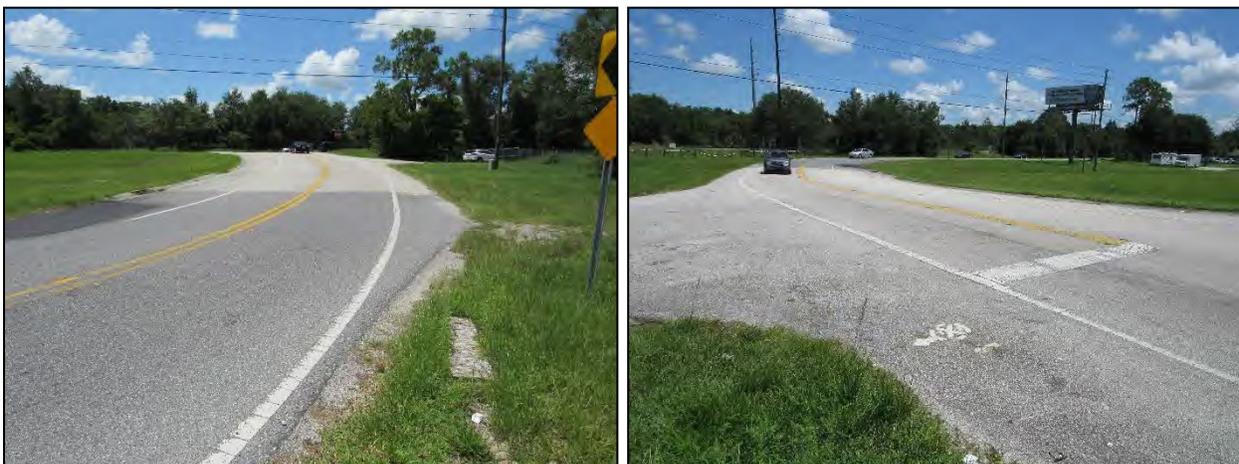
**Figure 47. Representative views of 8OS02567. Left: Facing south toward US 17/92. Right: Facing north from US 17/92.**

approximately 0.25 miles (0.4 kilometers) within the APE, starting at US 17/92 and running briefly north before turning and continuing northwest (**Figure 47**).

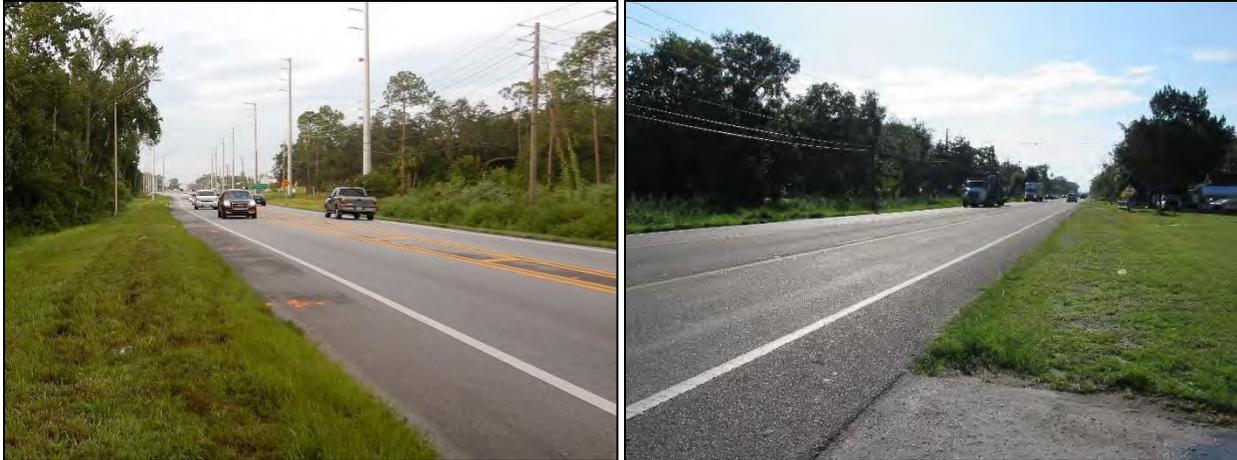
**Figure 49. Representative views of US Highway 17/92 within the APE. Left: Polk County segment (8PO08622) facing south. Right: Osceola County segment (8OS02796) facing east.**

through Intercession City toward the eastern end of the APE. Approximately 5.05 miles (8.12 kilometers) of US 17/92 is located within the APE, with roughly 4.11 miles (6.61 kilometers) of the resource within Osceola County (8OS02796), and 0.94 miles (1.51 kilometers) of the resource in Polk County (8PO08622) (**Figure 49**).

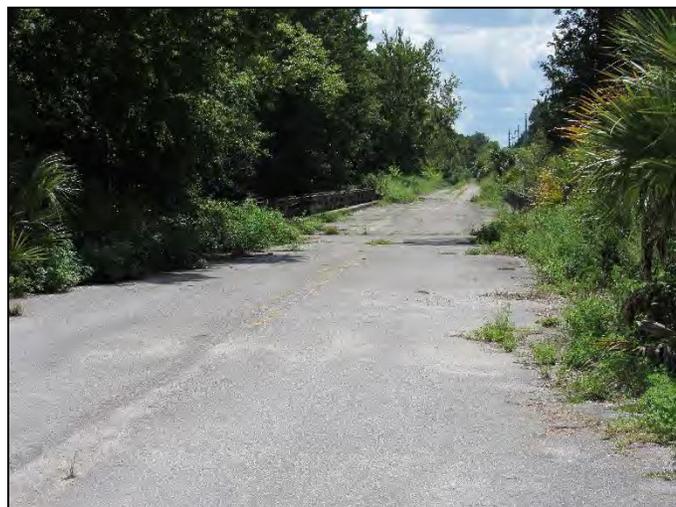
US 17 was one of the original routes of the US Highway system, which was established in 1926. The original southern end of the route was in Jacksonville, Florida, with the northern terminus in Fredericksburg, Virginia. In 1932, the southern end of US 17 was extended to its present terminus at US 41 in Punta Gorda, Florida (Sanderson 2016). In the vicinity of the project APE, US 17 initially utilized the Old Tampa Highway as its route. US 92, which was plotted out between Daytona

**Figure 50. Representative view of the abandoned segment of US Highway 17/92 (8OS02796/8PO08622) within the APE. One of the original 1938 bridges (8OS01747) is visible a short distance down the roadway.**
