**CULTURAL RESOURCE ASSESSMENT SURVEY OF  
US 17/92 FROM COUNTY ROAD 54 TO WEST OF POINCIANA BOULEVARD,  
OSCEOLA AND POLK COUNTIES, FLORIDA**

**FINANCIAL MANAGEMENT No. 437200-1-22-01  
SEARCH PROJECT No. T21052**

**FLORIDA DEPARTMENT OF TRANSPORTATION, DISTRICT 5  
DELAND, FLORIDA**

**OCTOBER 2021**

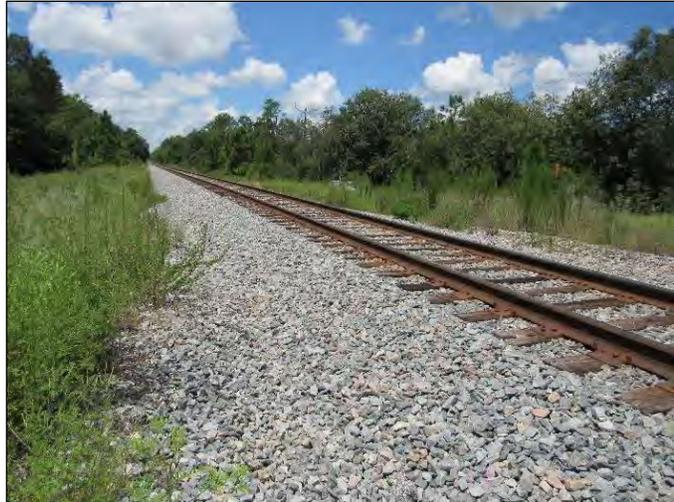
The development of the South Florida Railroad was originally established with the charter of the Lake Monroe and Orlando Railroad in 1875, with the surveyed section constructed in 1884 (SEARCH 2017). In 1879, a new charter for the railroad was acquired from the St. Johns River to Charlotte Harbor along the Gulf of Mexico, and the name was changed to the South Florida Railroad. In 1880, the railroad extended 23 miles (37 kilometers) from Sanford to Orlando, and by 1882, it was further extended to Kissimmee. In 1883, a three-fifth interest of the railroad was sold to Henry Plant, who intended to extend the line to Tampa Bay (Pettengill 1998:41). The extension to Tampa occurred at a fast rate upon Plant taking a three-fifth interest, as the land grant allowing the rail line to be built from Kissimmee to Tampa was close to expiration (Turner 2008). The line to Tampa, including the segment within the US 17/92 APE, opened in 1884. In the late nineteenth century, the Port of Tampa was the largest phosphate shipping terminal in the world and connected Tampa to regional and national markets (Turner 2008:126). Presently, the railroad is still in active use by CSX.

**Figure 51. Representative view of 8OS02540/8PO07219, facing southwest.**

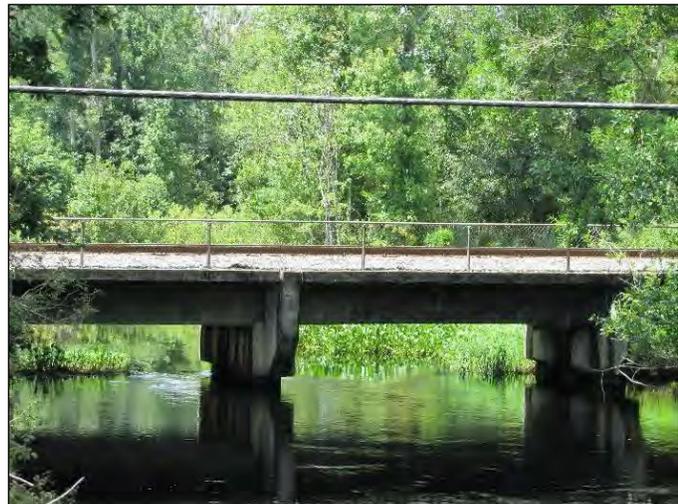
**Figure 52. Resource 8OS03176, facing north.**

Resource 8OS03176 is a newly recorded bridge located in Osceola County (see **Figure 33**). The bridge carries the South Florida Railroad (8OS02540) southwest to northeast over Reedy Creek in Section 32 of Township 25 South, Range 28 East, as shown on the 2018 *Intercession City, Fla.* USGS quadrangle map. Resource 8OS03176 is a four-span prestressed concrete tee beam bridge with a total length of 140 feet (42.67 meters) (**Figure 52**). It was constructed ca. 1950 and is currently part of the CSX railroad network. The bridge is constructed of a concrete deck supported by concrete girders resting atop concrete piers. The deck is approximately 17 feet (5.18 meters) wide, and the railbed is approximately 9.0 feet (2.74 meters) wide. There is a chain-link fence on either side of the railway, attached to the bridge with metal posts. The bridge has no distinguishing details or identifying signs.

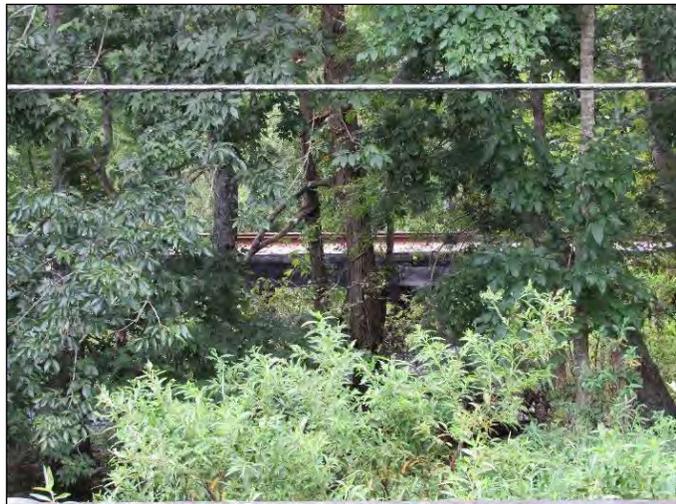
**Figure 53. Resource 8OS03177, facing northwest.**

Resource 8OS03177 is a newly recorded bridge located in Osceola County (see **Figure 33**). The bridge carries the South Florida Railroad (8OS02540) southwest to northeast over Reedy Creek in Section 32 of Township 25 South, Range 28 East, as shown on the 2018 *Intercession City, Fla.* USGS quadrangle map. Resource 8OS03177 is a three-span beam and girder bridge with a total length of approximately 61 feet (18.59 meters) (**Figure 53**). It was constructed ca. 1950 by CSX. The bridge is constructed of wood beams supported by wood girders resting atop wood piers. The deck is approximately 17 feet (5.18 meters) wide, and the railbed is approximately 9.0 feet (2.74 meters) wide. The bridge has no distinguishing details or identifying signs.

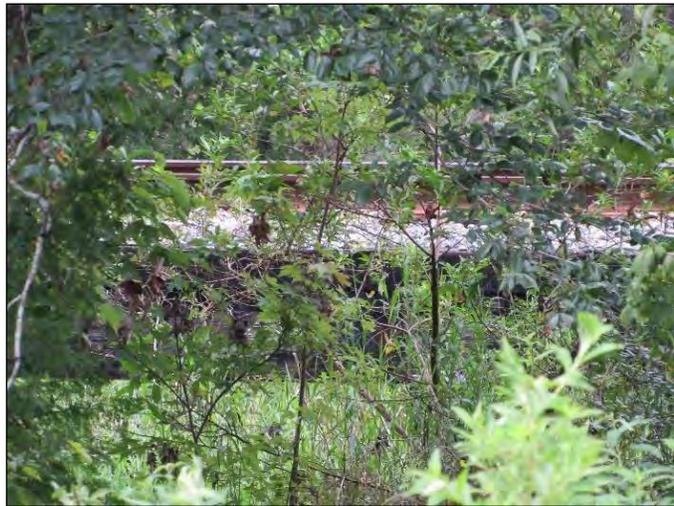
**Figure 54. Resource 8OS03178, facing north.**

Resource 8OS03178 is a newly recorded bridge located in Osceola County (see **Figure 33**). The bridge carries the South Florida Railroad (8OS02540) southwest to northeast over Reedy Creek in Section 32 of Township 25 South, Range 28 East, as shown on the 2018 *Intercession City, Fla.* USGS quadrangle map. Resource 8OS03178 is a four-span beam and girder bridge with a total length of approximately 120 feet (36.56 meters) (**Figure 54**). It was constructed ca. 1950 by CSX. The bridge is constructed of wood beams supported by wood girders resting atop wood piers. The deck is approximately 17 feet (5.18 meters) wide, and the railbed is approximately 9.0 feet (2.74 meters) wide. The bridge has no distinguishing details or identifying signs.

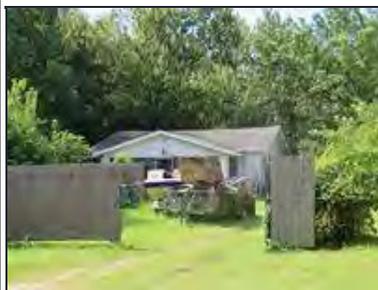
**Distinguishing Features:** Gable vent above porch, raked eaves, small concrete course at the gable line. The foundation is obscured by a fence, boat, and trailer.

**Evaluation:** Due to lack of sufficient historic significance and architectural distinction, 80S01733 is ineligible for listing in the NRHP, either individually or as part of a district. Resource 80S01733 was recommended ineligible in March 1994, SHPO concurred.

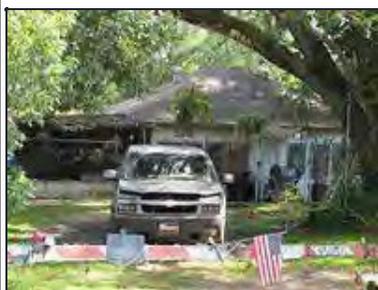
**Distinguishing Features:** Metal awning portico with decorative metal posts. Foundation is obscured by potted plants, a large tree, and parked car.

**Evaluation:** Due to lack of sufficient historic significance and architectural distinction, 80S01734 is ineligible for listing in the NRHP, either individually or as part of a district. Resource 80S01734 was recommended ineligible in March 1994, SHPO concurred.

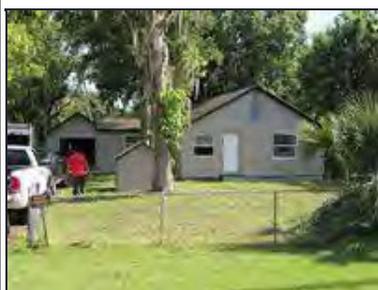
**Distinguishing Features:** Gable vents, closed eaves, lattice wood foundation skirting, meal roof ridge.

**Evaluation:** Due to lack of sufficient historic significance and architectural distinction, 80S01735 is ineligible for listing in the NRHP, either individually or as part of a district. Resource 80S01735 was recommended ineligible in March 1994, SHPO concurred.

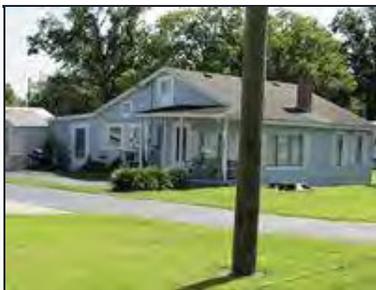
**Foundation:** Slab  
**Roof:** Gable/Shed  
**Main Entry:** Wood door w/ 9 upper lights, 2 lower panels w/ metal storm door  
**Porch(es):** Open, partial width porch on the western façade with a hipped roof supported by wood posts.  
**Windows:** DHS 1/1 wood-framed; Jalousie, aluminum-framed; picture window, aluminum-framed  
**Distinguishing Features:** Window and vent under gable end, faux shutters, vinyl corner boards  
**Ancillary Features:** Prefabricated vinyl shed south of dwelling. Office associated with trailer park on parcel.

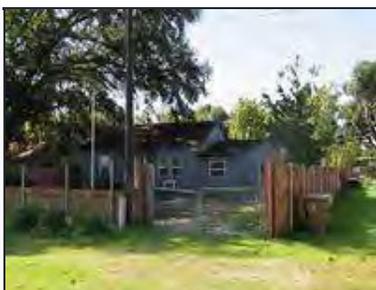
**Foundation:** Piers  
**Roof:** Gable  
**Main Entry:** Wood door with one upper light and two lower panels covered by metal storm door on N façade  
**Porch(es):** Small, gable portico with brackets supporting the gable and a concrete slab approach above main entry on N façade  
**Windows:** SHS 1/1 vinyl-framed  
**Distinguishing Features:** Gable vents, large windows casings, closed eaves  
**Ancillary Features:** Wood fence N or bldg w/chain link fence leading to dirt driveway

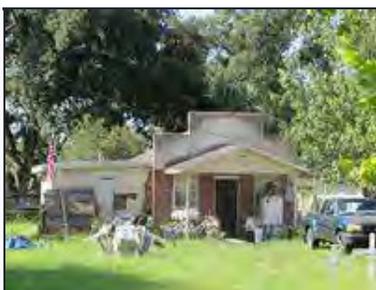
**Foundation:** Unknown  
**Roof:** Gable/Shed  
**Main Entry:** Metal door, six panels  
**Porch(es):** Open porch with a gable roof supported by wood posts on the northeast façade  
**Windows:** SHS 4/4 & 6/6 vinyl-framed  
**Distinguishing Features:** Large parapet rear of front porch gable roof, with brick below and stucco over the gable. Foundation obscured by furniture and section of fence.  
**Ancillary Features:** Fence, two white crosses, and trees N of bldg.

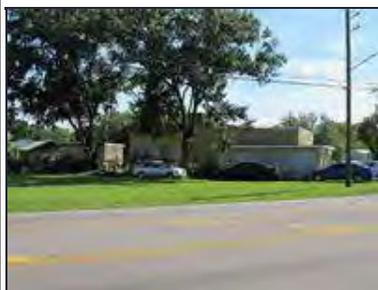
**Distinguishing Features:** S facing garage with molded concrete blocks, faux stone design on chimney

**Evaluation:** Due to lack of sufficient historic significance and architectural distinction, 8OS01741 is ineligible for listing in the NRHP, either individually or as part of a district. Resource 8OS01741 was recommended ineligible in March 1994, SHPO concurred.

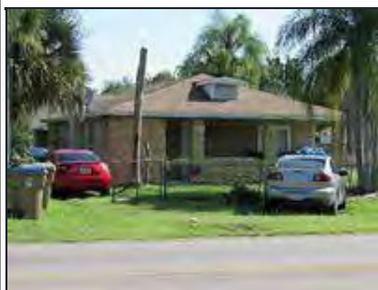
**Distinguishing Features:** Dormer above porch, rough, original stone facing on S facade around porch columns and walls. Metal chimney cap.

**Evaluation:** Due to lack of sufficient historic significance and architectural distinction, 8OS01742 is ineligible for listing in the NRHP, either individually or as part of a district. Resource 8OS01742 was recommended ineligible in March 1994, SHPO concurred.

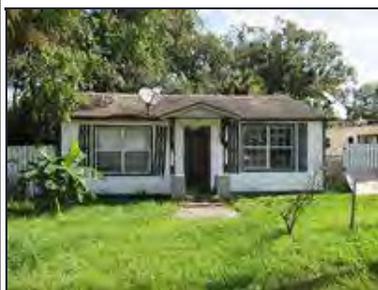
**Distinguishing Features:** Decorative wood posts set on brick columns supporting portico roof, brackets under portico, chimney, N shed roof extension.

**Evaluation:** Due to lack of sufficient historic significance and architectural distinction, 8OS01743 is ineligible for listing in the NRHP, either individually or as part of a district. Resource 8OS01743 was recommended ineligible in March 1994, SHPO concurred.

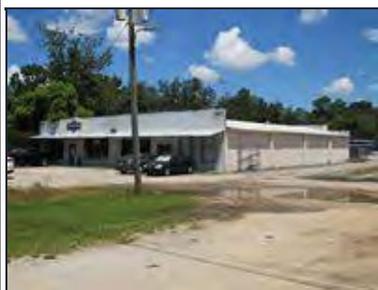
**Distinguishing Features:** Parapets on the north and south façade, three buttresses on the E façade, two units divide the bldg

**Evaluation:** Due to lack of sufficient historic significance and architectural distinction, 80S03123 is ineligible for listing in the NRHP, either individually or as a contributing resource within a potential or existing historic district.

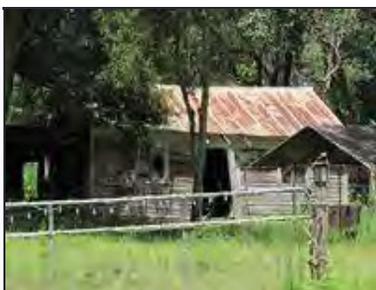
**Distinguishing Features:** Exposed rafters, missing entry way, foundation obscured by overgrown vegetation

**Evaluation:** Due to lack of sufficient historic significance and architectural distinction, 80S03130 is ineligible for listing in the NRHP, either individually or as a contributing resource within a potential or existing historic district.

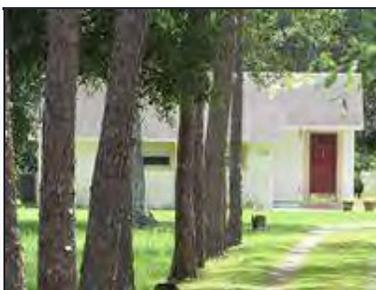
**Distinguishing Features:** Stucco on all sides, and vertical wood siding on a small section on N façade, large casing around windows and doors

**Evaluation:** Due to lack of sufficient historic significance and architectural distinction, 80S03131 is ineligible for listing in the NRHP, either individually or as a contributing resource within a potential or existing historic district.

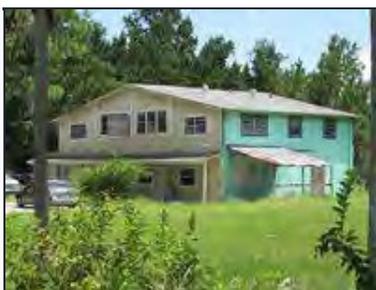
**Distinguishing Features:** Decorative vertical wood under gable ends, plywood covering doors and windows on N and W façade, exterior staircase on E façade

**Evaluation:** Due to lack of sufficient historic significance and architectural distinction, 80S03132 is ineligible for listing in the NRHP, either individually or as a contributing resource within a potential or existing historic district.

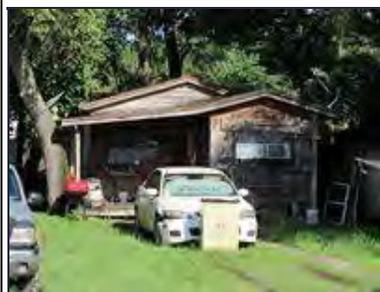
Rear end addition; Partially enclosed porch

**Foundation:** Piers

**Foundation Material:** Brick

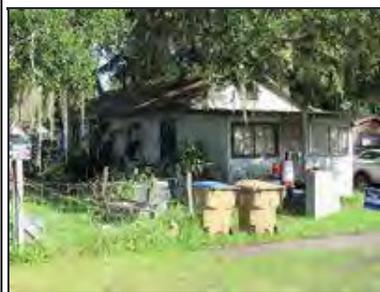
Enclosed porch, metal windows

**Foundation:** Piers

**Foundation Material:** Concrete Block

**Distinguishing Features:** Gable vents, metal awnings, enclosed porch clad in T1-11; wood lattice skirting around foundation

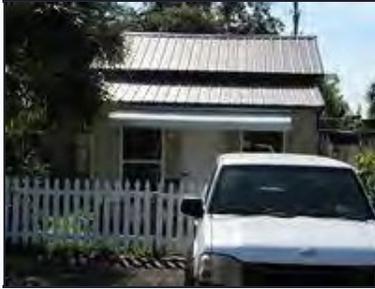
E façade addition; Replaced windows/doors/siding

**Foundation:** Unknown

**Foundation Material:** Obscured

**Distinguishing Features:** Metal awning, enclosed front porch, chimney on N facade. A fence obscures the foundation.

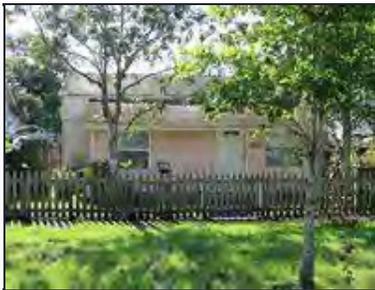
NW & SE shed roof additions; Replacement door & windows

**Foundation:** Unknown

**Foundation Material:** Obscured

**Distinguishing Features:** Corner board on SW façade corner. Fence and vegetation obscures view to the foundation.

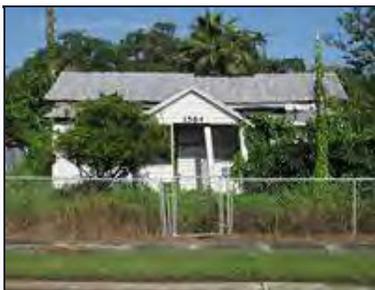
SE porch addition; UNK Siding replaced

**Foundation:** Unknown

**Foundation Material:** Obscured

**Distinguishing Features:** In a deteriorated condition, overgrown vegetation obscures foundation. Chimney on S façade

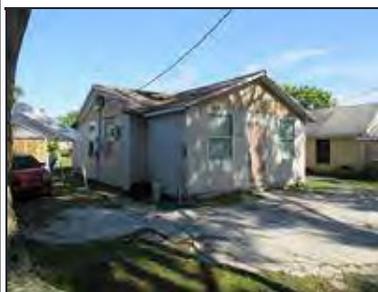
W façade shed roof addition; Doors and windows replaced

**Foundation:** Piers

**Foundation Material:** Concrete Block

**Distinguishing Features:** Asbestos siding under gable ends, plywood slightly obscures foundation. Original weatherboard siding can be found on the S façade a hole in stucco.

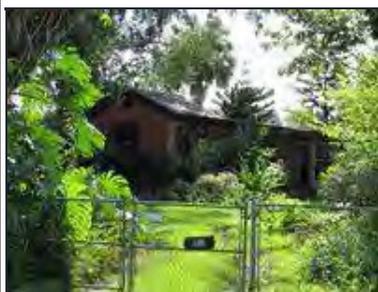
**Distinguishing Features:** Gable vents, metal awnings, decorative wood posts support portico entryway, exposed rafter tails. Metal flue on S elevation

**Ancillary Features:** Chain link fence W on bldg, forested parcel. Overgrown vegetation obscures view to foundation.

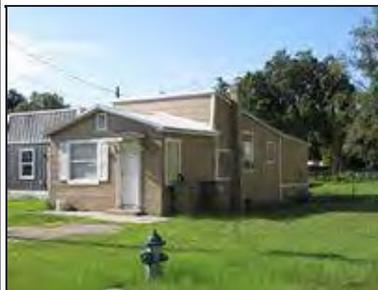
Two, S façade additions; Windows/door replaced

**Foundation:** Unknown

**Foundation Material:** Obscured

**Distinguishing Features:** The residence is arranged as a gable to large, steeply pitched roof shed configuration. Foundation is obscured by stucco.

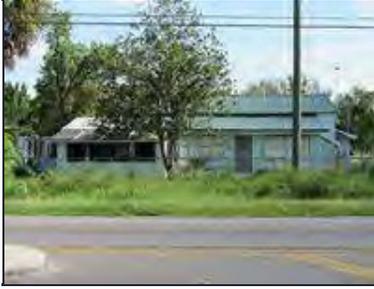
**Foundation Material:** Obscured

**Foundation:** Unknown

**Roof Material:** Sheet metal:5V crimp

**Distinguishing Features:** Metal awnings; two entryways, one E and one S with vinyl storm doors. Foundation obscured by overgrown vegetation.

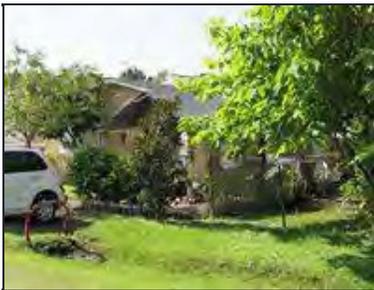
**Foundation Material:** Concrete Block

**Foundation:** Piers

**Roof Material:** Composition shingles

**Distinguishing Features:** Wood lattice foundation skirting, large window and door casings, metal flue vent toward N on original block

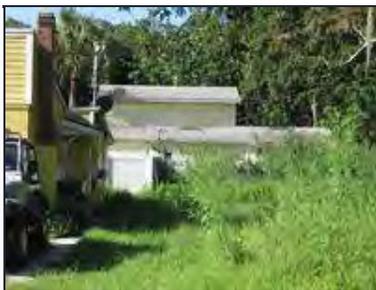
E addition; Vinyl window

**Foundation:** Unknown

**Foundation Material:** Obscured

**Distinguishing Features:** Irregular plan with additions to create an L shaped lower level, but no upper level additions. Foundation is obscured by vinyl fence.

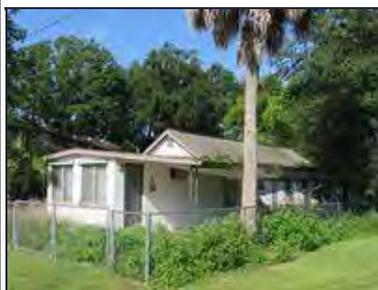
**Structural System:** Concrete block  
**Exterior Fabric:** Stucco

**Foundation:** Unknown  
**Roof:** Gable  
**Main Entry:** Metal door with jalousie window on N façade  
**Porch(es):** None observed from public right of way

**Foundation Material:** Obscured  
**Roof Material:** Composition shingles

**Distinguishing Features:** Shallow gable E addition w/ shed roof carport, carport supported by decorative metal post assemblies. Overgrown vegetation blocks foundation

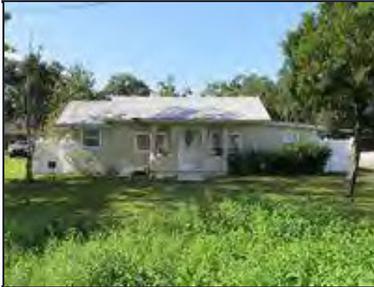
W gable add., E shed add.; Doors, windows replaced

**Foundation:** Unknown

**Foundation Material:** Obscured

**Distinguishing Features:** Plaster quoins on N facade on the E & W corners. Porch arcade w/3 arches. Shed roof additions to S & W, gable add. to W. Stucco obscures foundation.

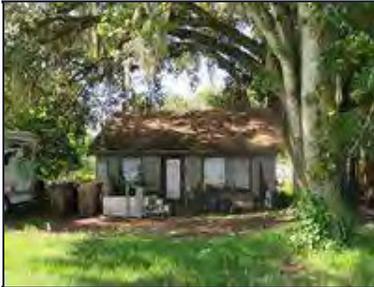
**Additions and Alterations:** None

**Foundation:** Unknown

**Foundation Material:** Obscured

**Distinguishing Features:** Drop siding on gable ends, gable vents, large casing around windows and doors. Foundation obscured by planted box and items.

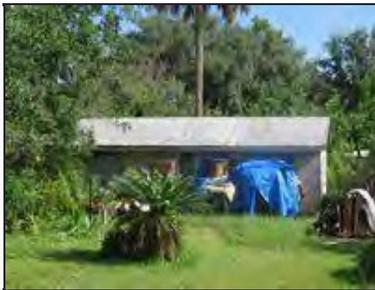
**Structural System:** Concrete block  
**Exterior Fabric:** Concrete block

**Foundation:** Unknown  
**Roof:** Gable

**Foundation Material:** Obscured  
**Roof Material:** Sheet metal:3V crimp

**Main Entry:** Wood door obscured by metal storm door w/ Jalousie window on S façade  
**Porch(es):** None observed from public right of way

**Distinguishing Features:** Metal roof ridge. Items and overgrown grass obscures the foundation.

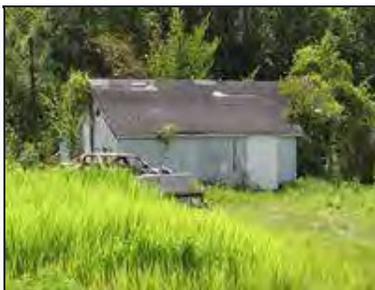
**Foundation Material:** Obscured

**Foundation:** Unknown

**Roof:** Gable

**Distinguishing Features:** Corner boards, barge board, boarded windows and entryway. Foundation obscured by vegetation.

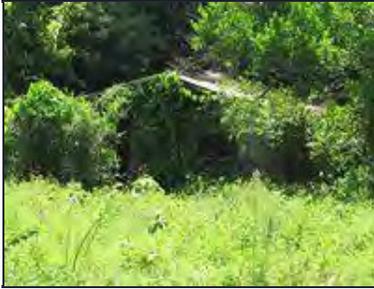
**Foundation:** Unknown

**Foundation Material:** Obscured

**Distinguishing Features:** Metal roof ridge, corner boards. Vegetation is growing over the N facade of the structure and is obscuring the foundation.

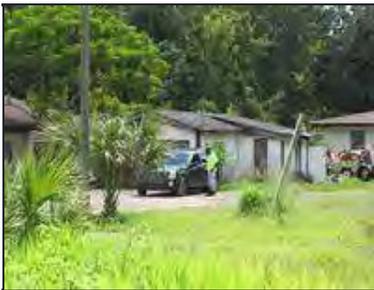
S façade addition

**Foundation:** Unknown

**Foundation Material:** Obscured

**Distinguishing Features:** Prominent barge board, large rear gable, corner boards. Foundation obscured by vegetation and parked cars.

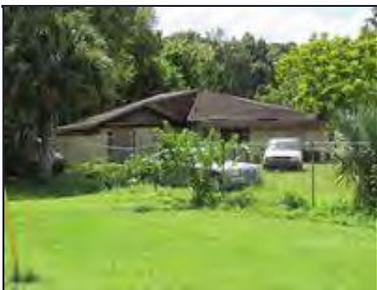
<h1>8PO08199</h1>	<p><b>Name:</b> 6703 US Highway 17/92 N Building 3</p> <p><b>Original or Update:</b> Update      <b>US Quad Map:</b> DAVENPORT (2021)</p>	<p><b>Built:</b> ca. 1972</p> <p><b>TRS:</b> 26S28E6</p>
<p><b>Original Use:</b> Private Residence  <b>Style:</b> Masonry Vernacular  <b>Additions and Alterations:</b></p>	<p><b>Present Use:</b> Private Residence  <b>Plan:</b> Irregular                  Addition to W; West boarded door</p> <p><b>Foundation:</b> Continuous  <b>Roof:</b> Gable/Pyramid  <b>Main Entry:</b> Covered by plywood on N façade  <b>Porch(es):</b> None visible from public right of way</p> <p><b>Windows:</b> SHS 2/2, aluminum-framed, paired</p> <p><b>Distinguishing Features:</b> Gable vents, metal security bars. Western addition w/pyramidal roof connecting to main gable roof</p> <p><b>Ancillary Features:</b> Shares parcel with 8PO08200 and 8PO07156 to S, chain link fence to N</p>	<p><b>Structural System:</b> Masonry - General  <b>Exterior Fabric:</b> Stucco</p> <p><b>Foundation Material:</b> Concrete, Generic  <b>Roof Material:</b> Asphalt shingles</p> <p><b>Relocated:</b> NO  <b>Stories:</b> 1  <b>Chimneys:</b> 0</p>

<p><b>Individually Eligible:</b> NO  <b>Contributing Resource:</b> NO</p>	<p><b>Evaluation:</b> Due to lack of sufficient historic significance and architectural distinction, 8PO08199 is ineligible for listing in the NRHP, either individually or as a contributing resource within a potential or existing historic district.</p>

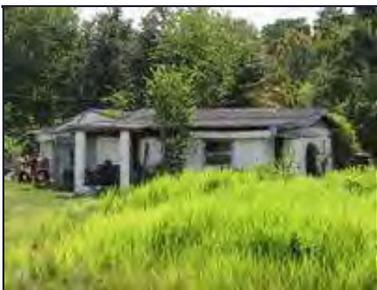
<h1>8PO08200</h1>	<p><b>Name:</b> 6702 US Highway 17/92 N</p> <p><b>Original or Update:</b> Update      <b>US Quad Map:</b> DAVENPORT (2021)</p>	<p><b>Built:</b> ca. 1962</p> <p><b>TRS:</b> 26S28E6</p>
<p><b>Original Use:</b> Private Residence  <b>Style:</b> Frame Vernacular  <b>Additions and Alterations:</b></p>	<p><b>Present Use:</b> Private Residence  <b>Plan:</b> L-shaped                  NE add, SE add; Stucco board siding W façade</p> <p><b>Foundation:</b> Continuous  <b>Roof:</b> Gable  <b>Main Entry:</b> Covered by plywood on NE façade  <b>Porch(es):</b> Open, partial width porch with a flat roof extension, supported by large square columns on NW façade</p> <p><b>Windows:</b> SHS, 1/1 &amp; 2/2, aluminum-framed, individual; DHS 1/1, vinyl-framed, individual; DHS 1/1, wood-framed, individual</p> <p><b>Distinguishing Features:</b> Addition has a gable portico over the entryway. The structures are in a deteriorated condition with siding and decorative features falling off.</p> <p><b>Ancillary Features:</b> Attached gable structure to the NE of main structure, mature tree E of dwelling</p>	<p><b>Structural System:</b> Wood frame  <b>Exterior Fabric:</b> Drop siding, Wood/Plywood</p> <p><b>Foundation Material:</b> Concrete Block  <b>Roof Material:</b> Composition roll</p> <p><b>Relocated:</b>  <b>Stories:</b> 1  <b>Chimneys:</b> 0</p>

<p><b>Individually Eligible:</b> NO  <b>Contributing Resource:</b> NO</p>	<p><b>Evaluation:</b> Due to lack of sufficient historic significance and architectural distinction, 8PO08200 is ineligible for listing in the NRHP, either individually or as a contributing resource within a potential or existing historic district.</p>

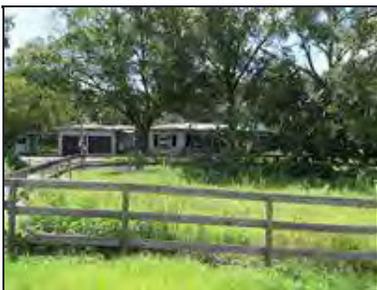
<h1>8PO08615</h1>	<p><b>Name:</b> 6110 US Highway 17/92 N Building 1</p> <p><b>Original or Update:</b> Original      <b>US Quad Map:</b> DAVENPORT (2021)</p>	<p><b>Built:</b> ca. 1953</p> <p><b>TRS:</b> 26S28E7</p>
<p><b>Original Use:</b> Private Residence  <b>Style:</b> Ranch  <b>Additions and Alterations:</b></p>	<p><b>Present Use:</b> Private Residence  <b>Plan:</b> Irregular                  Connection garage to house</p> <p><b>Foundation:</b> Unknown  <b>Roof:</b> Hip  <b>Main Entry:</b> Wood door w/ three upper lights, covered by a fully-glazed metal-framed storm door on NW elevation  <b>Porch(es):</b> Incised porch in the center of the NW elevation. Second incised porch on N elevation.</p> <p><b>Windows:</b> 16 light fixed picture, aluminum-framed; 4 light awning, aluminum-framed</p> <p><b>Distinguishing Features:</b> A small, dentil-like frieze located above the incised porch on NW facade. Hip extension on SE façade.</p> <p><b>Ancillary Features:</b> Shares parcel with 8PO08616 to the SE, concrete slab driveway to the NE, wood fence to N.</p>	<p><b>Structural System:</b> Concrete block  <b>Exterior Fabric:</b> Concrete block</p> <p><b>Foundation Material:</b> Obscured  <b>Roof Material:</b> Asphalt shingles</p> <p><b>Relocated:</b> NO  <b>Stories:</b> 1  <b>Chimneys:</b> 1</p>

<p><b>Individually Eligible:</b> NO  <b>Contributing Resource:</b> NO</p>	<p><b>Evaluation:</b> Due to lack of sufficient historic significance and architectural distinction, 8PO08615 is ineligible for listing in the NRHP, either individually or as a contributing resource within a potential or existing historic district.</p>

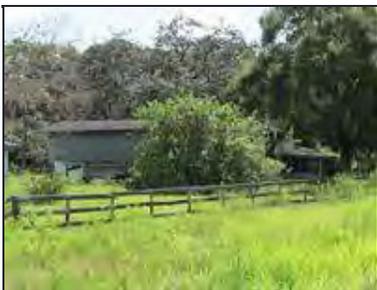
<h1 style="margin:0;">8PO08616</h1>	<p><b>Name:</b> 6110 US Highway 17/92 Building 2</p> <p><b>Original or Update:</b> Original      <b>US Quad Map:</b> DAVENPORT (2021)</p> <p><b>Present Use:</b> Private Residence      <b>Structural System:</b> Wood frame</p> <p><b>Plan:</b> L-shaped      <b>Exterior Fabric:</b> Drop siding</p> <p>Vegetation obscures residence</p> <p><b>Foundation:</b> Unknown      <b>Foundation Material:</b> Obscured</p> <p><b>Roof:</b> Shed      <b>Roof Material:</b> Composition roll</p> <p><b>Main Entry:</b> Not visible from public right of way</p> <p><b>Porch(es):</b> Closed, screened in porch on S elevation with a shed roof supported by wood posts and lattice wood under screen windows. The porch entry is found on the E end of the S façade</p> <p><b>Windows:</b> None visible from public right of way</p> <p><b>Distinguishing Features:</b> Resource is a Shed style residence as exhibited by the the multi-directional &amp; multilevel shed roofs. The resource is heavily obscured by vegetation.</p> <p><b>Ancillary Features:</b> Shares parcel with 8PO08615 to the NW, carport to the N.</p>	<p><b>Built:</b> ca. 1958</p> <p><b>TRS:</b> 26S28E7</p> <p><b>Relocated:</b> NO</p> <p><b>Stories:</b> 1</p> <p><b>Chimneys:</b> 0</p>

<p><b>Original Use:</b> Private Residence</p> <p><b>Style:</b> Frame Vernacular</p> <p><b>Additions and Alterations:</b></p>

<p><b>Individually Eligible:</b> NO</p> <p><b>Contributing Resource:</b> NO</p>	<p><b>Evaluation:</b> Due to lack of sufficient historic significance and architectural distinction, PO08616 is ineligible for listing in the NRHP, either individually or as a contributing resource within a potential or existing historic district.</p>

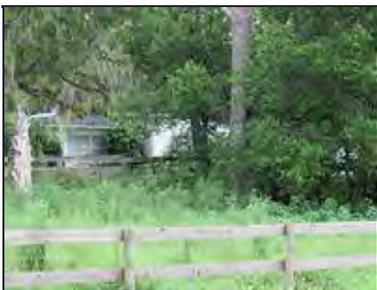
<h1 style="margin:0;">8PO08617</h1>	<p><b>Name:</b> 6118 US Highway 17/92 N</p> <p><b>Original or Update:</b> Original      <b>US Quad Map:</b> DAVENPORT (2021)</p> <p><b>Present Use:</b> Vacant      <b>Structural System:</b> Concrete block</p> <p><b>Plan:</b> Rectangular      <b>Exterior Fabric:</b> Concrete block</p> <p>Converted carport to office</p> <p><b>Foundation:</b> Unknown      <b>Foundation Material:</b> Obscured</p> <p><b>Roof:</b> Hip      <b>Roof Material:</b> Composition shingles</p> <p><b>Main Entry:</b> Glass door w/ metal from and two large side lights on NW façade</p> <p><b>Porch(es):</b> Open, shed roof porch with a concrete slab floor, a concrete block wall to the S, and a decorative metal posts on the northern section of the porch.</p> <p><b>Windows:</b> Jalousie, aluminum-framed grouping; awning, aluminum-frame, paired, 4-light</p> <p><b>Distinguishing Features:</b> Gabled vents, carport addition. Wood fence and overgrown vegetation obscure foundation.</p> <p><b>Ancillary Features:</b> One barn with a shed roof clad in horizontal wood plank NE of bldg. One gable barn E of bldg, visible on 2021 aerials. Wood fence to N</p>	<p><b>Built:</b> ca. 1958</p> <p><b>TRS:</b> 26S28E7</p> <p><b>Relocated:</b> NO</p> <p><b>Stories:</b> 1</p> <p><b>Chimneys:</b> 0</p>

<p><b>Original Use:</b> Farm</p> <p><b>Style:</b> Masonry Vernacular</p> <p><b>Additions and Alterations:</b></p>

<p><b>Individually Eligible:</b> NO</p> <p><b>Contributing Resource:</b> NO</p>	<p><b>Evaluation:</b> Due to lack of sufficient historic significance and architectural distinction, 8PO08617 is ineligible for listing in the NRHP, either individually or as a contributing resource within a potential or existing historic district.</p>

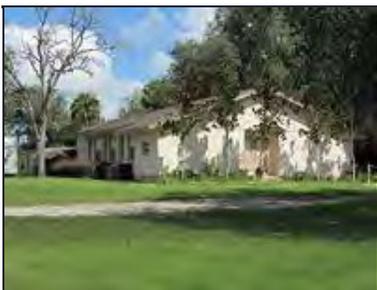
<h1 style="margin:0;">8PO08618</h1>	<p><b>Name:</b> Casa De Israel Yarah Church; 6311 US Highway 17/92</p> <p><b>Original or Update:</b> Original      <b>US Quad Map:</b> DAVENPORT (2021)</p> <p><b>Present Use:</b> Church      <b>Structural System:</b> Masonry - General</p> <p><b>Plan:</b> Rectangular      <b>Exterior Fabric:</b> Concrete block</p> <p><b>Foundation:</b> Continuous      <b>Foundation Material:</b> Concrete, Generic</p> <p><b>Roof:</b> Gable      <b>Roof Material:</b> Composition shingles</p> <p><b>Main Entry:</b> Double vinyl doors s with 9 upper lights on SE façade</p> <p><b>Porch(es):</b> Small, incised porch with a concrete slab landing and thin, concrete block steps on SE façade</p> <p><b>Windows:</b> SHS vinyl-framed 1/1 , 4/4 &amp; , 9/9, individual</p> <p><b>Distinguishing Features:</b> Unelaborate square, concrete block buttresses on the east and west facades between windows, T1-11 siding on gable end.</p> <p><b>Ancillary Features:</b> Gabled historic outbuilding west-northwest of main structure, planters and concrete slab walkway on E, W, and N facade.</p>	<p><b>Built:</b> ca. 1970</p> <p><b>TRS:</b> 26S28E7</p> <p><b>Relocated:</b> NO</p> <p><b>Stories:</b> 1</p> <p><b>Chimneys:</b> 0</p>

<p><b>Original Use:</b> Church</p> <p><b>Style:</b> Masonry Vernacular</p> <p><b>Additions and Alterations:</b> None</p>

<p><b>Individually Eligible:</b> NO</p> <p><b>Contributing Resource:</b> NO</p>	<p><b>Evaluation:</b> Due to lack of sufficient historic significance and architectural distinction, 8PO08618 is ineligible for listing in the NRHP, either individually or as a contributing resource within a potential or existing historic district.</p>

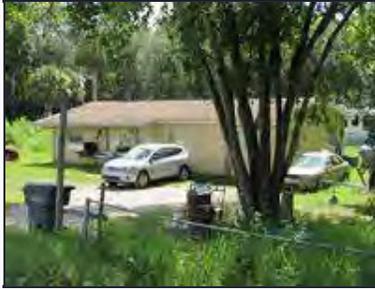
**Distinguishing Features:** Asphalt roof ridge, roof overhang on northwestern façade, vents on gable end, faux window sills on N facade, secondary entrance on E facade.

**Ancillary Features:** Gable roof shed with concrete block walls N of bldg; dirt driveway N of bldg

**Evaluation:** Due to lack of sufficient historic significance and architectural distinction, 8PO08619 is ineligible for listing in the NRHP, either individually or as a contributing resource within a potential or existing historic district.
